Modern and contemporary art

# The deterioration of Apuan white marble in contemporary architectural context

This paper reports the results obtained from the analyses carried out on marble slabs used as floor, cladding and sloping roof of the Oslo Opera House in order to understand the causes of the intense yellow discoloration and to investigate their state of conservation, aiming to define new guidelines for the maintenance of the building.

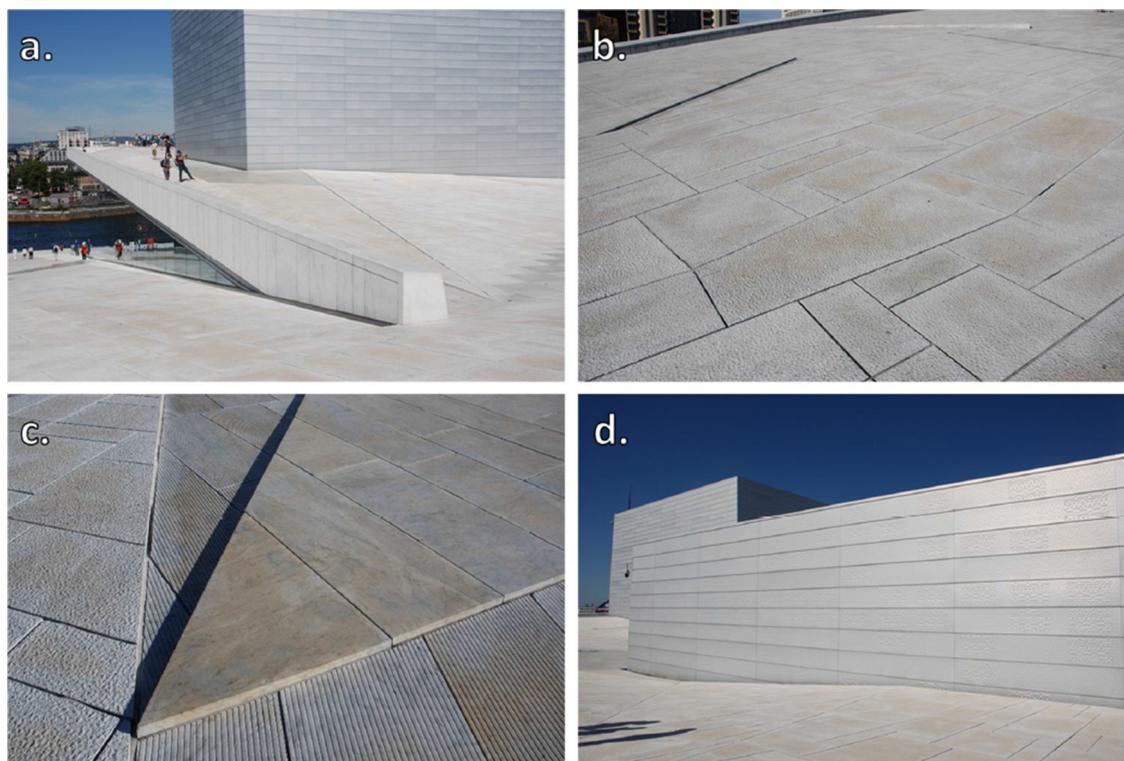
**Fig. 1.** The Oslo Opera House: a) vertical surface cladding and b) ornamental pavement slabs made of Carrara marble, characterized by c) different surface finishings; d) vertical surface cladding made of aluminum sheets.

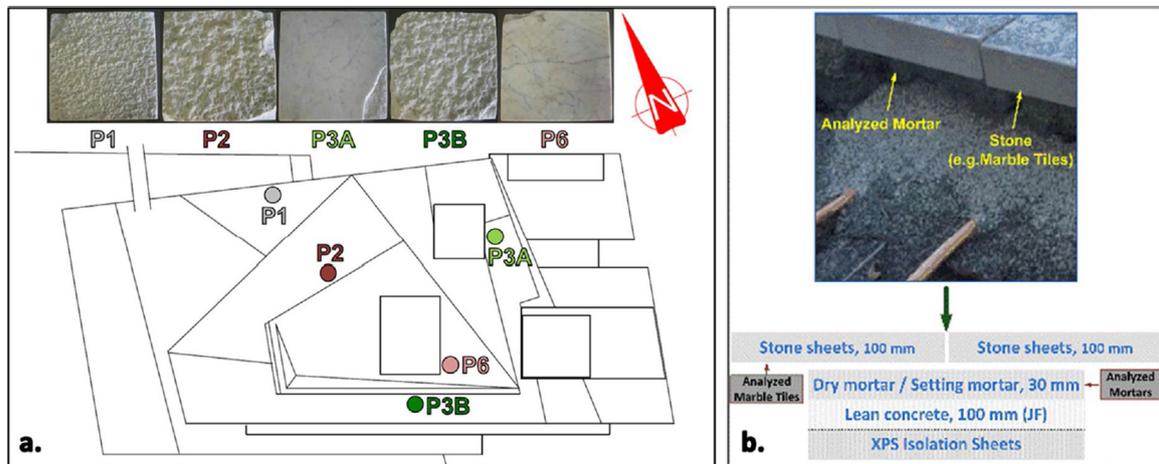
**Fig. 2.** Location and surface characteristics of the sampled marble slabs. a: P1, P2, P3A, P3B and P6 areas and their localization in the building plan; b: marble slabs mounting during construction and cladding technology and materials. Courtesy of Statsbygg [9].

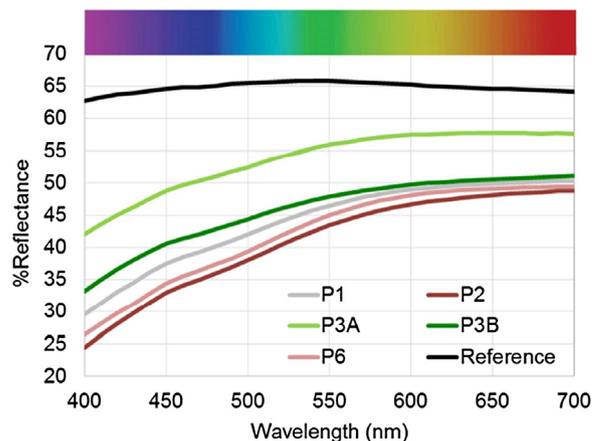
**Fig. 3.** Reflectance spectra obtained from Vis spectrophotometric measurements on unexposed (Reference) and exposed (P1, P2, P3A, P3B and P6) slabs.

VIS reflectance measurements of both unexposed and exposed surfaces of marble samples provide a quantitative basis to the visual perception of the alteration of color. Compared to the reference sample, P1–P6 slabs exhibit a remarkable decrease in  $L^*$ , that accounts for a loss of brightness, and an increase in  $b^*$  values which represents the saturation of the yellow component in the CIE  $L^*a^*b^*$  system (Table 2). Reflectance curves (Fig. 3) display a general decrease in reflectance values as compared to the white reference marble slab and a marked decrease at wavelengths lower than  $500\text{ nm}$  with shoulder peaked at  $450$  and around  $570\text{ nm}$ . Indeed, the former feature can be linked to the decrease of the observed  $L^*$  values while the two shoulders account for the general yellowing. Among them, P2 and P6 slabs are those showing a more intense discoloration with an increase of  $b^*$  coordinate of  $12$  units (Table 2 and Fig. 3).

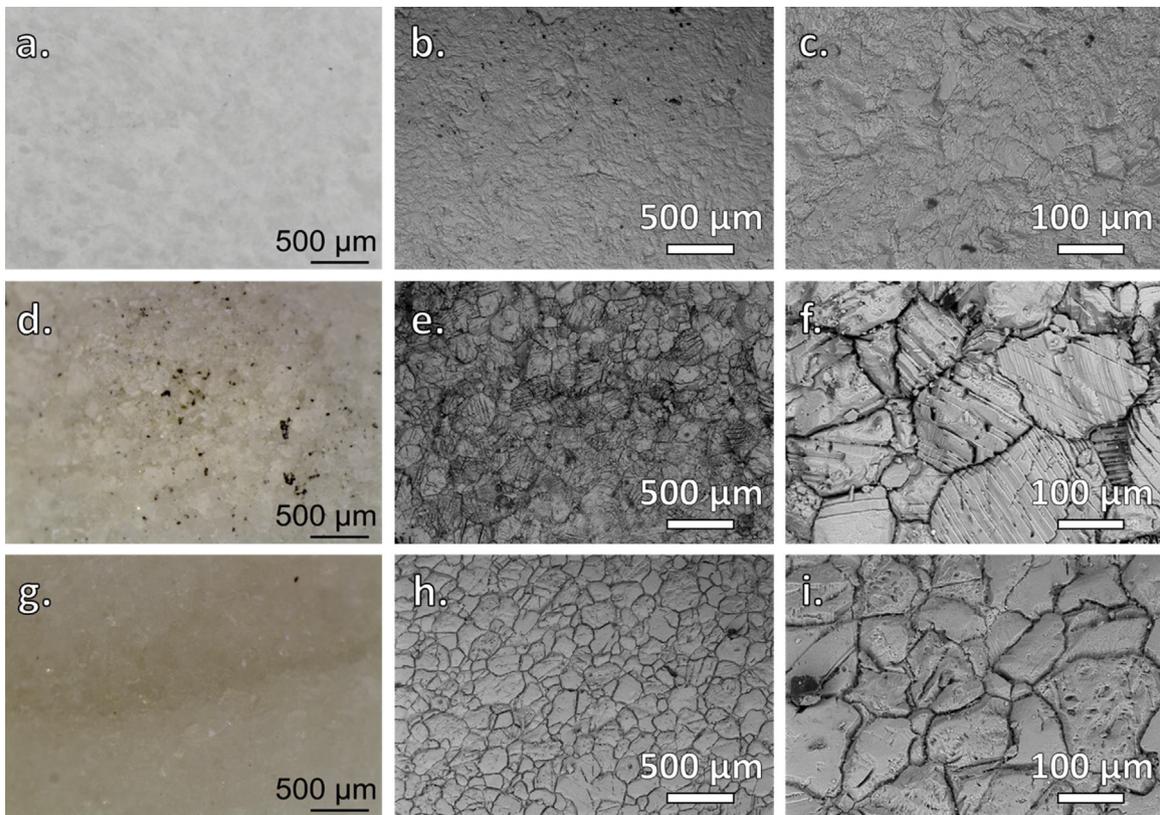
The crystal structure of the unexposed reference slab is very compact and the boundaries of calcite grains are almost not visible (Fig. 4b and c). This morphology, which is peculiar of a sound Apuan marble microstructure, can be highlighted also in the cross-section observations (Fig. 6a). The surface of exposed slabs is rather different, as far as an intense decohesion of the crystal fabric can be detected [7,14]. The grain boundaries can be clearly perceived with rounded edges and detachment empty spaces creating a network of microfissures (Fig. 4e, f, h and i and Fig. 5b–f). Moreover, in the calcite crystals of hammered slabs (P1, P2, P3B), the cleavage planes are evidenced with the appearance of internal subparallel lines due to an ongoing intragranular corrosion phenomenon in the initial phase (Fig. 4f and Fig. 5b, c and e). Observing the cross-

**Fig. 4.** Optical and BSE-ESEM images of surface of unexposed reference (a, b, c) and exposed P1 (d, e, f) and P6 (g, h, i) slabs.

Compared to the unexposed slab (Fig. 4a), the exposed ones exhibit a general yellowing and brown/grey surface particulate deposit (Fig. 4d and g). In particular, the yellow discoloration penetrates in the marble for about 20 mm (Figure S1). At higher magnifications, solid materials with different morphologies can be observed (Fig. 6). The elemental compositions of the deposits show Na, Mg, Al, Si, S, Cl and K peaks related to environmental deposits and sea spray (Fig. 7a and b). It is important to highlight that on the yellowed surface of the exposed slabs, iron (Fe) was scarcely detected by EDX analyses, and only very few grains of pyrite can be observed, pertaining to the mineral composition of the marble. On the “sawn” slabs (P3A and P6) the surface deposits accumulate both on the surface and inside the micro-cavities of the grains. In particular, some darker areas in BSE can be evidenced with the accumulation of “drops” of organic materials (Fig. 7c). The elemen-

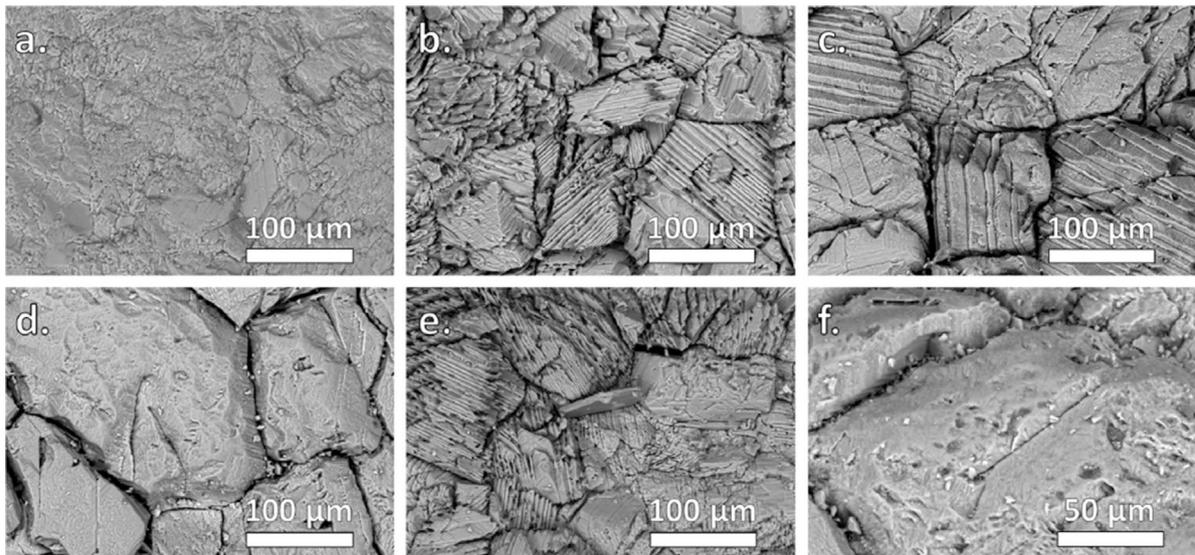
**Fig. 5.** BSE-ESEM images of surface of unexposed reference (a) and exposed P1 (b), P2 (c), P3A (d), P3B (e) and P6 (f) slabs.

sections of P1, P2, P3B slabs the surface is characterized by the network of microfractures (more than 200  $\mu\text{m}$  inside the bulk of the material) and the incipient detachment of corroded surface grains (Fig. 6). Slabs with a “sawn” finishing exhibit a crystalline microstructure with the same intergranular decohesion, whereas the single grain shows a better preservation of the internal crystalline microstructure (Fig. 4h and i). Only some isolated crystals are deteriorated and corroded, with microfractures that can be noticed on the surface at higher magnification (Fig. 4i and Fig. 5d and f). By observing the cross-section of the samples collected from P6 slab, one of the most altered in color, high granular decohesion can be observed not only on the surface (Fig. 6c), where the grains are detached, but also inside the sample till about 2 mm. It is well evident that the different finishing surface working determine a different reaction of calcite grains towards environmental corrosion. The degradation phenomenon of the crystalline microstructure should be primarily ascribed to thermal excursions due to severe microclimatic condition in Oslo, subjected to frequent and long freezing-thawing cycles [7,14–16]. In addition, surface erosion phenomena caused by weather precipitations (rain and snow) and salt crystallization cycles due to  $\text{Cl}^-$  containing marine spray and therefore cyclic dissolution and re-crystallization of halite ( $\text{NaCl}$ ) inside the surface porosity of the stone can play a significant role in the observed surface decay. The surface finishing of the marble slabs can have influenced their state of conservation, as the hammered ones evidenced a more intense corrosion and damage of the crystal grains.

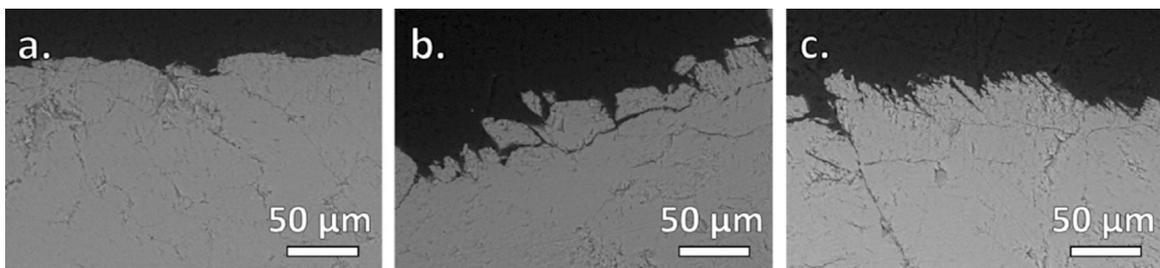
**Fig. 6.** BSE-ESEM images of cross-sections of unexposed reference (a) and exposed P2 (b) and P6 (c) slabs.

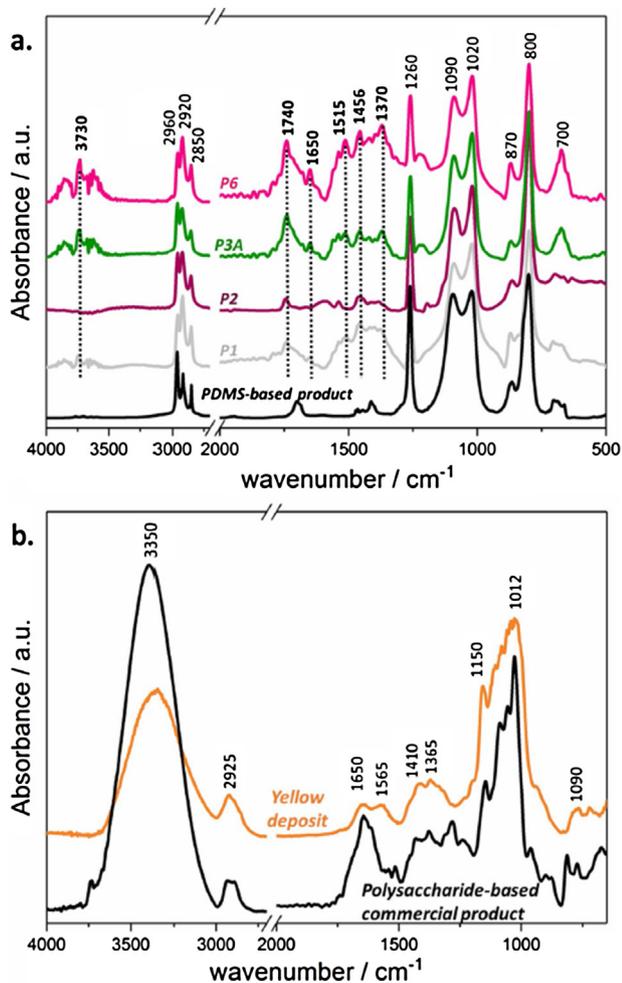
The FTIR spectra (Fig. 8a) of the hexane extracts obtained from the surface of four different slabs (P1, P2, P3A, P6) show a pattern of absorption peaks at 1020 and 1090  $\text{cm}^{-1}$  (Si-O-Si stretching), 1260  $\text{cm}^{-1}$  (Si- $\text{CH}_3$  bending), 800  $\text{cm}^{-1}$  (Si- $\text{CH}_3$  rocking) and from 2950–2850  $\text{cm}^{-1}$  (C-H stretching). These signals indicate the presence of a polysiloxane macromolecule [17–20], as the comparison with the reference spectrum of one of the most common siloxanes, i.e. polydimethylsiloxane (PDMS), clarifies (Fig. 8a). The finding of such product is plausible, since, to the best of our knowledge, a siloxane-like product was most probably applied on marble slabs in 2012, yet the chemical composition of this coating remains unknown to us, hence it must be emphasized that the reported reference spectrum does not necessarily refer to the product actually applied few years ago on marble. Moreover, further signals can be observed in the spectra of the materials extracted with different organic solvents, which clearly point to the co-presence of other organic compounds. Indeed, the peak around 1740  $\text{cm}^{-1}$  (C=O stretching of esters) and the multiple peaks in the range from 1650–1510  $\text{cm}^{-1}$  (not readily interpretable but possibly comprising the  $\text{COO}^-$  stretching vibrations of carboxylate ions) suggest the presence of esters and carboxylates [21], while the wide band between 3800–3300  $\text{cm}^{-1}$  (O-H stretching) is evidence of the presence of free hydroxyl groups. These signals were observed in the spectra of extracts up to several millimeters under the surface, extending as deeply as the yellowing of marble, whereas signals ascribable to the siloxane backbone were only detected on the marble surface. Their co-extension with the yellowing suggests that they may be degradation products, with a likely implication in the discoloration of marble, yet their source and formation mech-

**Fig. 8.** a: FTIR spectra of the extract with hexane from surface powder of P1, P2, P3A and P6 slabs and the spectrum of a reference poly(dimethylsiloxane)-based product (PDMS); b: FTIR spectrum of a yellow deposit collected from P1 slab and the spectrum of the polysaccharide-based commercial product (PSS20).

The FTIR spectra (Fig. 8b) of the localized yellow-brown deposits collected from the surface of marble slabs show the typical features of a polysaccharide compound. This is evident through the strong absorption bands around  $3350\text{ cm}^{-1}$  and from  $1000\text{--}1150\text{ cm}^{-1}$ , which are typically the most intense signals in the spectra of polysaccharides, related to the O-H and C-C-O stretching vibrations, respectively [22]. Furthermore, a comparison with the spectrum (Fig. 8b) of PSS20, the commercial anti-graffiti product that was applied on marble slabs in 2007–2008 and is based on a natural polysaccharide, indicates with strong probability that the yellow-brown deposits are residuals of this treatment. Among the other signals, a peak at  $1650\text{ cm}^{-1}$  can be noticed. This peak is difficult to assign univocally, but, according to one reasonable hypothesis, it may be related to the O-H bending vibration of adsorbed water, which can be found in variable content in the spectra of these com-

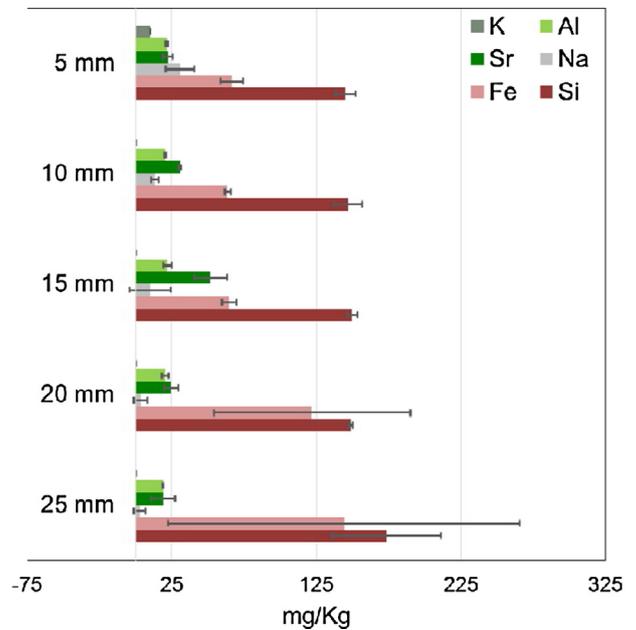
**Fig. 9.** Average elemental composition (mg/Kg, ppm) obtained by ICP-OES of 2 sets of samples collected from P6 slab at different depth from the external surface: 5, 10, 15, 20, 25 mm.

ICP-OES determination of the in depth (20 cm) elemental composition, demonstrated that there is not a correlation of yellowing with iron (Fe) ions concentration.

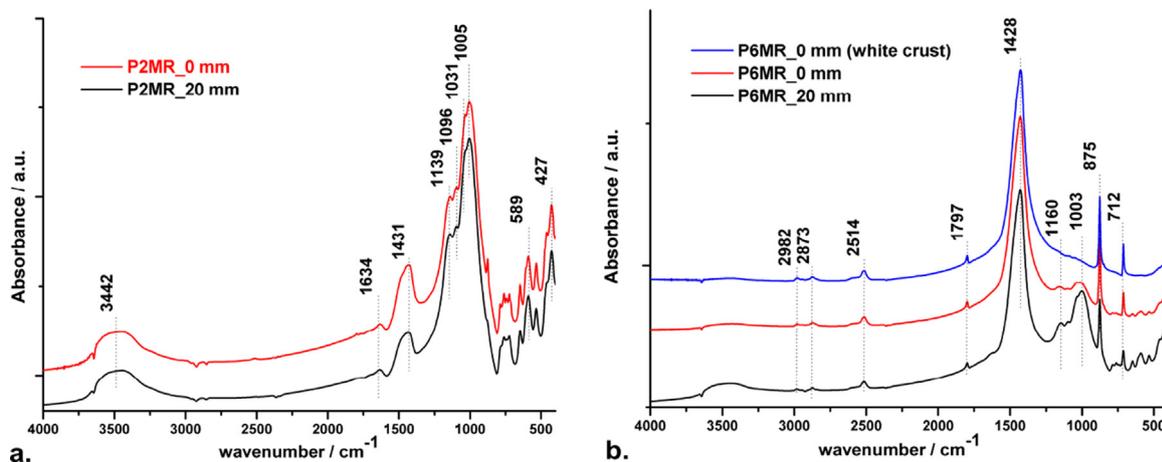
Fig. 10. FTIR spectra of both sides of P2MR (a) and P6MR (b) mortars.

The mortars P2MR and P6MR at two different depths from the surface, along with the whitish crust of P6MR, were analysed by FTIR spectroscopy. P2MR mortar sample (Fig. 10a) consists of calcite (1431  $\text{cm}^{-1}$ ), hydrated aluminosilicate and siloxane components which exhibited absorption peaks in the spectral range 1000–1100  $\text{cm}^{-1}$  (1005, 1031 and 1096  $\text{cm}^{-1}$ ). It is well established that the  $\text{SiO}_4^{4-}$  vibration of the CSH compounds of cement show infrared absorption bands in the range of 970–990  $\text{cm}^{-1}$  [26]. The sharp peaks in the range 1000–1100  $\text{cm}^{-1}$  shown in the Fig. 10a are attributed to the Si-O-Si due to siloxane admixtures in the mortars. The presence of hydrated sulphates is indicated by absorptions at 3442, 1634, 1139 and 589  $\text{cm}^{-1}$ . The infrared spectrum of the whitish upper layer of P6MR mortar reported in Fig. 10b, showed absorption peaks of calcite with traces of absorptions in the range

1000–1100  $\text{cm}^{-1}$  attributed to Si-O-Si bonds of CSH and siloxane components; the latter increase in the spectra of the internal part of the mortar sample (20 mm). The high content of calcite should be ascribed to the residual marble adhered to the cement bedding mortar and could be considered as an indication of no migration of the components of bedding mortar through the marble.

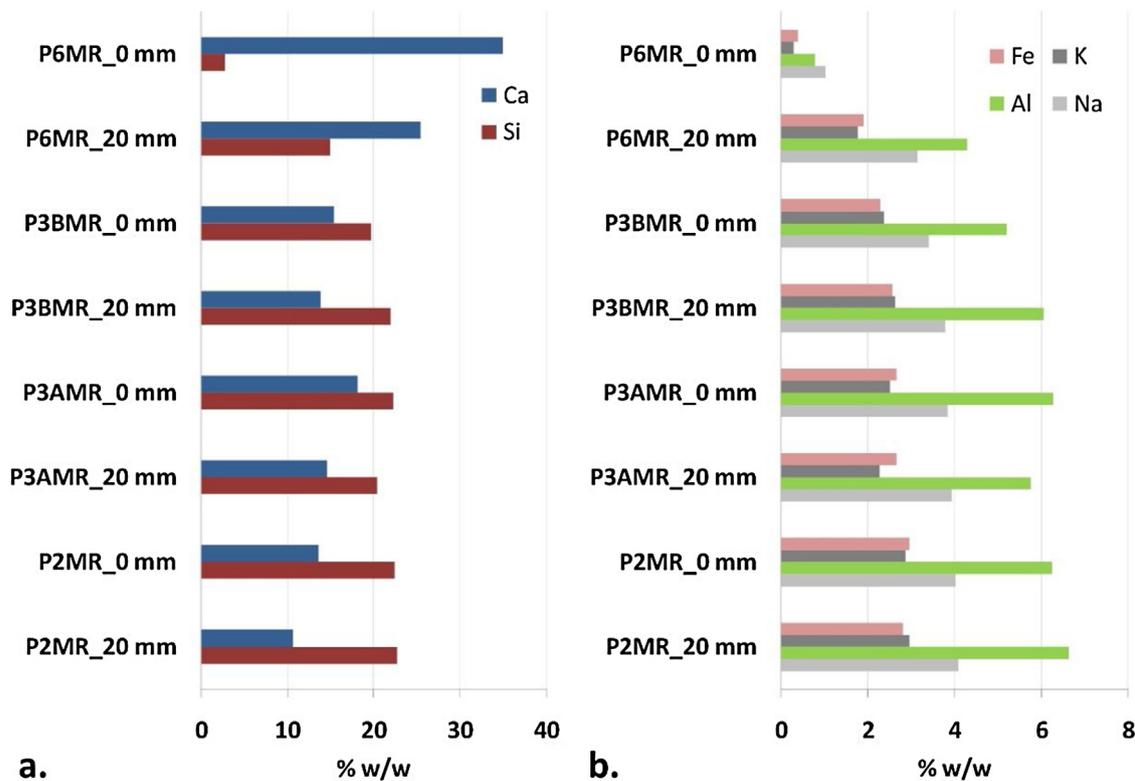
The diagram of Fig. 11a compares the concentration of Si and Ca (%w/w) identified in all the mortars. The lowest content of Si that was detected for P6MR.S sample can be correlated with the high Ca concentration due to the marble residue adhered to the mortar and it is in agreement with the FTIR results. Moreover, the considerable Na amount detected in the mortars is in good agreement with the Na quantity found in the lower side of the marble slab, which were in direct contact with the mortars. Finally, it is important to highlight that no Fe migration occurred from the mortars to the marble slabs. This becomes evident from the lowest Fe amount detected in the P6MR.0 mm sample (Fig. 11b), which reflects the residual marble adhered to the mortar.

Fig. 11. EDXRF analysis on the surface and up to a depth of 20 mm of the studied mortars.
