The impact of multiparameter ageing of stator poles of traction motors on diagnostic methods

School of Electrical and Computer Engineering
Technical University of Crete

Antonios Douvaras

Chania, March 2024

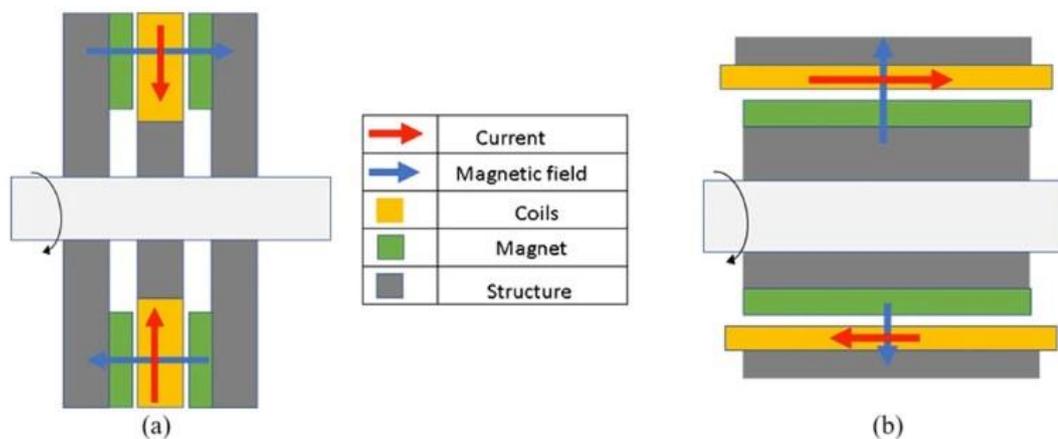
Fig.1.7. Magnetic Field Orientation: (a) Axial Flux, (b) Radial Flux [18]

Direct-drive machines impose stringent requirements on the axial length of electric motors. This configuration has given rise to a new category of electric motors known as Axial Flux Motors [10]. In these motors, the magnetic flux lines run parallel to the axis of rotation, unlike conventional radial flux motors where the magnetic flux is perpendicular to the axis of rotation as can be shown in Fig.1.7.

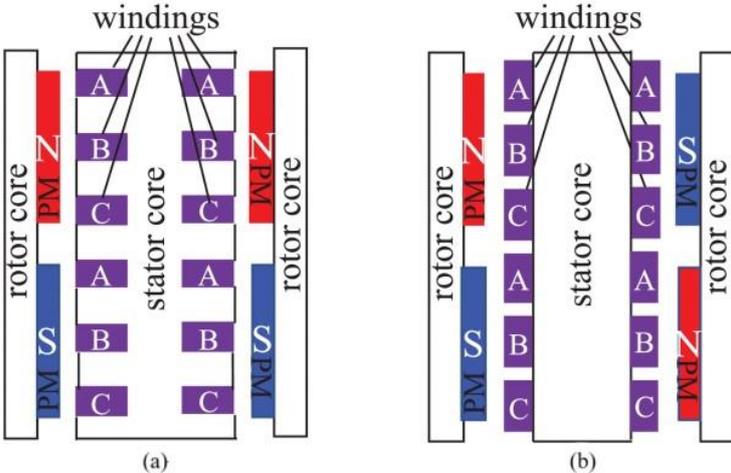
Fig.1.8. AFPM machines TORUS topology: (a) Slotted stator N-N PM TORUS, (b) Slotless stator N-S PM TORUS [10]

The category of Permanent Magnet Synchronous Motors (PMSM) includes double-sided Axial Flux Permanent Magnet (AFPM) machines with an external-rotor internal-stator configuration, referred to as TORUS (Fig.1.8). In TORUS, magnets on opposing disks can be arranged either in N-N or N-S configurations. The N-S arrangement allows for the removal of the stator back core, resulting in decreased axial length, diminished iron losses, and an amplified power density and efficiency. Conversely, the TORUS N-N topology retains a relatively substantial stator back core to manage the magnetic flux originating from the external rotors.

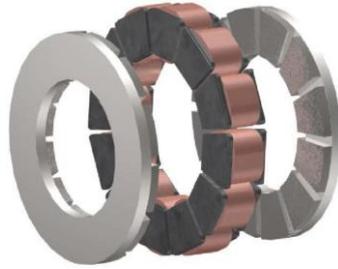
Fig.1.10. YASA topology [10]

Eliminating the stator yoke from the TORUS N-S type structure and incorporating tooth-wound concentrated windings (CWs) for a segmented stator construction result in the Yokeless And Segmented Armature (YASA) AFPM machine topology (Fig.1.10) [11],[12]. YASA motors are gaining increasing prominence due to their high torque density, compact structure, and low weight, rendering them appropriate for the automotive industry.

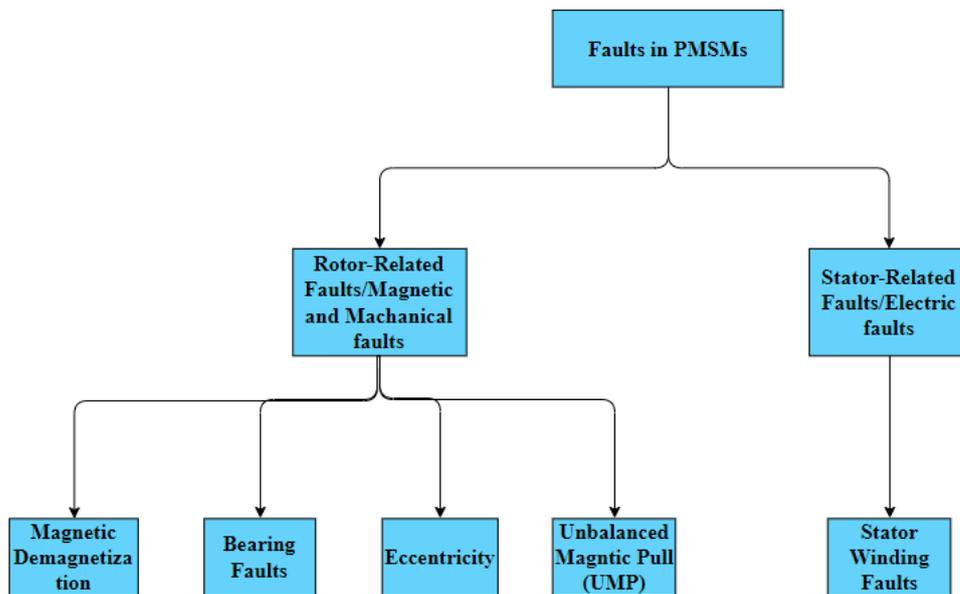
Fig.2.1: Faults in PMSMs

Faults in PM machines can be categorized into two types (Fig.2.1), as indicated by [27]-[29]: rotor-related faults and stator-related faults. Rotor faults encompass magnetic demagnetization, bearing faults, eccentricity, and unbalanced magnetic pull (UMP), which are collectively referred to as both magnetic and mechanical faults. Stator-related faults, alternatively known as electric faults, are associated with winding faults.

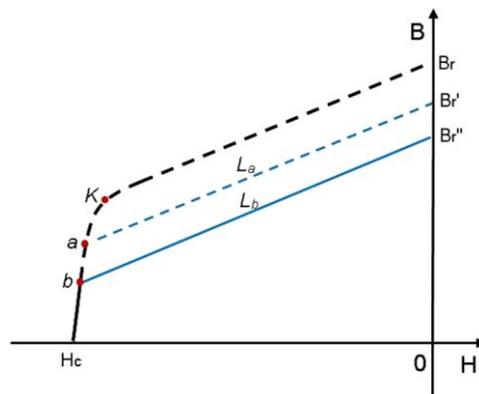
Fig.2.2. Irreversible demagnetization due to working point below knee point [30]

In Fig.2.2, a typical demagnetization characteristic can be observed [30]. If the operating point of the magnetic material is located below the knee point K , even if the external demagnetization field H_a is reduced or removed, the operating point can't reach its original B-H characteristic and will follow the recoil line L_a . As long as the

value of the external demagnetization field does not exceed the value of H_a , then the operating point of the magnetic material continues to coincide with the recoil line L_a . However, in the case where an external demagnetizing field H_b higher than H_a is applied, then again, the operating point of the magnetic material will change, and there will be a lower knee point b as well as a new recoil line b . Thus, the change in the operating point leads to the elimination of the previous demagnetization curves, indicating that a strong external electric field may cause the irreversible demagnetization of PM. This electric field may be caused by a high short circuit current.

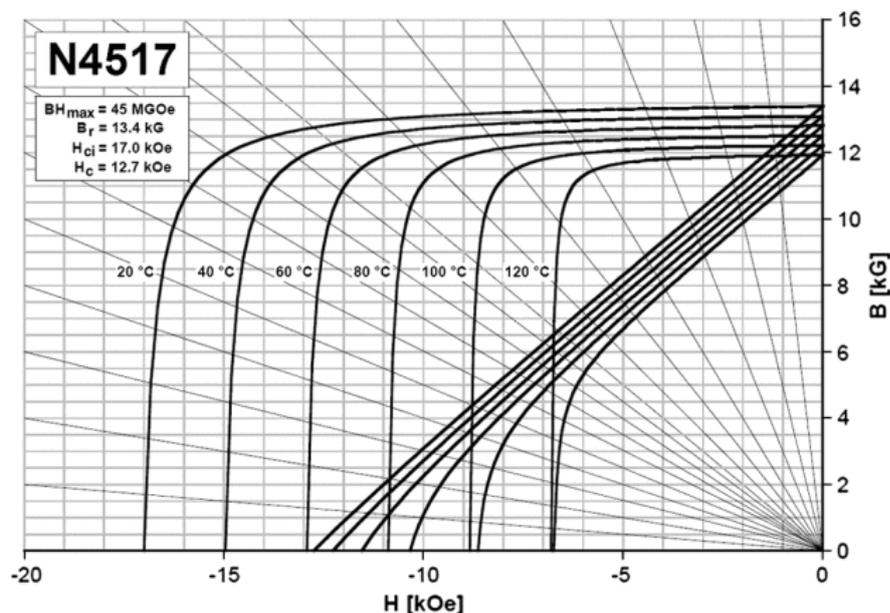
Fig.2.3. Effect of temperature on the B-H characteristic of a PM material [30]

In Fig.2.3, it can be concluded that the demagnetization curves are very sensitive to the rise in temperature. As the temperature increases, the region surrounded by the B-H curve becomes smaller, and when the temperature significantly rises, the irreversible demagnetization of the PM is highly probable.

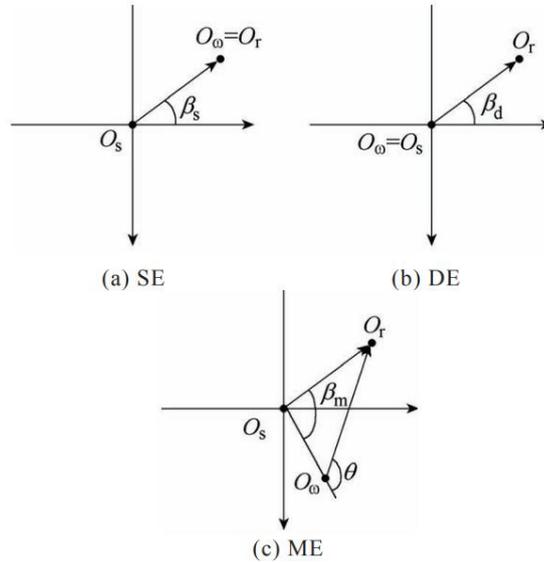
Fig.2.4: Stator and rotor cross-section positions [31]

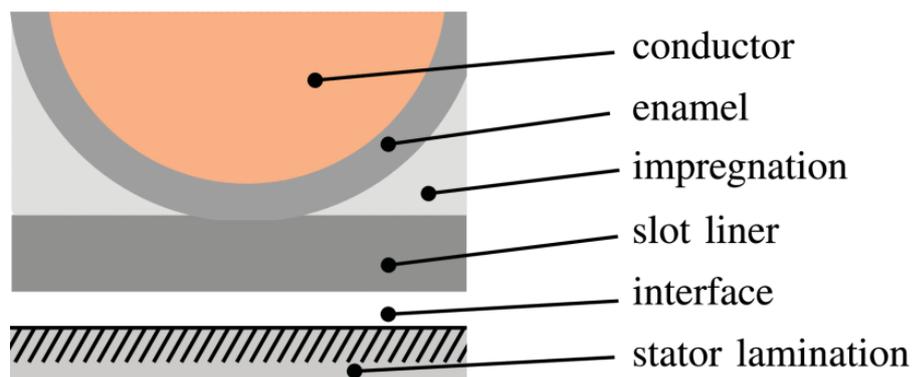
Fig.3.1: Geometry of insulation system [50]

Insulation materials are essential for the proper functioning of electric machines, providing electrical isolation between conductors, components, and subsystems through the utilization of a high-resistance medium ($T\Omega/\text{mm}$). A diverse variety of materials is used, including polyester, polyamide-imide (PAI), polyester-imide (PEI), mica, asphalt, nylon, and epoxy resins, which find application in various insulation roles, such as turn-to-turn insulation, or coil-to-core and other insulation within a machine's stator and rotor [49]. A classification of insulation materials based on Fig.3.1 follows:

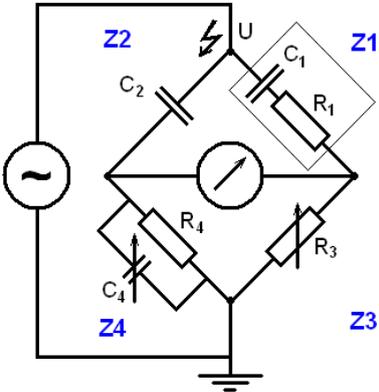
- C_1 : The capacitor whose capacitance is to be calculated
- R_1 : A series resistance representing the loss of C_1
- C_2 : A standard capacitor
- R_3 : A variable non-inductive resistance
- C_4 : A variable capacitor
- R_4 : A non-inductive resistance

One way for measuring the DF involves using a balanced bridge-type instrument – typically a Schering Bridge (Fig.3.6). In this setup, a resistive-capacitive circuit (Z_4) is adjusted to match the voltage and loss angle δ measured across the stator winding (Z_1). Subsequently, the DF is computed based on the resistive (R_1) and capacitive (C_1) elements in the bridge that result in a zero voltage.

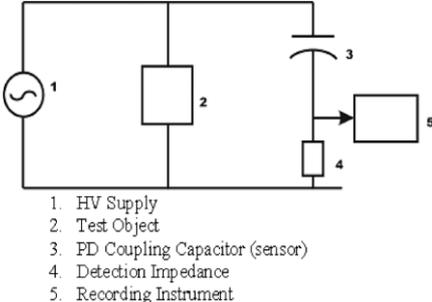
Fig.3.7: Offline PD Test Setup

Any sensor, also known as a PD coupling device, that is sensitive to high frequencies can detect the PD pulse currents. In an offline PD test (Fig.3.7), the detection of PD currents typically involves utilizing a sensor-PD coupling device, commonly a capacitor connected to the terminals of the equipment undergoing testing. This capacitor, with a capacitance value ranging between 80 and 1000 pF, is designed to be responsive to high frequencies, allowing it to effectively capture PD pulse currents resulting from electron emissions during PD occurrences. The output from this capacitor then triggers a detector, which converts the PD pulse currents into voltage. This detector, often referred to as an RLC detector, exhibits either resistive or inductive-capacitive behavior, functioning as a low-pass filter. It integrates the PD pulse current, generating a signal magnitude proportional to the apparent charge transfer caused by PD. This detection method proves highly effective, as the extent of insulation deterioration correlates with the quantity of electrons and ions impacting the insulation.

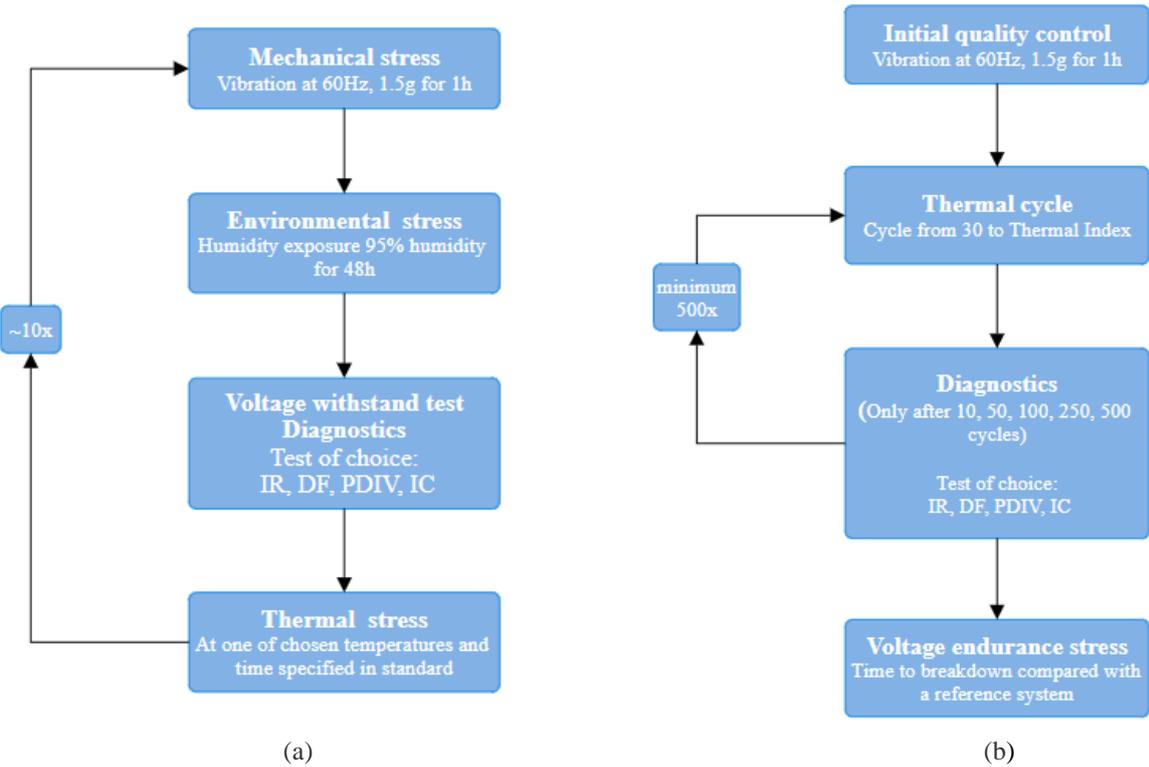
Fig.3.8: (a) Testing Protocol for Electrical Insulation System Qualification per IEC 60034-18-31, (b) Testing Protocol for Electrical Insulation System per IEC 60034-18-34 [72],[73]

weaker samples, which are subsequently eliminated from the test procedure. Following this, the specimens undergo a thermal cycling test, exposed to temperatures ranging from 30 degrees Celsius up to the Temperature Index. The Temperature Index is a numerical representation derived either mathematically or graphically from the thermal endurance graph, corresponding to the temperature in degrees Celsius. The thermal endurance graph, in turn, visually depicts the thermal endurance relationship, plotting the time to failure against the reciprocal of the absolute test temperature [17]. Diagnostic tests, including IR, DF, PDIV, IC, and other chosen tests, are conducted after a specific number of cycles, as illustrated in Fig.3.8. Finally, the specimens are subjected to thermal endurance tests where a voltage exceeding that expected in operation is applied to the insulation system. The time to failure is measured and compared with a reference system.

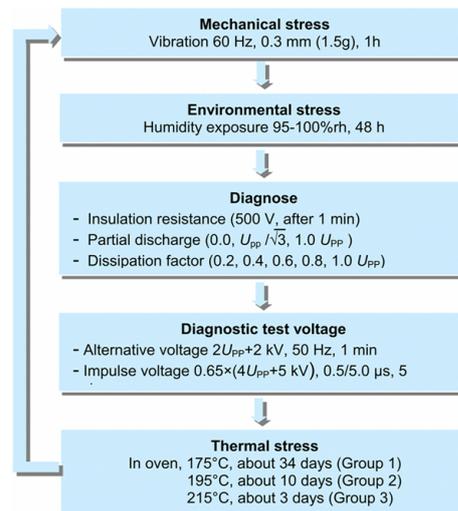
Fig.3.10: Procedure for Accelerated Thermal Ageing Test [71]

Initially, the insulation system undergoes mechanical stress, where the sample is placed on a shake table and exposed to vibration at a frequency of 60Hz, with a peak-to-peak amplitude of 0.3mm and acceleration of 1.5g for one hour at room temperature (23°C). Subsequently, the sample is subjected to environmental stress through exposure to humidity ranging between 95% and 100% relative humidity for 48 hours. Non-destructive diagnostic tests follow, focusing on Insulation Resistance, PD (Partial Discharge) test, and Dissipation Factor. For assessing the insulation condition and determining its lifespan, alternative and impulse voltage tests are applied. Finally, the samples are transferred to ovens at temperatures specified in the diagram. After all these stages, the presented procedure is repeated.

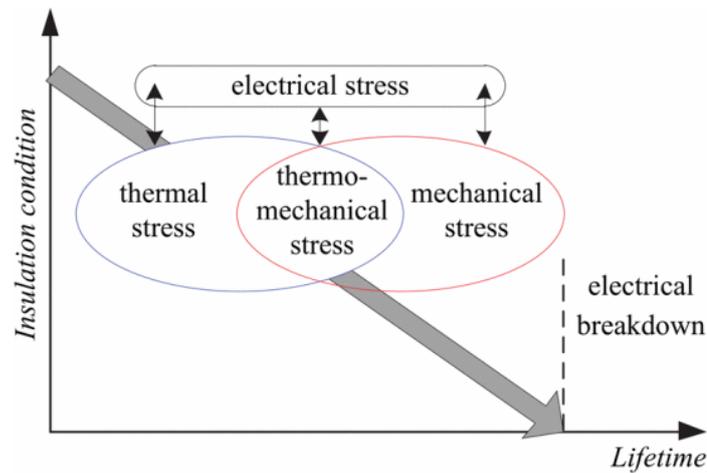
Fig.3.13: Aging mechanism of electrical insulation on stator bars [75]

• In [75],[84] electrical, thermal and mechanical stress act simultaneously and synergistically. The ageing process of the insulation system can be shown in Fig.3.13:

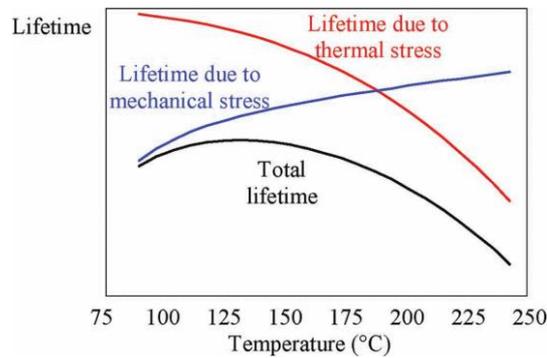
Fig.3.14: Lifetime as Influenced by Thermal, Mechanical, and Their Synergistic Interaction [84]

The synergy effect of thermal and mechanical stress accelerates the ageing process of the electrical insulation system, leading to a shortened lifespan. This interaction exerts a greater impact on the insulation system compared to the mere summation of individual ageing factors due to their nonlinear characteristics (Fig.3.14).

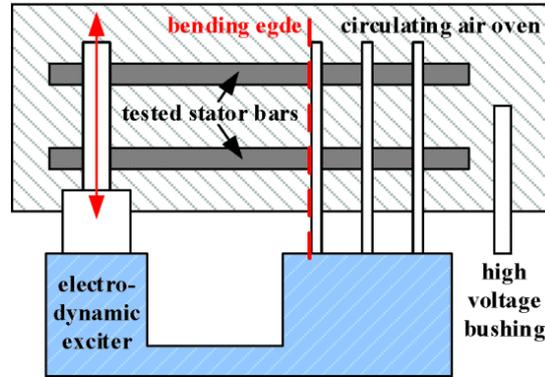
Fig.3.17: Test Set-Up

The setup for the accelerated ageing test includes a mechanical stress exciter, a circulating air oven for thermal stress, and a single-phase transformer for electrical stress (Fig.3.17).

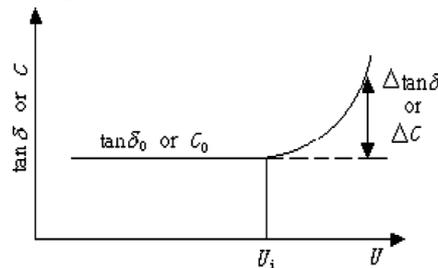
Fig3.18: Illustration of Dissipation Factor and Capacitance Increase with Applied Voltage

b) Dissipation Factor: The characteristic of the dissipation factor versus the applied voltage is shown in Fig.3.18:

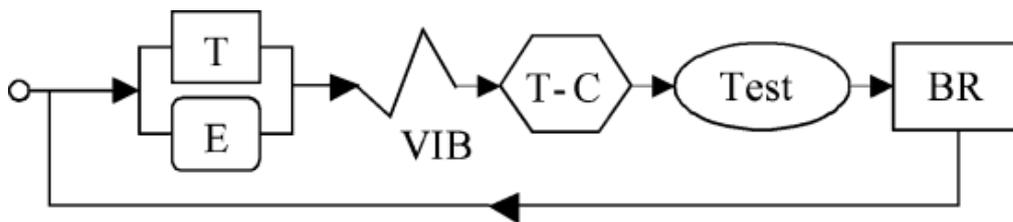
Fig3.19: Test sequence of accelerated ageing test, T: thermal stress, E: electrical stress, VIB: mechanical vibration, T-C: thermal cycling test, Test: Test parameters, BR: breakdown test [88]

• In [88], the study introduces a multifactor ageing test, the sequence of which is illustrated in Fig.3.19:

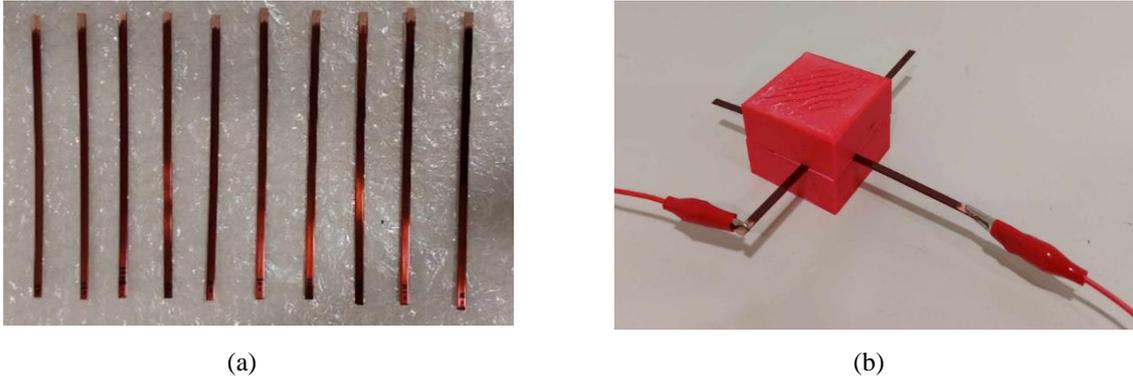
Fig: 4.4: (a) Copper wire specimens, (b) Capacitance measurement between turns set-up

To calculate the capacitance between coil turns, a series of 10 copper bars, each coated with PAI insulation and derived from the same coil wire, was employed. The procedure unfolds as follows: a pair of these bars is inserted into dedicated ducts within a specially crafted enclosure (Fig.4.4). Positioned perpendicular to one another, they create a square contact area, facilitated by their identical width. This configuration permits both vertical movement of the first bar and horizontal movement of the second, thereby establishing multiple points of contact. Stripped of their PAI insulation at the ends, these bars function as electrical contact points for the impedance spectroscopy electrodes.

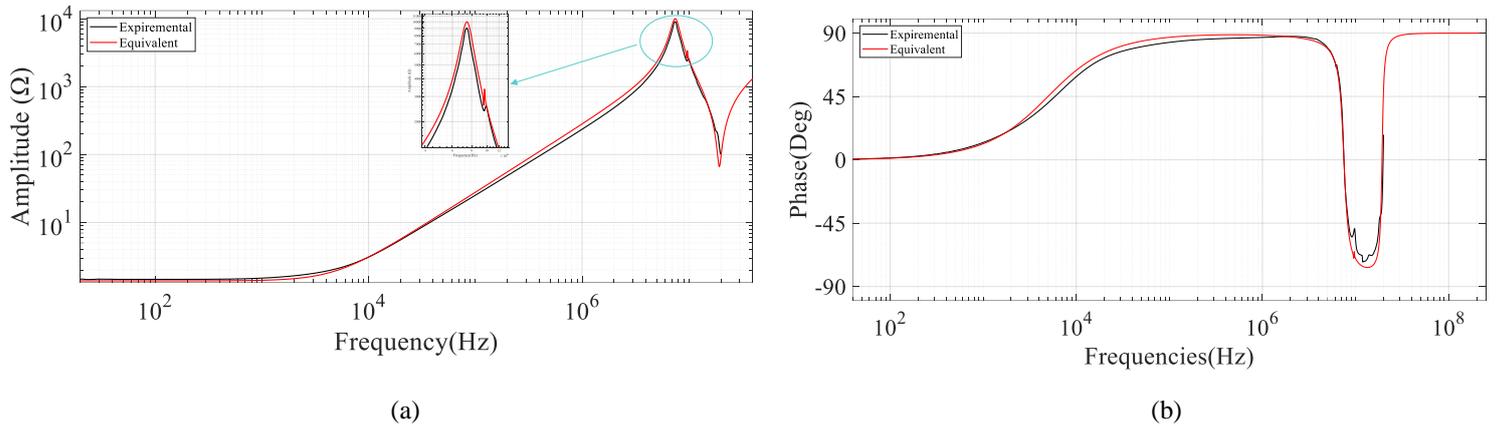
Fig.4.8: Impedance spectroscopy of the complete equivalent circuit model (red) and the experimentally measured pole (black) where: a) the impedance and b) the phase.

The low-frequency resonance (peak) refers to the point where the inductive and capacitive reactions are approximately equal, while the high-frequency resonance (spike) is attributed to the asymmetries of the end-turns.

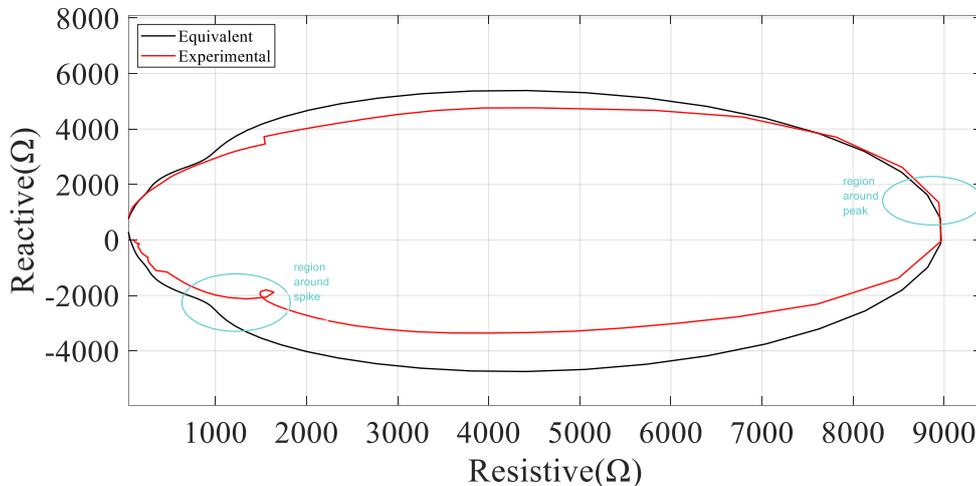
Fig.4.9 Nyquist Diagram of the complete equivalent circuit model (red) and the experimentally measured pole (black).

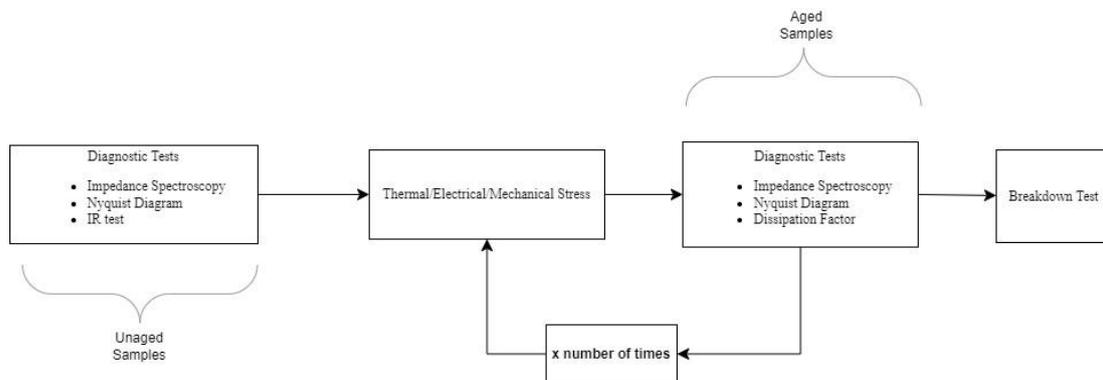
Fig.5.1: General Multistress Procedure

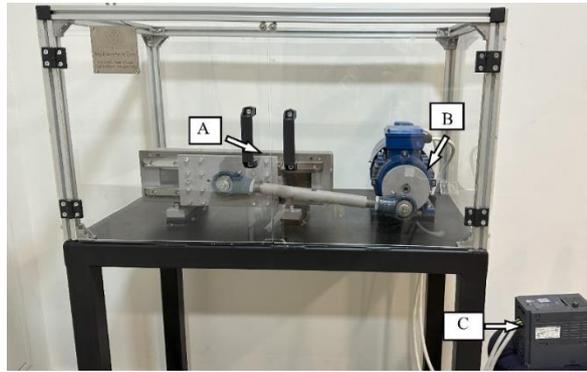
Fig.5.2. Mechanical Stress Test Set-Up, where A: Mechanical Vibration Device, B: Induction Motor, C:Inverter

The inverter is responsible for regulating the frequency of power supplied to an AC motor, thereby controlling the motor's rotation speed. In the absence of an inverter, the AC motor would run at full speed immediately upon power supply activation, rendering speed control unattainable and limiting the motor's applicability. Utilizing an inverter to modulate the speed and acceleration of an AC motor broadens the scope of its applications compared to a motor operating at a fixed speed. In this test setup, a single phase of the inverter's three phases was utilized and connected to the motor. The frequency of the inverter was set at 5Hz. The resulting motor speed is calculated to be 258 rpm through a tachometer. As a control method, V/f control is chosen to regulate the induction motor by supplying a predetermined current to the coil to produce a specific torque output. Consequently, there exists a proportional relationship between the voltage and frequency, which is referred to as the V/f characteristics.

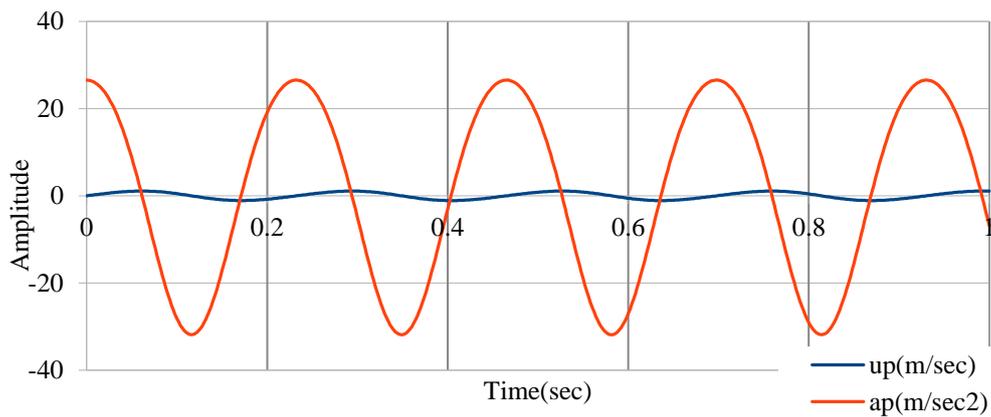
Fig.5.4: Acceleration and Velocity of Mechanical Vibration

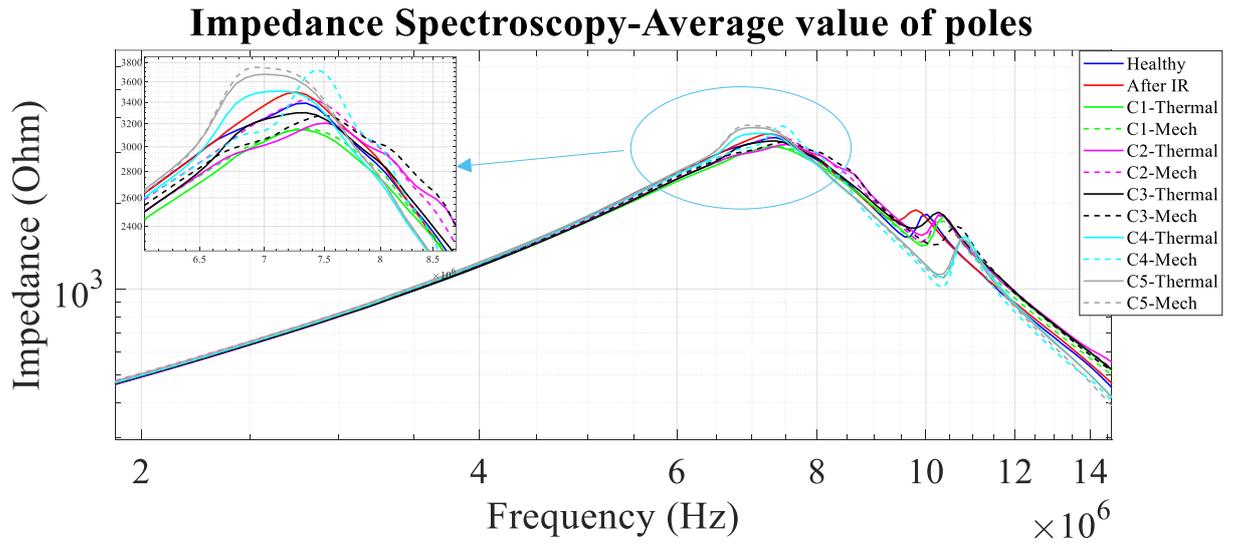
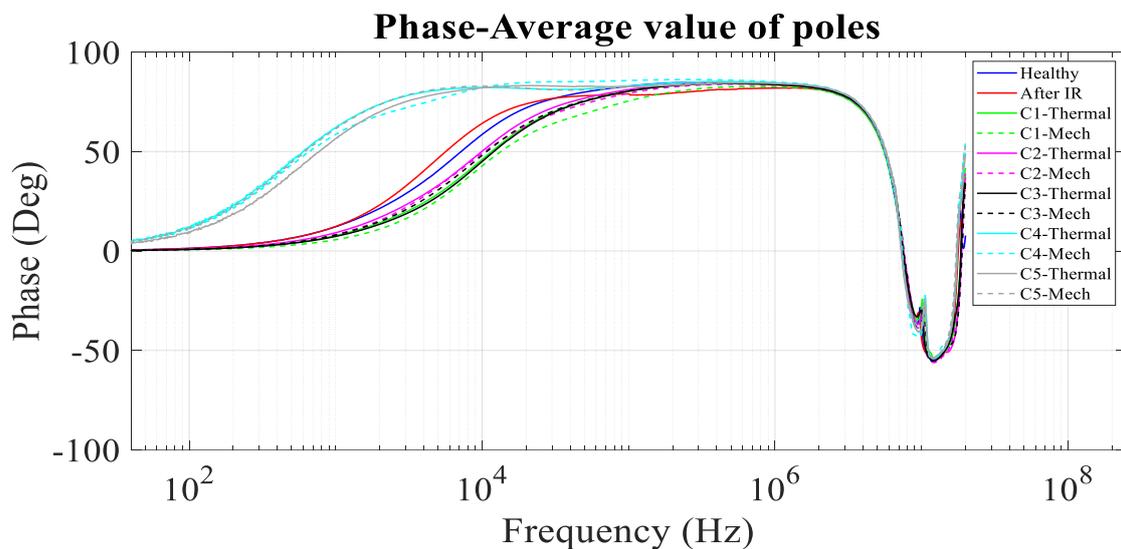
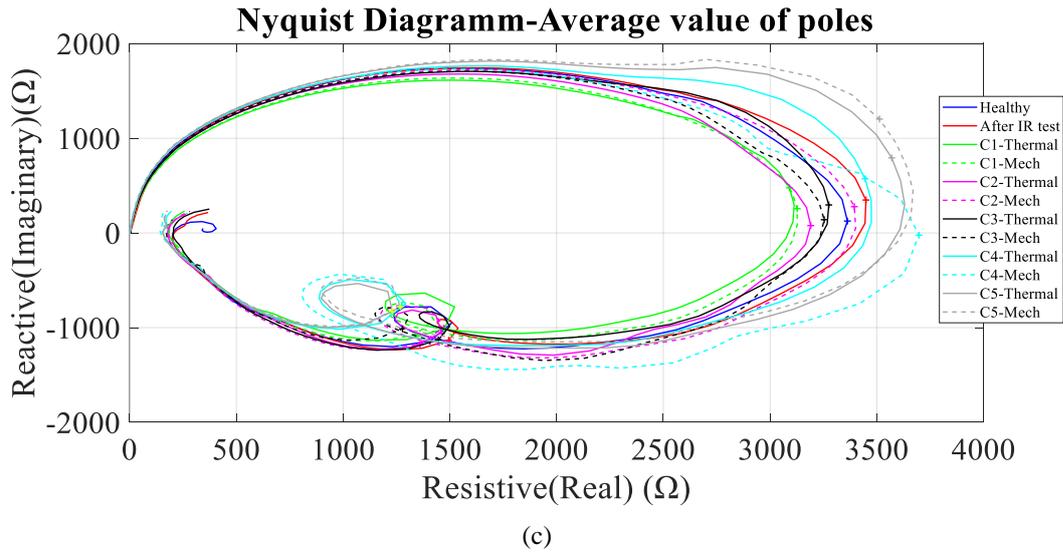
Fig.5.7: Comparative FRA results, where: (a) Impedance Spectroscopy, (b) Phase, (c) Nyquist Plot

The impedance and phase-amplitude across the frequency spectrum are illustrated in Fig.5.7a and Fig.5.7b, respectively. The low-frequency resonance (peak) is situated within a frequency range of 6.9-7.6MHz, while the high-frequency resonance (spike) is observed in the frequency range of 10-10.1MHz. The Nyquist diagram is presented in Fig.5.7c, with the peak indicated by a '+' symbol, nearly aligned with the real axis on the right-hand side of the plot, while the spike region is delineated by the encirclement that appears.

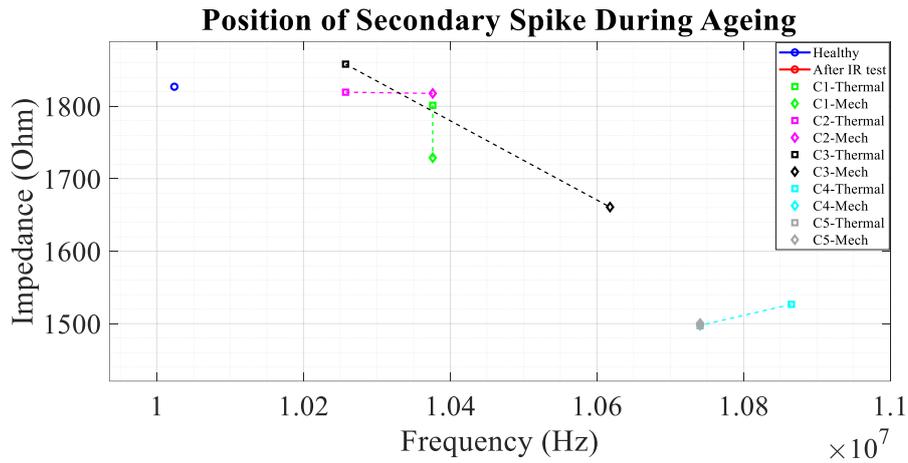
Fig.5.9: High-Frequency Resonance (Spike) Positions

The effect of the **IR test** is not negligible and leads to an increase in the angle, attributable to the fact that the absorption current confounds the capacitance meter, resulting in a capacitance reading much larger than its actual value. Simultaneously, the resistance increases. Subsequently, during the **first cycle of Thermal Stress**, the impedance decreases significantly, and the Nyquist diagram shrinks, while the angle continues to increase. This behaviour indicates that the primarily affected element is the resistance, which decreased due to Thermal Stress. Following this, in the **first mechanical cycle**, an increase in the magnitude and a decrease in the angle are observed, translating to an expansion of the Nyquist curve and a shift towards the negative imaginary part, demonstrating an increase in capacitive behaviour through capacitance reduction. The decrease in capacitance continues into the **next thermal cycle (2)**, attributed to the introduction of air into the insulation, where the dielectric constant of air is lower than that of all solid insulation materials, resulting in a decrease in capacitance according to the parallel plate equation. Consequently, there is an increase in the circuit's capacitive behaviour, as evidenced by the shift and expansion of the Nyquist curve and an increase in impedance. After the **second mechanical cycle**, the resistance and Nyquist curve increase significantly. This may be related to the appearance of local delamination due to thermal deterioration from thermal stress, which introduced air bubbles into the insulation, likely increasing its resistance. Subsequently, in the third cycle, the resistance decreases due to thermal ageing. However, in the **fourth thermal cycle**, it is evident that local delamination has significantly intensified, with a rapid increase in impedance and, consequently, the Nyquist diagram, attributable to the resistance increase due to R_{air} , until the **fourth mechanical cycle** causes cracks in the insulation, evident from the change in shape of the peak, which split as a result of the insulation crack. Moreover, this split in the peak may be attributed to permanent alterations in the insulation material caused by delamination. Overall, the **fourth cycle** represents a critical threshold where delamination escalates significantly in severity, leading to insulation cracks and permanent changes in the insulation material. Following this, in the fifth cycle, we immediately observe a decrease in resistance, indicating that the insulation has separated from the copper, resulting in a decrease in its resistance. The characteristics of the pole are completely altered due to the crack and delamination after the fourth cycle.

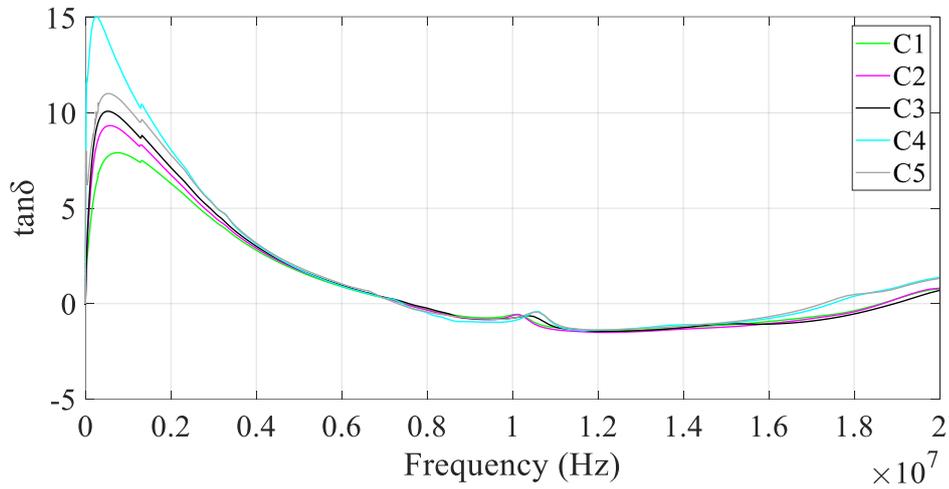
Fig.5.10: Dissipation Factor versus Frequency

By using Eq.5.1, the dissipation factor as a function of frequency is computed (Fig.5.10) following each complete cycle of multistress (thermal and mechanical). This approach aims to comprehensively illustrate the overall impact of multistress as a method.

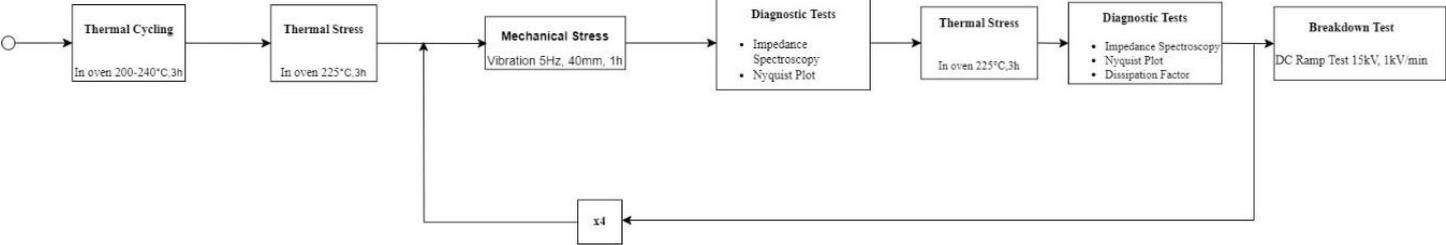
Fig.5.11: Test Procedure

The second team of poles to undergo multi-stress ageing consists of 18 poles. The accelerated ageing process is shown in Table 5.5 and Fig.5.11.

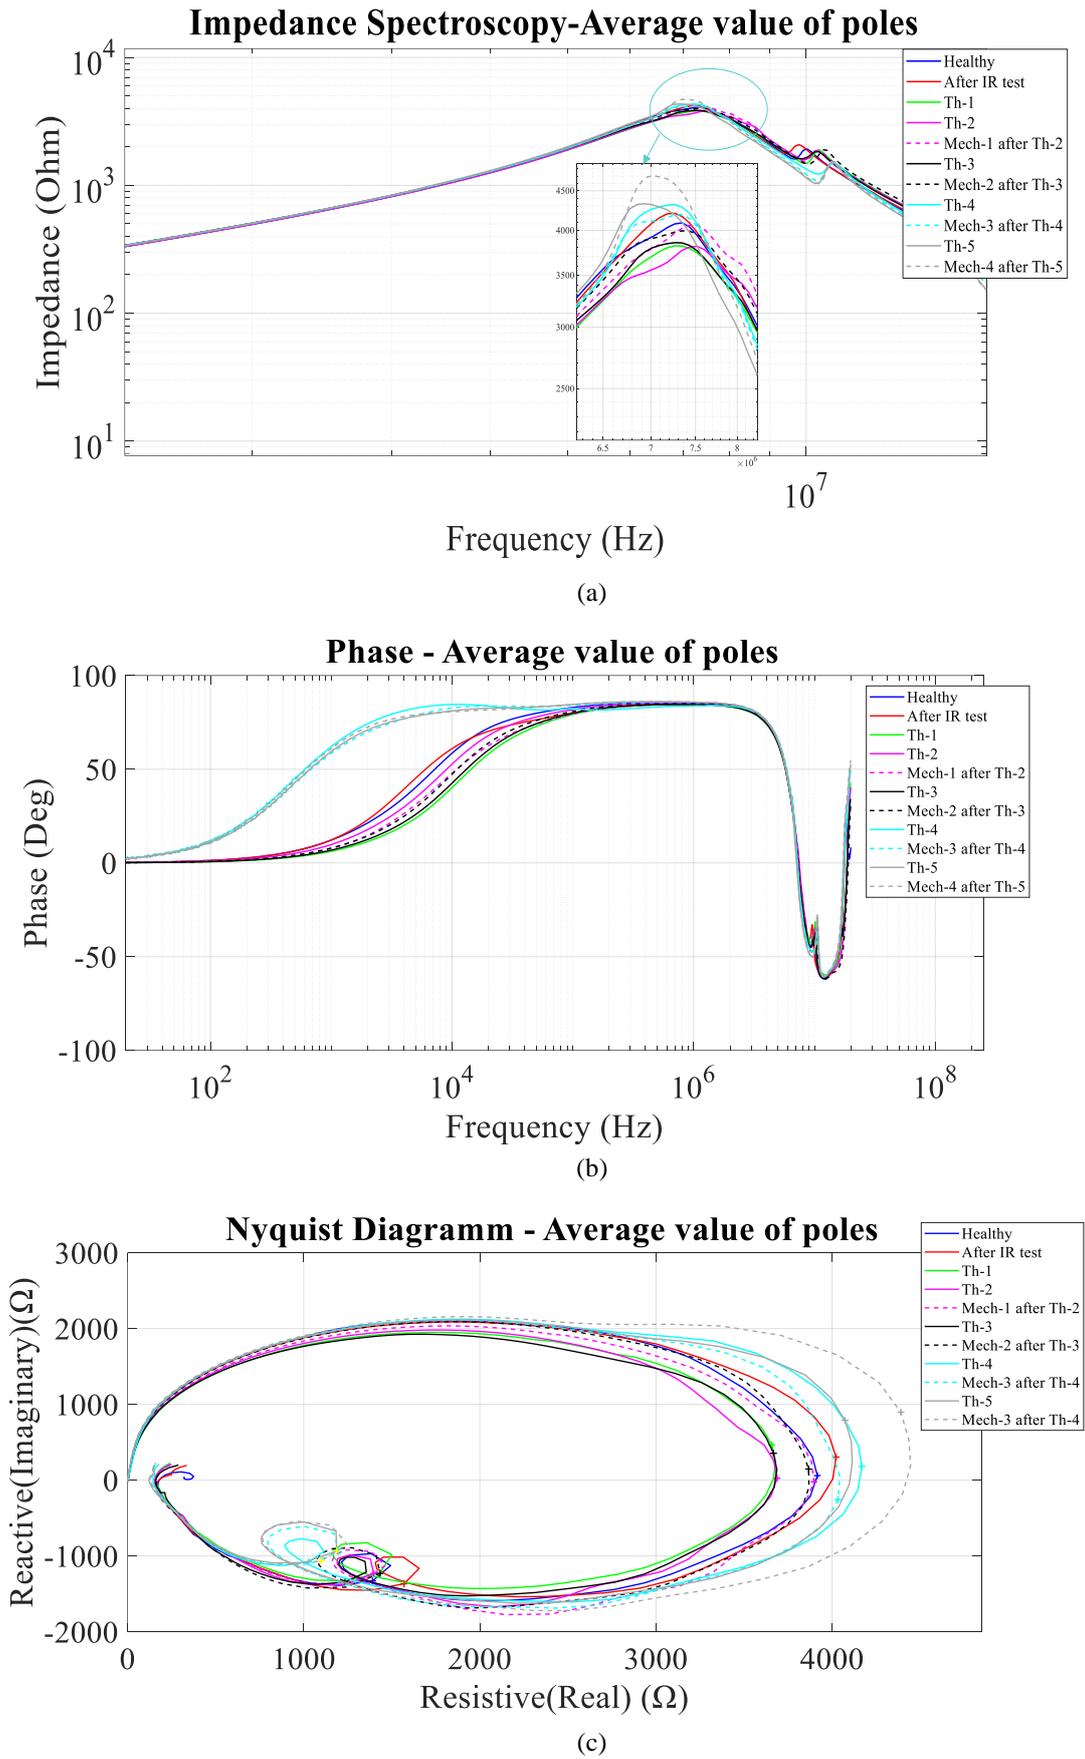
Fig.5.12: Comparative FRA results, where: (a) Impedance Spectroscopy, (b) Phase, (c) Nyquist Plot

The impedance and phase amplitude across the frequency spectrum are illustrated in Fig.5.12a and Fig.5.12b, respectively. The low-frequency resonance (peak) is situated within a frequency range of 6.9-7.6MHz, while the high-frequency resonance (spike) is observed in the frequency range of 10-10.1MHz. The Nyquist diagram is presented in Fig.5.12c, with the peak indicated by a '+' symbol, nearly aligned with the real axis on the right-hand side of the plot, while the spike region is delineated by the encirclement that appears.

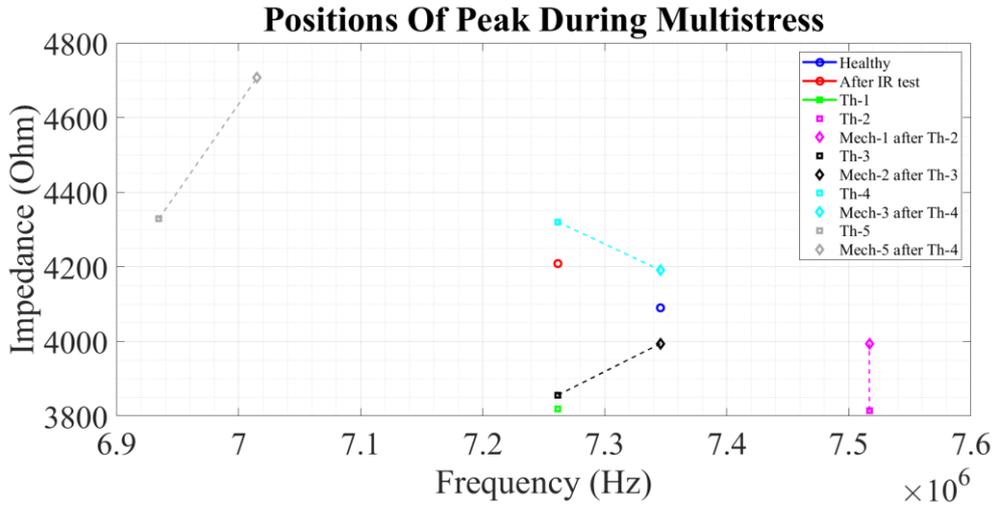
Fig.5.13: Low-Frequency Resonance (Peak) Positions

In Fig.5.13 and Fig.5.14, as well as in Table 5.6 and Table 5.7, the displacements, magnitudes, angles, and both real and imaginary parts of the peak and resonance impedances are summarized. This coordination facilitates a more thorough analysis of the results.

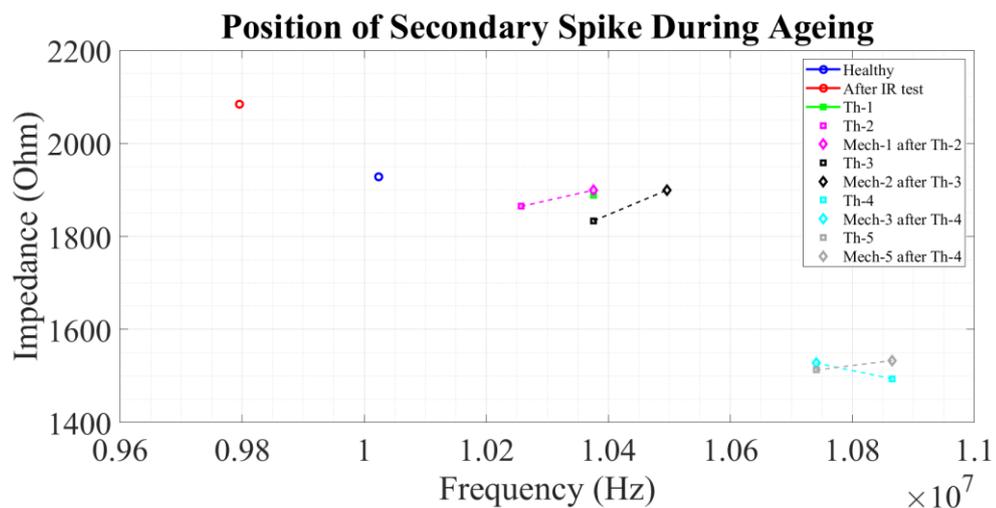
Fig.5.14: Spike Positions

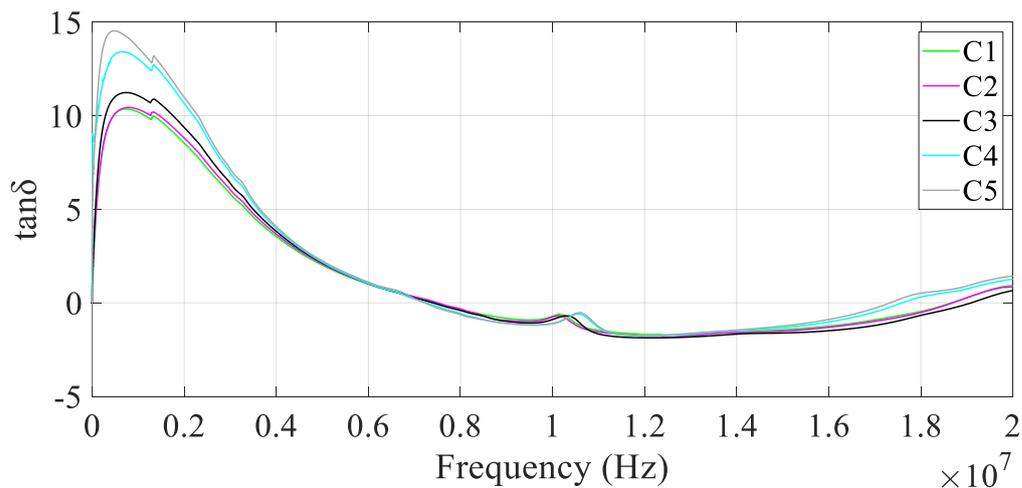
Fig.5.15: Dissipation Factor

Following is the graphical representation of the dissipation factor (Fig.5.15), utilized for the evaluation of multistress after each complete ageing cycle.

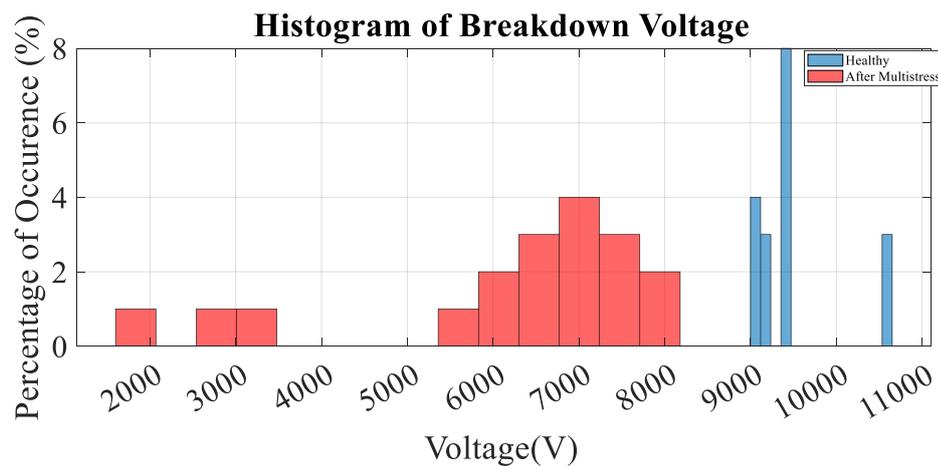
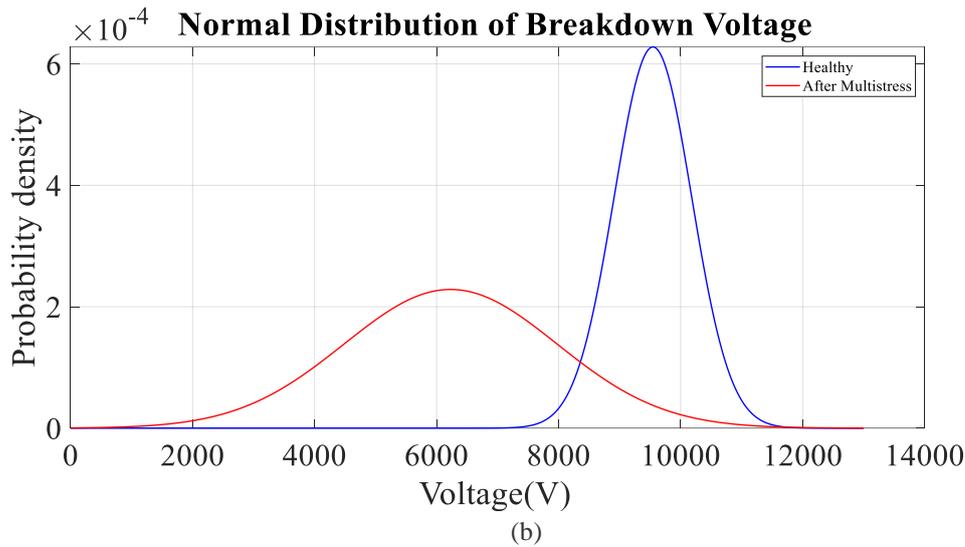
Fig.5.16: (a) Histogram and (b) normal distribution of the breakdown voltage of the poles that have been subjected to alternating thermal and mechanical stress cycles compared to the healthy samples.

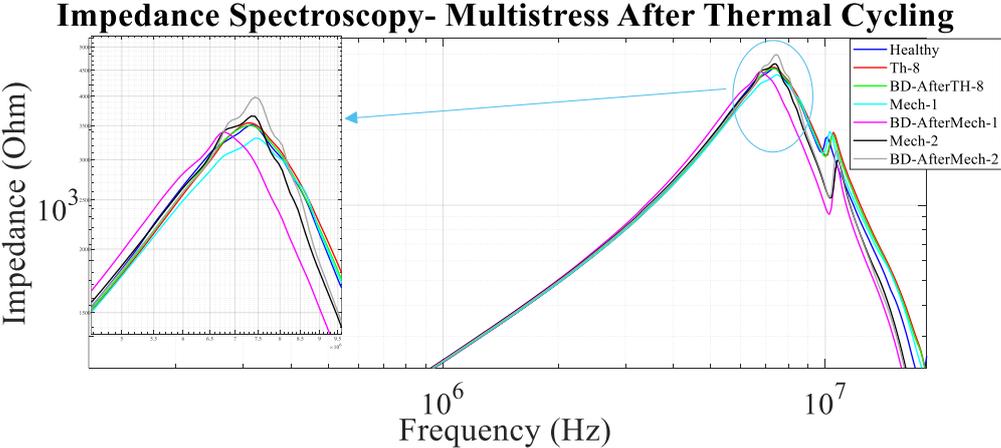
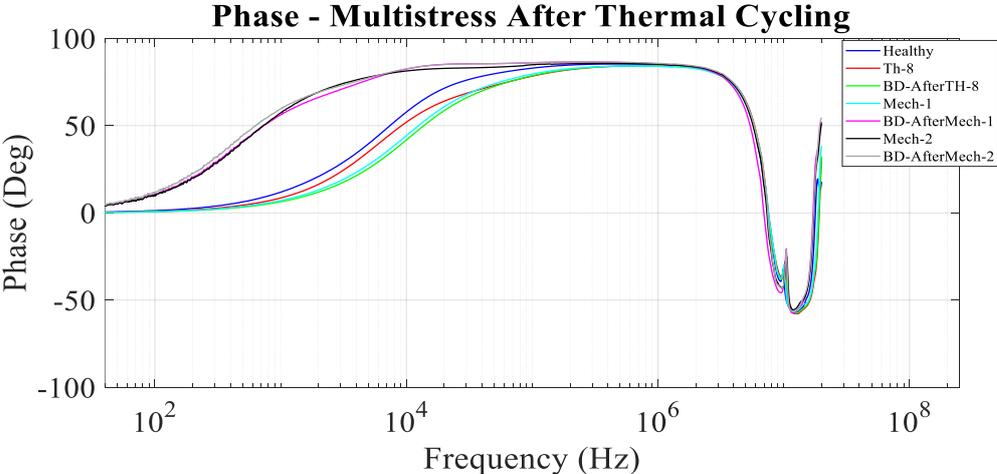
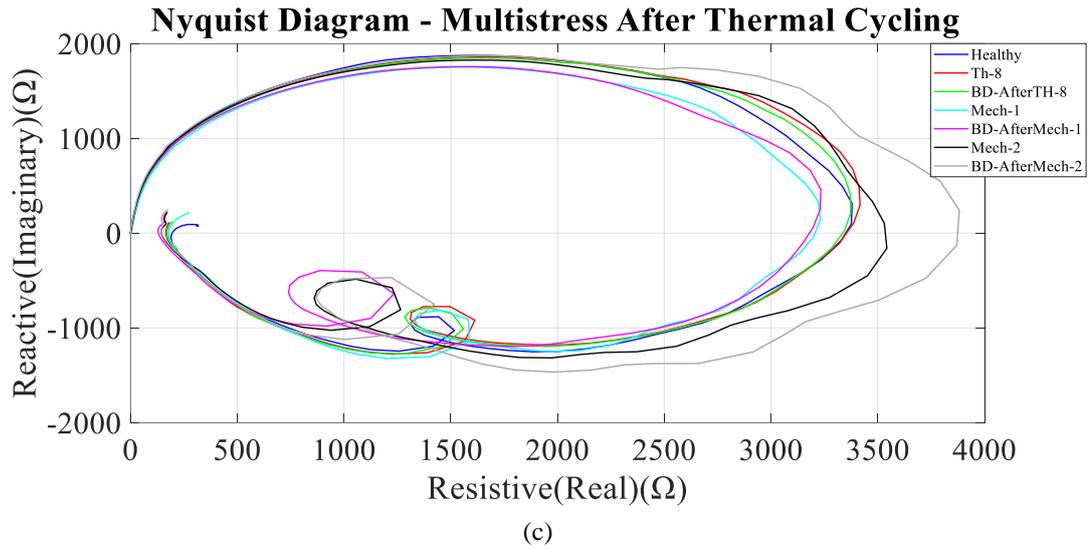
Fig.5.19: (a) Impedance, b) Phase versus the frequency for the poles, and (c) Nyquist plot, after various thermal cycling stress conditions

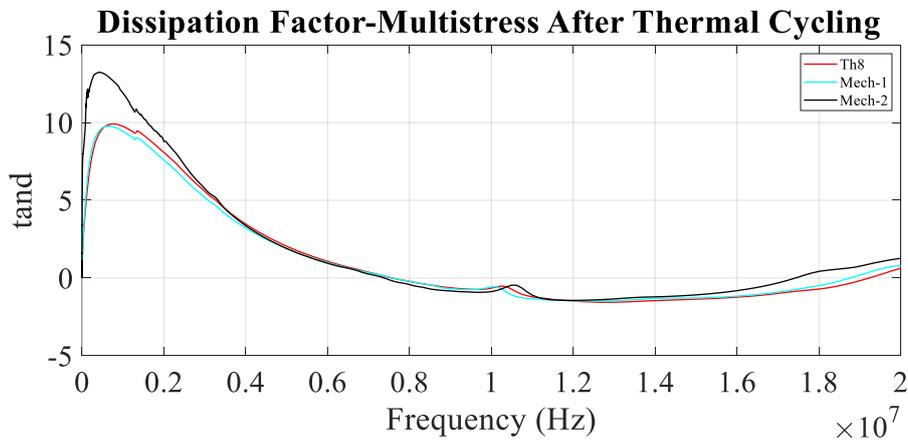
Fig.5.20: Multistress procedure after Thermal Cycling

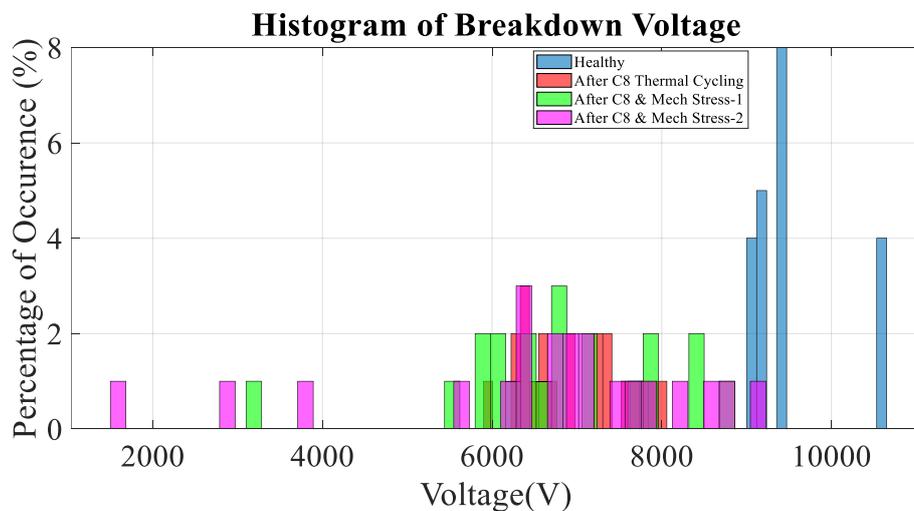
Fig.5.21. Comparative Histograms for all Stages of Multistress
