The impact of multiparameter ageing of stator poles of traction motors on diagnostic methods

School of Electrical and Computer Engineering
Technical University of Crete

Antonios Douvaras

Chania, March 2024

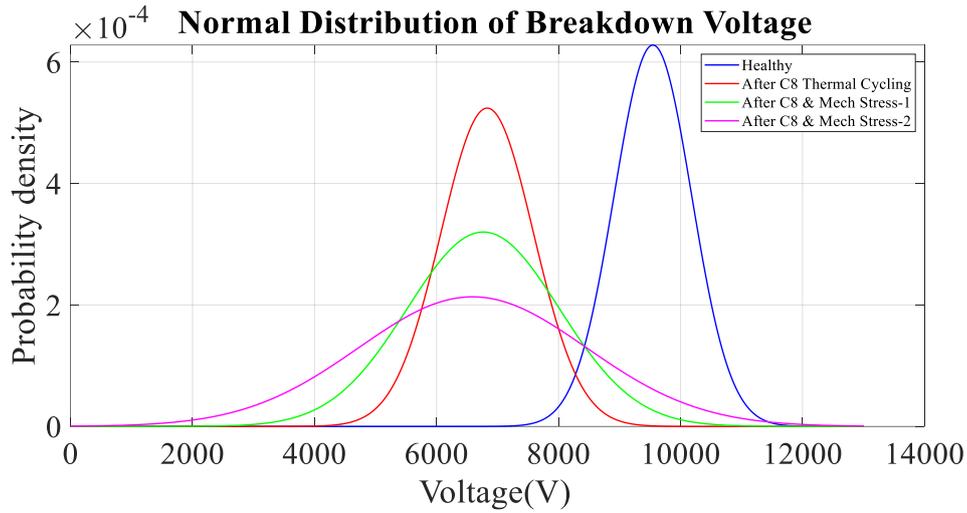
Fig.5.22: Comparative Analysis of Normal Distributions Across All Stages of Multistress

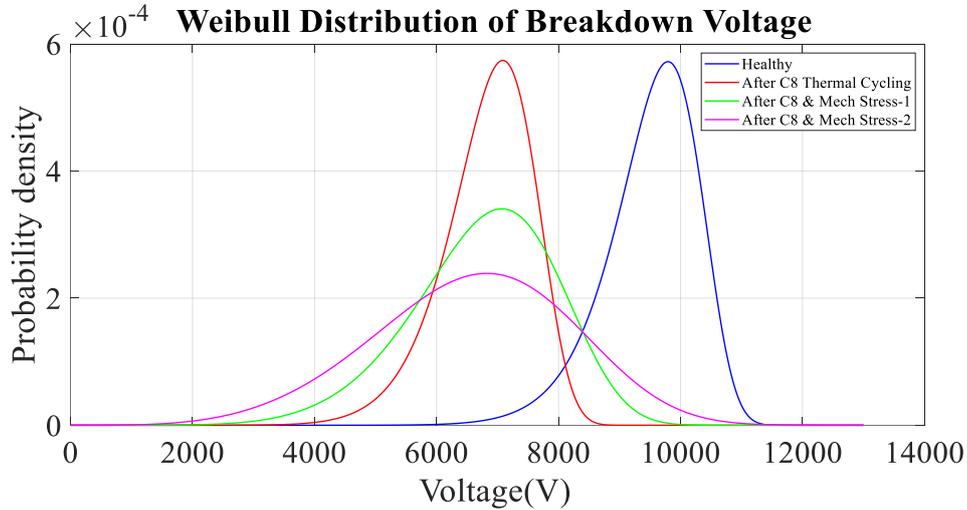
Fig.5.23. Comparative Analysis of Weibull Distributions Across All Stages of Multistress

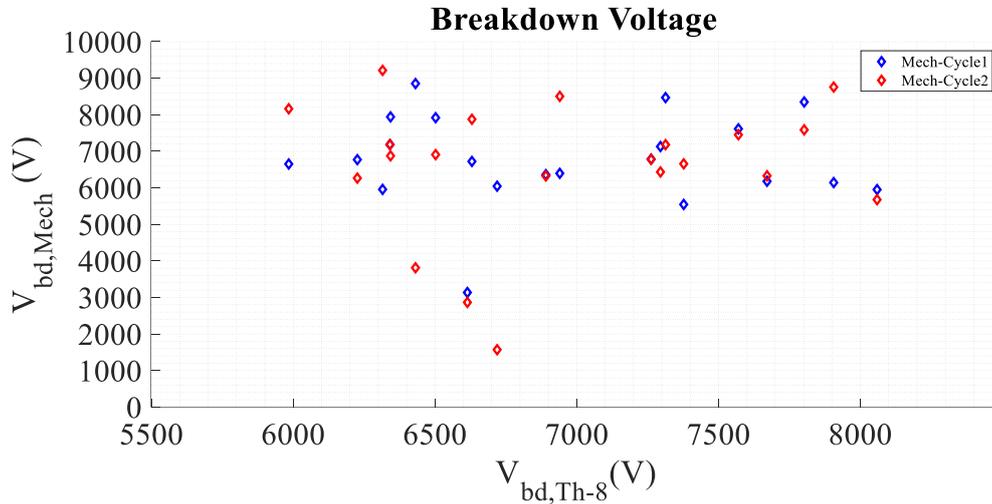
Fig.5.24. Scatter Plot Analysis of Breakdown Voltage Across Multistress Cycles

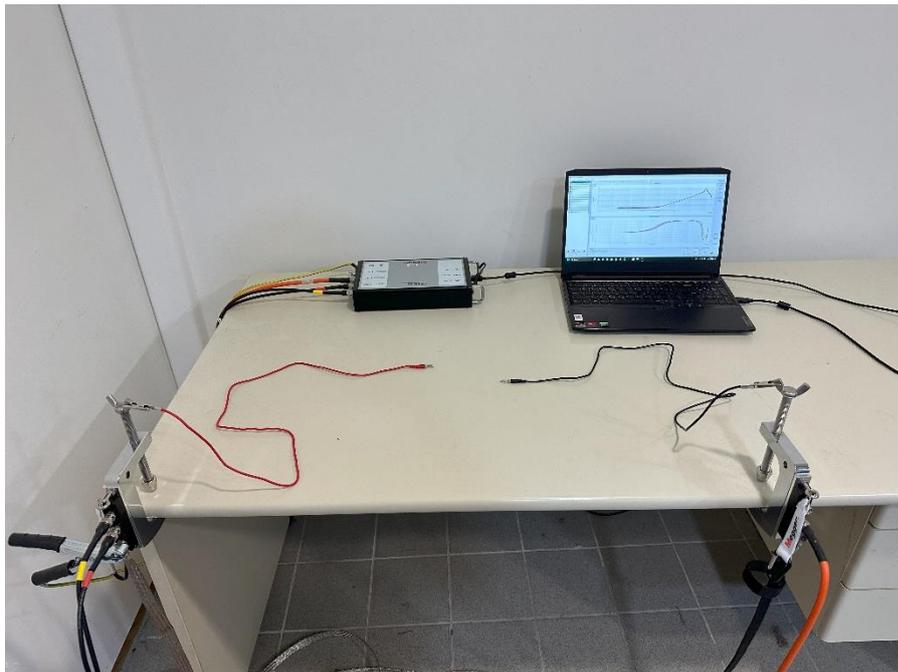
Fig6.1: Impedance Spectroscopy Set-Up

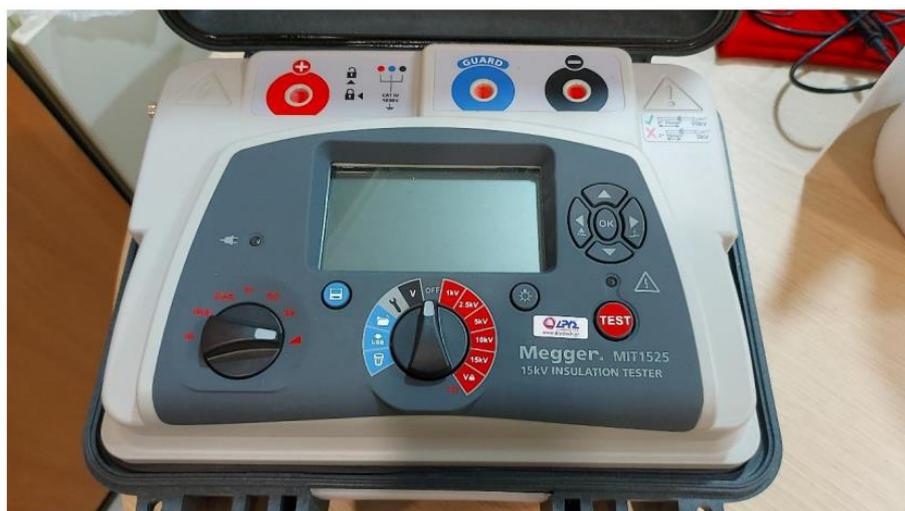
Fig6.2: Megohmmeter 15kV Insulation Tester

For the measurement of coil-to-core resistance, a 15kV Megohmmeter (Fig. 6.2) was utilized in IR test mode. The connection configuration is depicted in Fig.6.7, where it is evident that one terminal of the Megohmmeter is connected to the top terminal of the pole, and the other terminal of the Megohmmeter to the bottom electrode of the casing, facilitating the application of high voltage between the coil and core for measuring the coil-to-pole insulation resistance.

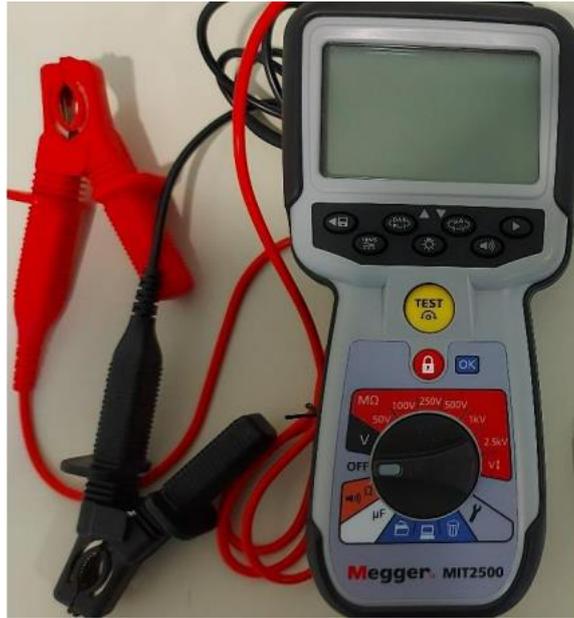
Fig.6.3: Portable Megger Device

The portable megger device (Fig. 6.3) was utilized to measure the internal DC resistance of the pole, with one end of the probe connected to the top end of the pole and the other end of the probe connected to the bottom end of the pole.

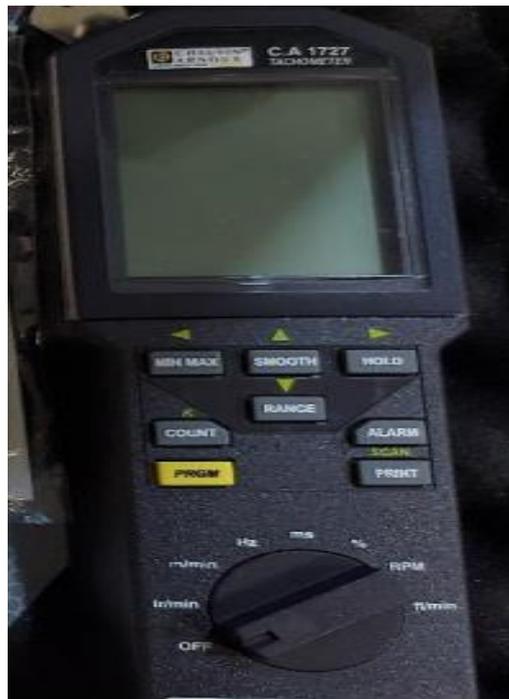
Fig.6.4: Digital Tachometer

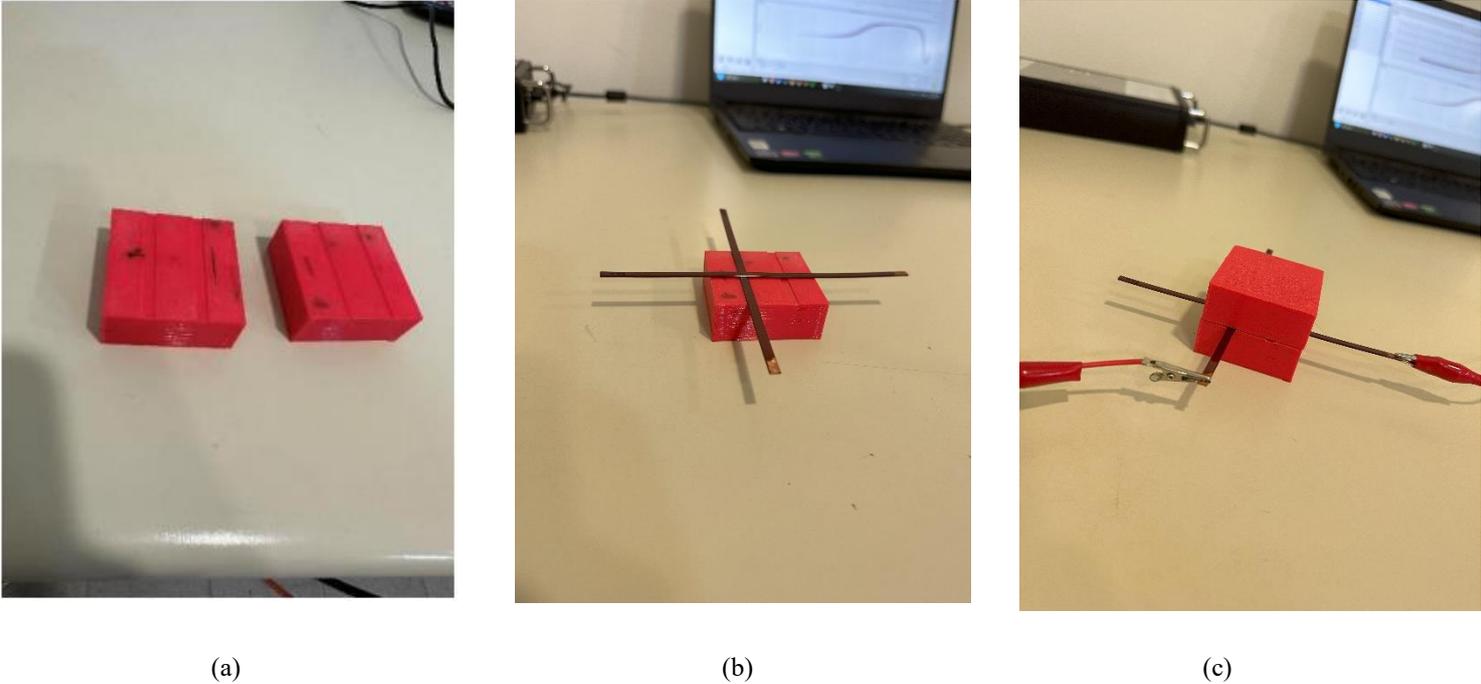
Fig. 6.6. a) The two parts of the casing, b) placing the copper bas and c) shielding the couple and connecting the electrodes.

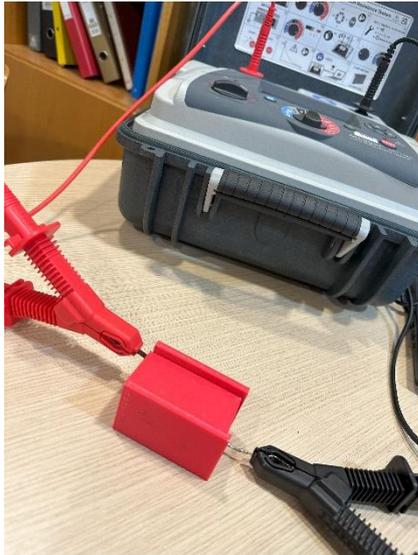
Fig.6.7: Setup for measuring the coil-to-pole insulation resistance.

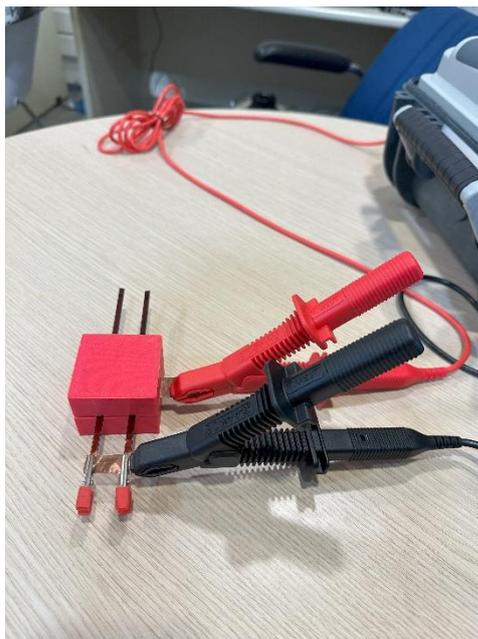
Fig. 6.8. Setup for the measurement of the turn-to-turn insulation resistance.

The measurement of the turn-to-turn insulation resistance was measured with the setup shown in Fig. 6.8. Due to high resistance value restrictions, two bars were tested simultaneously. The bars were placed in the two parallel ducts of the casing. A thin copper plate was placed on both of them and its end was outside the casing. Furthermore, the ends of the bars on one side are shorted. The Megohmmeter electrodes are applying a voltage at the copper plate and the shorted turns of the bars. The measurement is the equivalent surface resistance of the two bars (parallel connection).

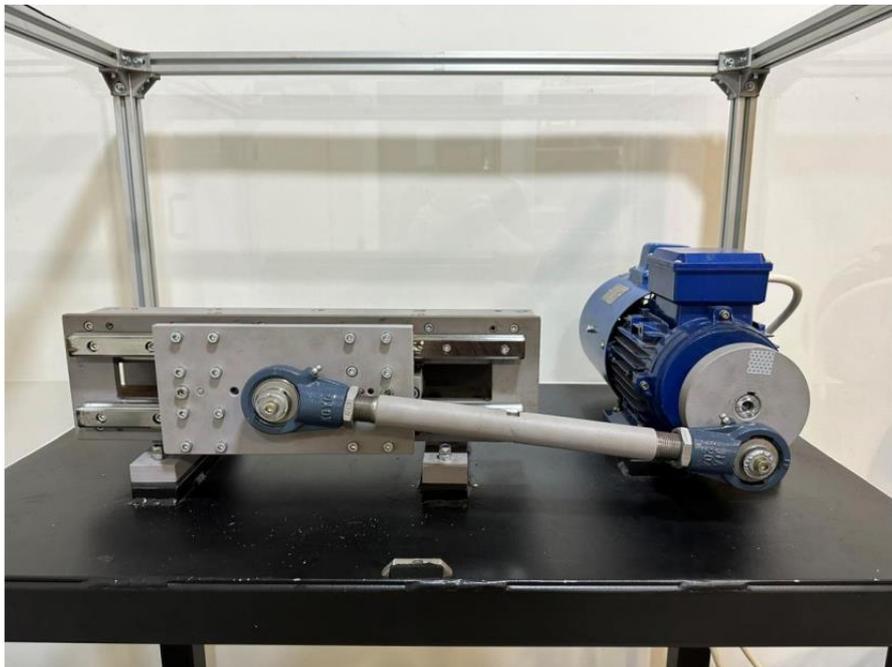
Fig.6.10: Final assembly of the mechanical stressing device

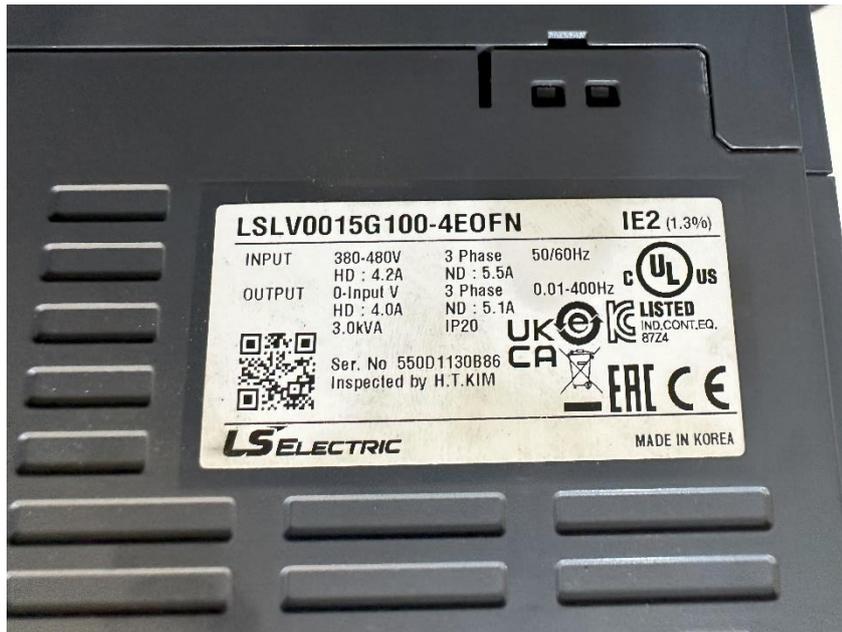
Fig.6.11: Inverter used for the mechanical stressing machine drive

Finally, the mechanical stressing device works as follows. Six poles are first placed in the moving wagon. The poles are placed between two still plates that are screwed in order to trap the poles. Then the electrical connections are made and the poles are connected in series. The wagon is then placed inside the C-core (Fig. 6.9) and screwed. The final assembly before operation is shown in Fig.6.10. Then the motor (Fig.6.11) is turned on via the inverter (Fig.6.12).
