**ΠΟΛΥΤΕΧΝΕΙΟ
ΚΡΗΤΗΣ**

Mechanisms and parameters for life-cycle optimization of traditional lime-based mortars

PhD Thesis
by
Maria Amenta

Chania, July 2017

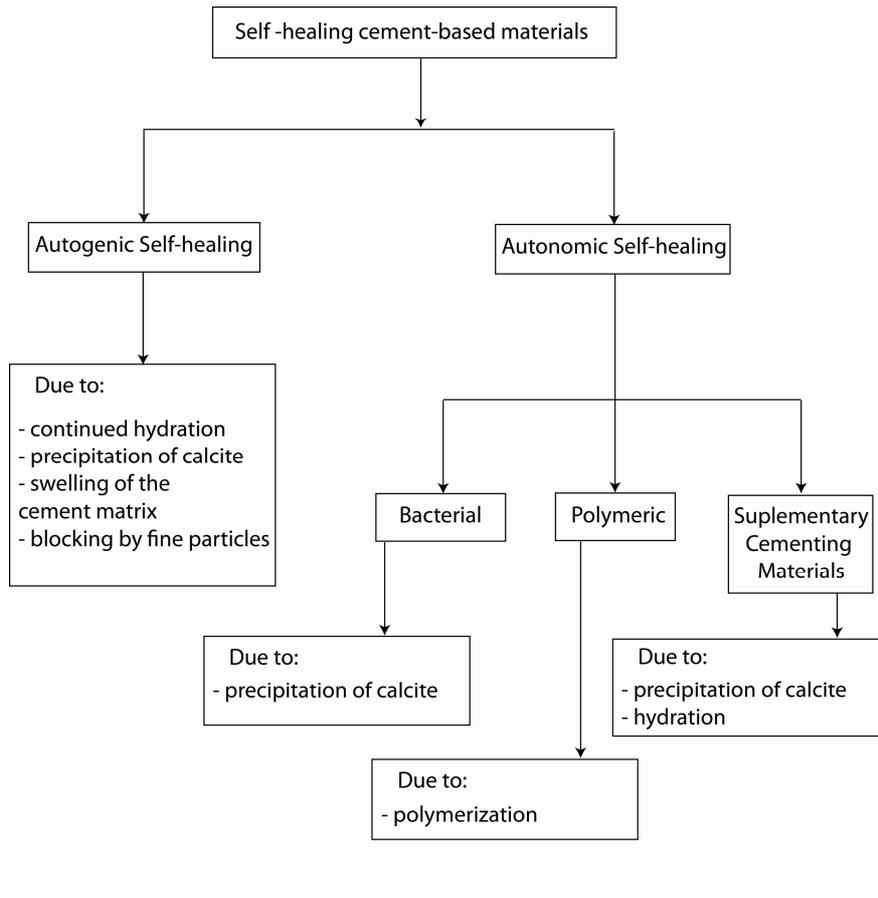
Figure 3.2: Autogenic and autonomic self-healing mechanisms.

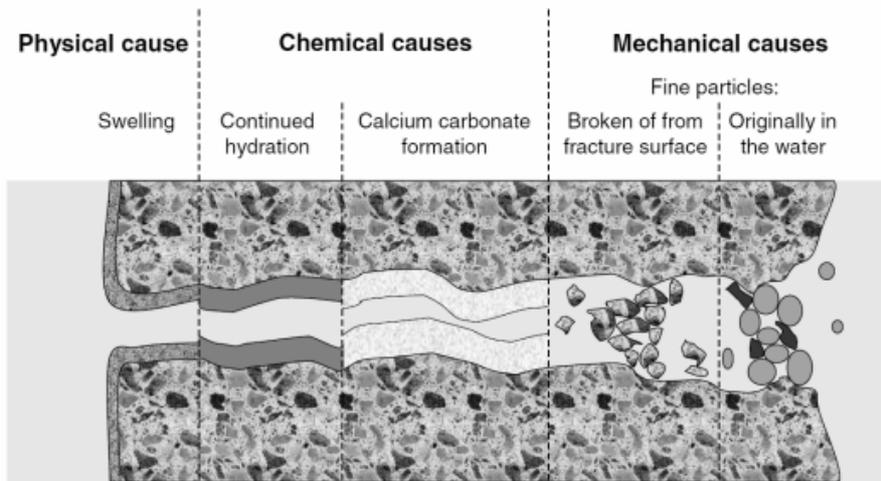
Figure 3.3: Different causes that can lead to autogenic self-healing (Reinhardt et al., 2013)

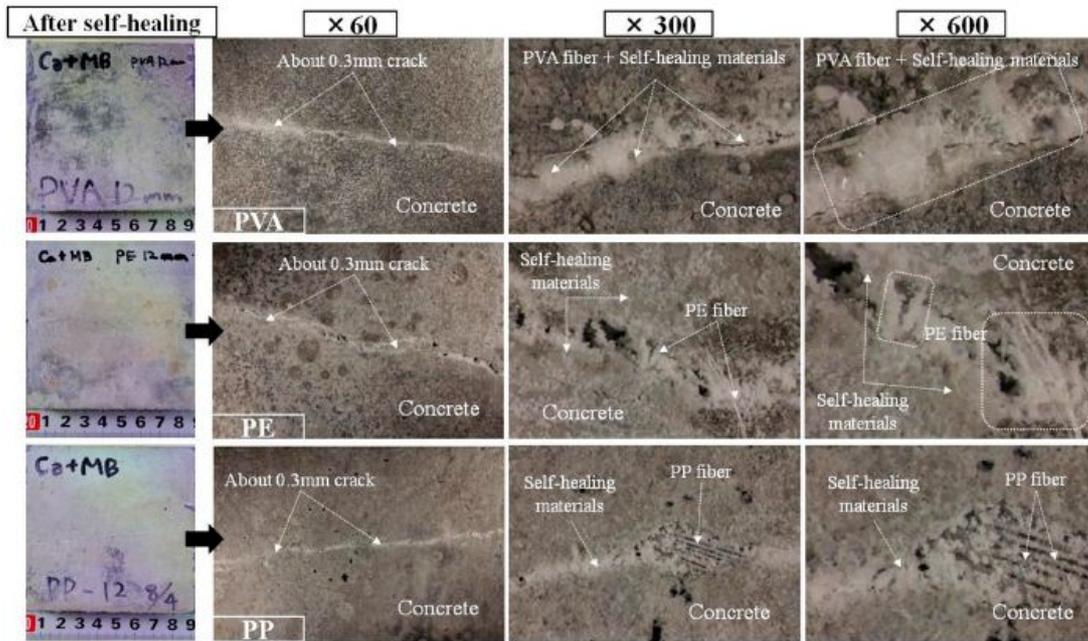
Figure 3.5: Crack closure observed by optical microscopy in concrete samples with different kind of fibers (Choi et al, 2016).

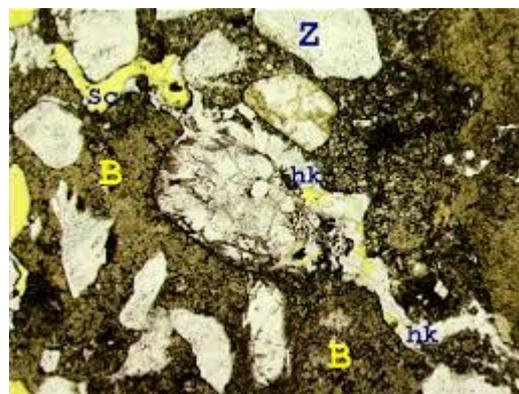
Figure 3.6: Discrimination of binder, aggregates and secondary precipitated calcite inside crack by polarized light microscopy. 50x magnification (2.7 x 1.4 mm), cross polarized light (Bridge, Amsterdam) (Lubelli et al, 2011)

Optical microscopy offers the possibility of larger field of view observations, thus allowing a more complete assessment of the sample condition (Fig 3.5-3.6). Another advantage is related to the discrimination of minerals by observing their characteristic variations of color, in contrast to SEM where differences in mineralogy are discriminated by different shades of gray. Both these characteristics are essential to the study of self-healing mechanism as it offers the visualization of the full length of a crack and at the same time a notable contrast between the cement matrix and the secondary phases.

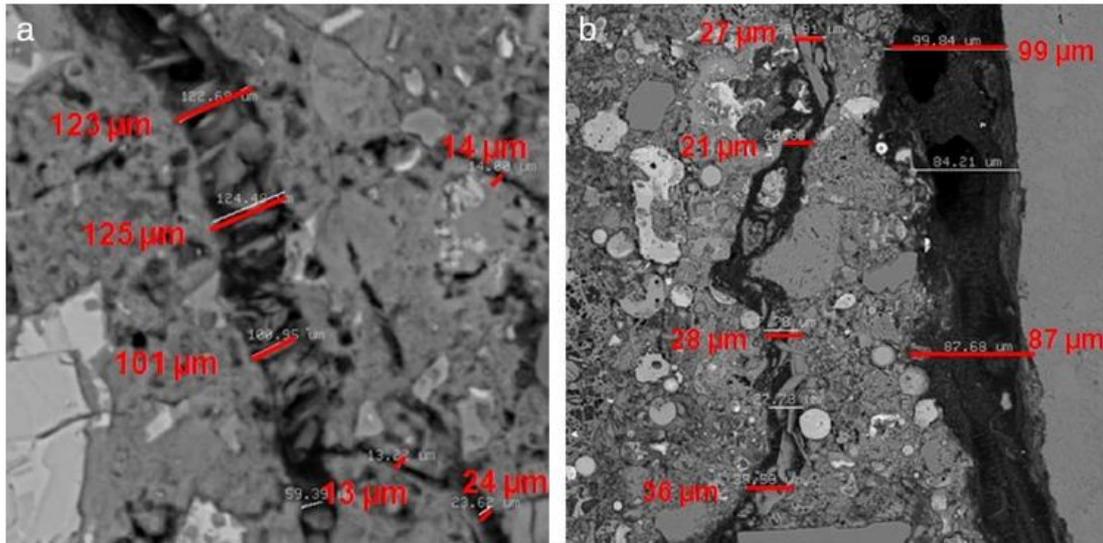
Figure 3.7: Observation of crack healing in fly-ash concrete samples by SEM (Jozwiak, 2015).

Usually it is used for the observation of polished sections of damaged samples after the healing treatment, in order to visualize crack closure (Fig.3.7).

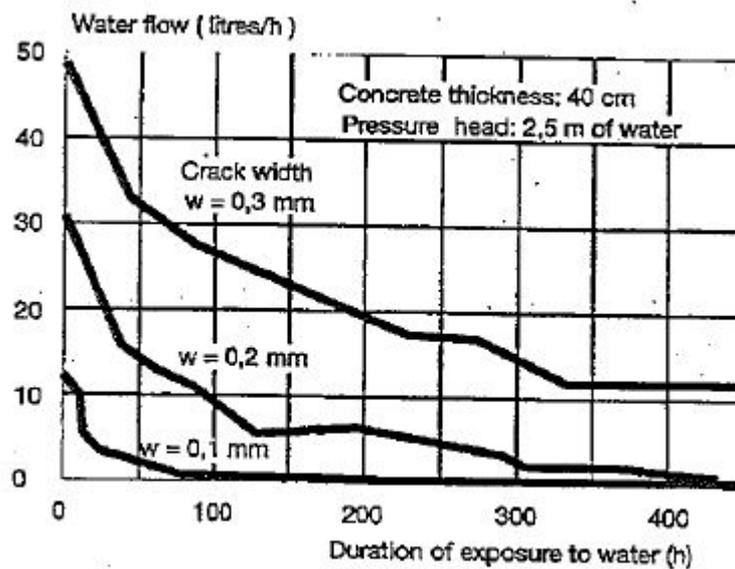
Figure 3.9: Relation between and water flow and time for different crack widths (Edvarsen 1999)

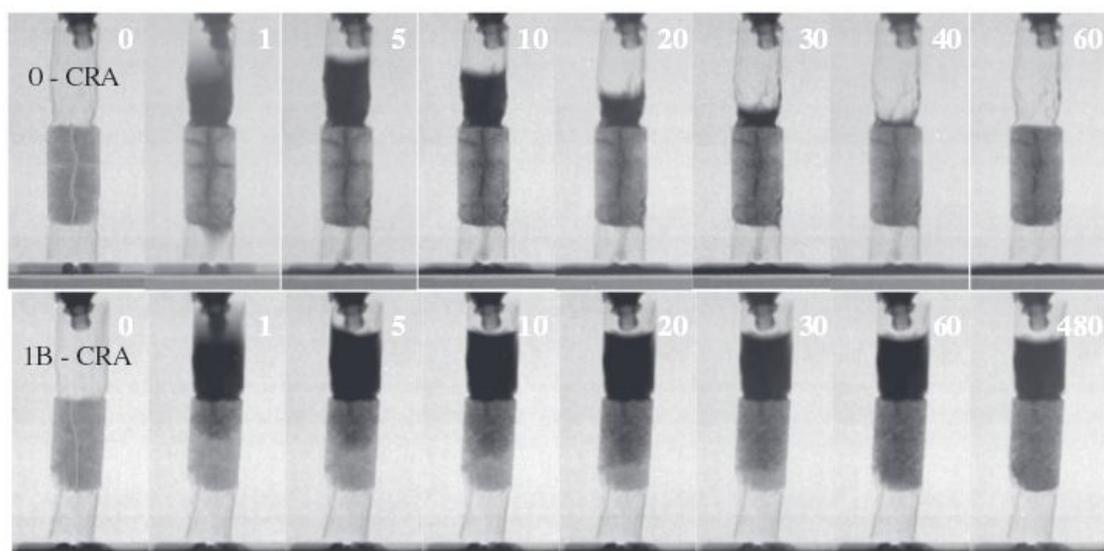
Figure 3.10: Visualization of water permeability test by neutron radiography. Time is expressed in seconds. (Snoeck et al., 2012)

Since then, several new water permeability test equipments have been developed, including high-pressure setups and monitoring by means of neutron radiography (Fig.3.10) (Snoeck et al. 2012).

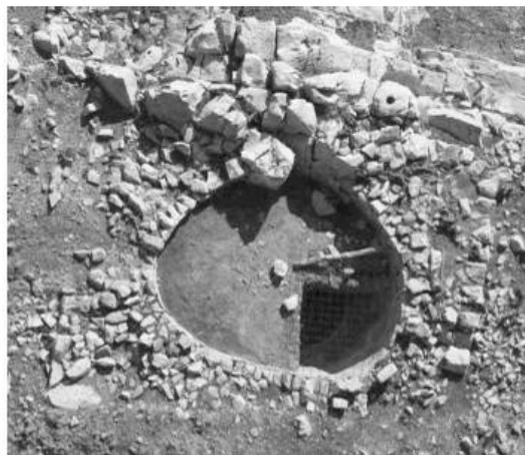
Excavations in the Kastraki area in the island of Agathonisi have identified this region as the Ancient Tragaia, a fortified settlement first inhabited during the late 4th millennium BC. During the 2nd century BC, the site was rebuilt under Roman influence, and multiple structures such as cisterns, tanks, as well as enhanced fortifications were dated to that era (Fig 4.3) (Triantafyllidis, 2015).

Figure 4.3: Terrace 1; citadel with cistern; Late Hellenistic–Early Roman period (Triantafyllidis, 2015)

Sampling: The samples examined were part of two tanks lined with hydraulic plaster built during that period and were used for water retaining. More precisely, six samples from two tanks were analyzed, two samples from the first tank (Ag 2, Ag 5) and four samples from the second (Ag14, Ag 17, Ag 18, Ag20).

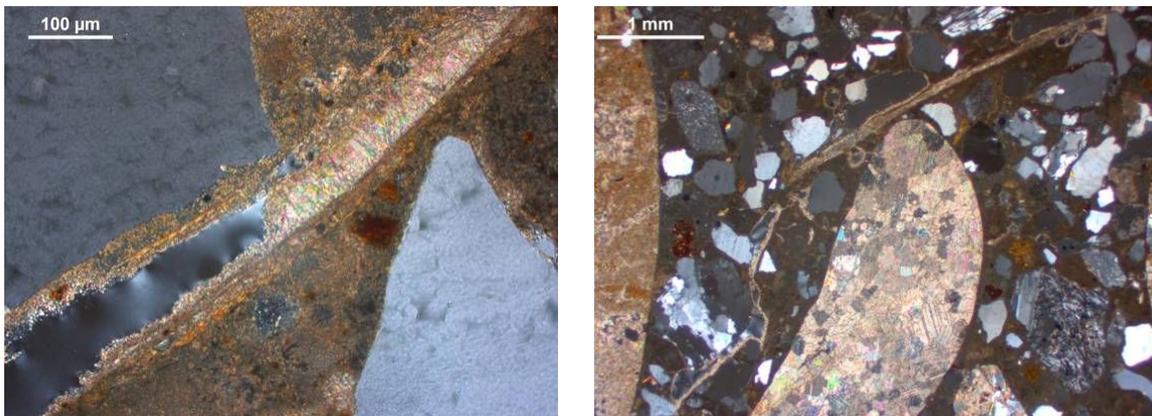
Figure 4.4 (Left): Secondary calcite precipitated filling a crack of 100 μm width. Micritic calcite can be seen precipitated on the crack walls where the crack is only partly filled.-Ag2

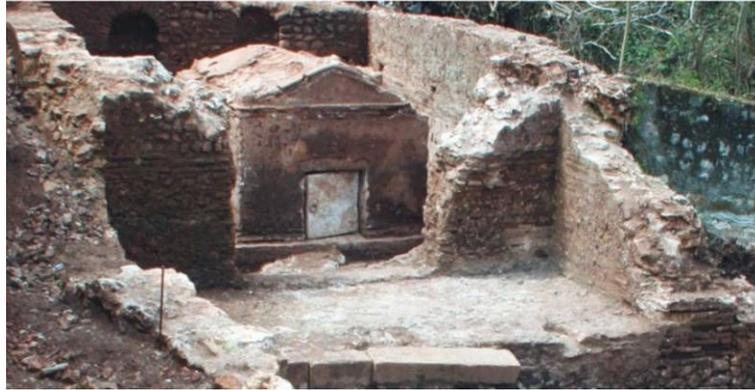
Figure 4.10: Roman tomb in Fiscardo excavation

Sampling: Two samples were examined, namely, one was lining material from the external masonry of a Roman tomb (F3) (Fig.4.10), and the second was joint mortar from the Roman baths (F6).

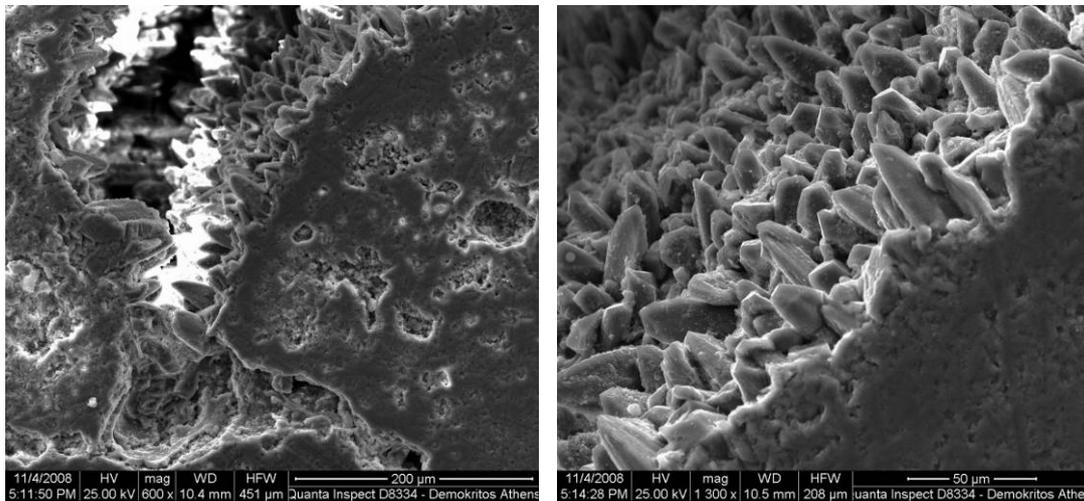
Figure 4.11: (Left) Well crystallized calcite crystals ranging in size up to 50 μm inside a large void; (Right) Detailed microphotograph of the crystals microstructure-F3

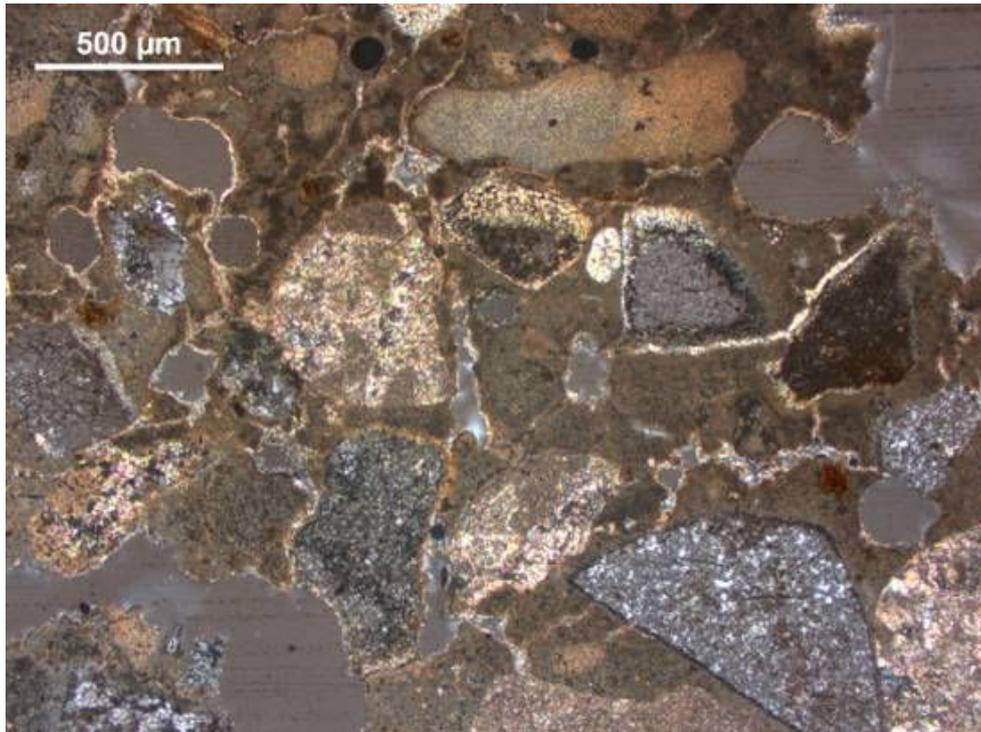
Figure 4.12: Extended network of microcracks partially filled with secondary calcite –F6

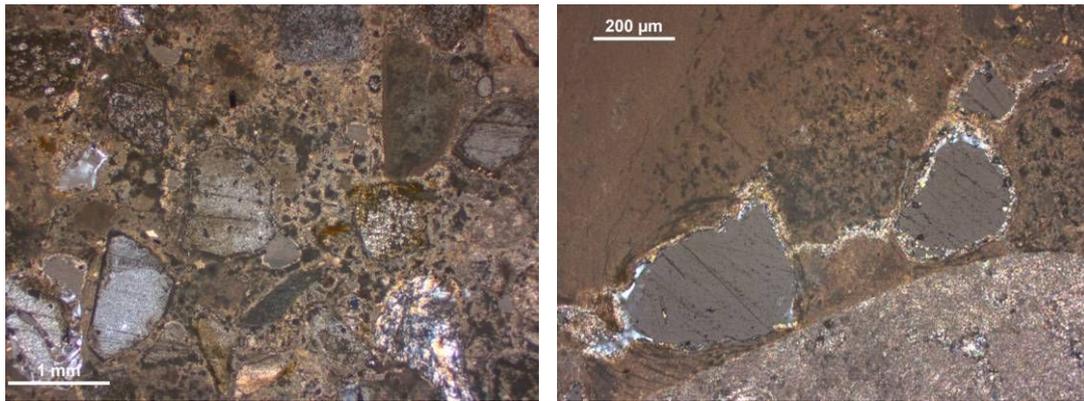
Figure 4.13 (Left): Extended network of microcracks partially filled with secondary calcite-S1

Figure 4.14 (Right): Completely healed crack bridging two large pores. A homogenous layer of calcite precipitation can be seen on the pore walls - S15

Micro-cracks are not observed regularly and the binder matrix is very cohesive. Re-crystallized calcite is grown inside the walls of voids or small cracks that are completely filled. Distinctive crystallized prismatic calcite crystals were observed in higher magnification at the scanning electron microscope inside voids (Fig 4.13-4.15).

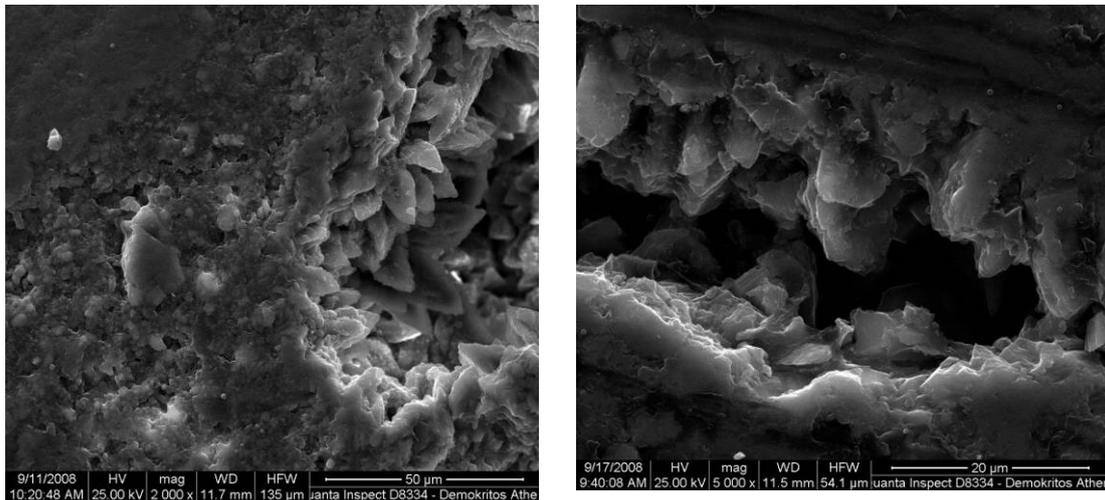
Figure 4.15: Calcite crystals growing on the voids' walls (Left) S2 (Right) S6

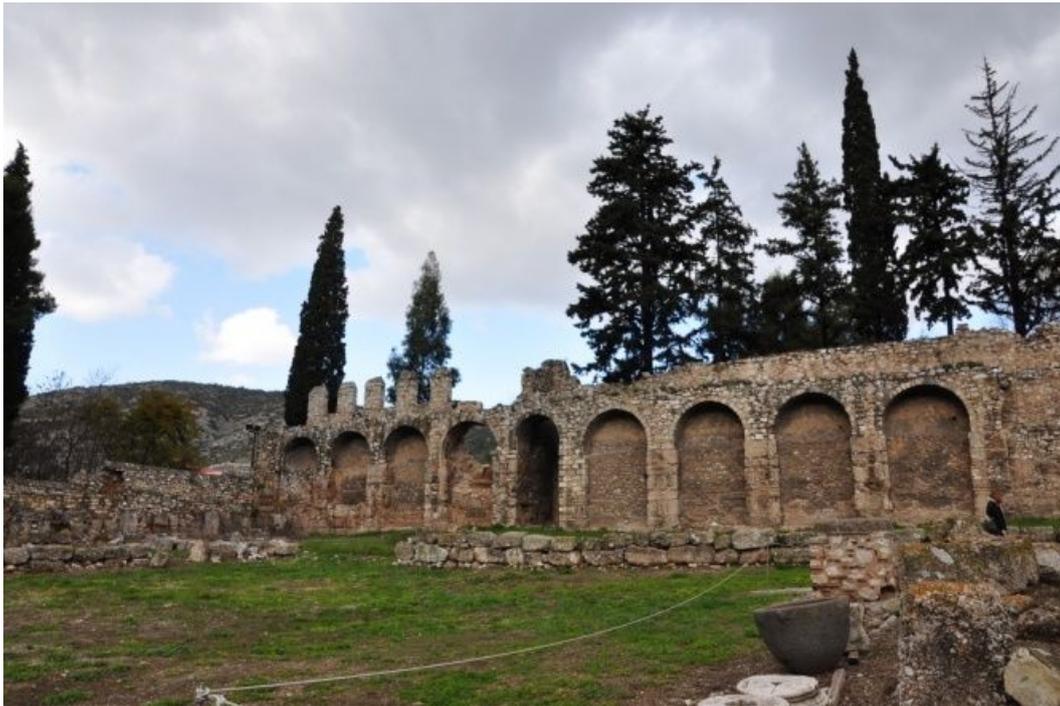
Figure 4.16: Exterior fortification walls of Daphni monastery (Commons wikimedia, 2011).

Sampling: Samples of joint mortars were collected from the exterior fortification walls (Fig 4.16). In all samples an extensive network of micro-cracks was observed. Crystallization of micritic calcite crystals can be seen partially or completely filling cracks of maximum 100 μm (Fig 4.17- 4.19).

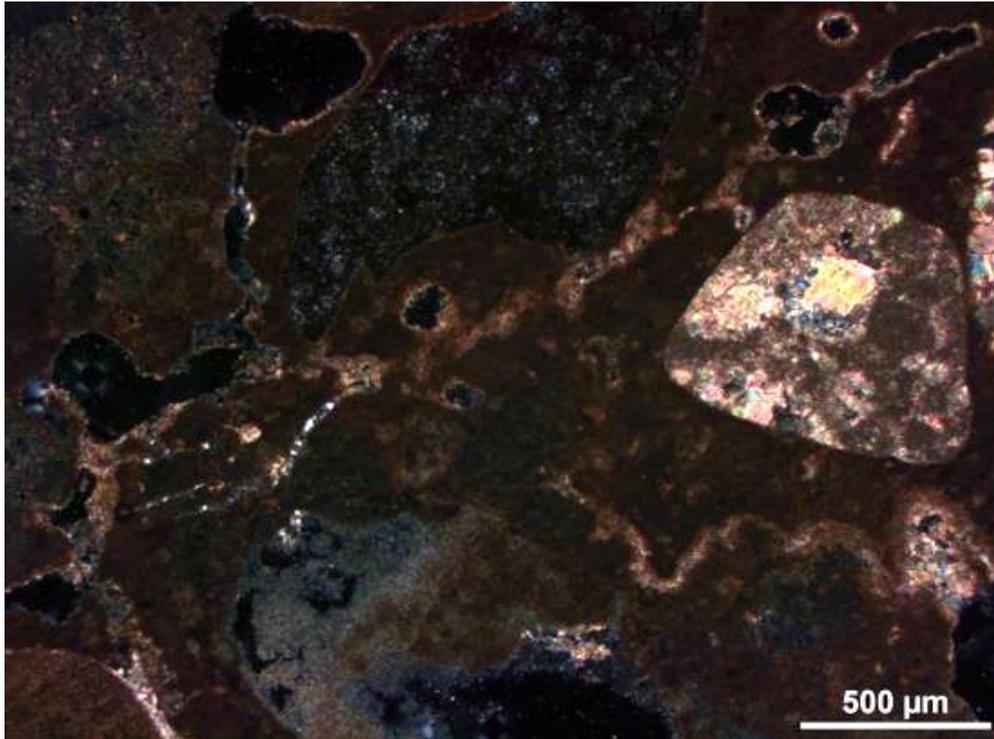
Figure 4.24: Secondary sparitic calcite crystals in the vicinity of lime lump filling completely a 50μm width crack.-PK17

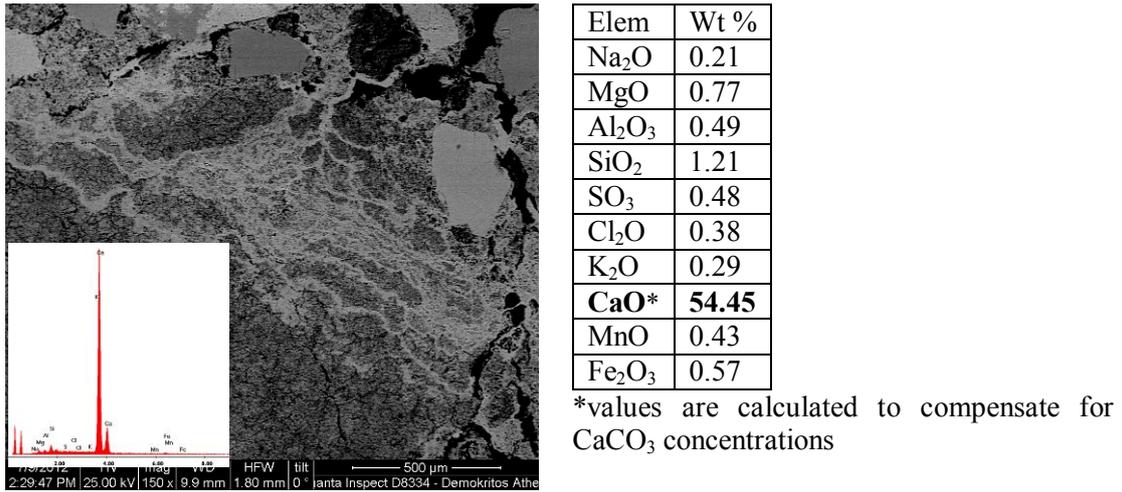
Figure 4.25: (Left) Leached secondary calcite partly repairing damaged microstructure. (Right) Chemical analysis of precipitated calcite –XD1

Leaching and re-crystallization of calcium carbonate was observed in the joint mortar sample (XD1). In both samples micritic calcite is re-crystallized filling micro-cracks and small voids completely (Fig. 4.25-4.27).

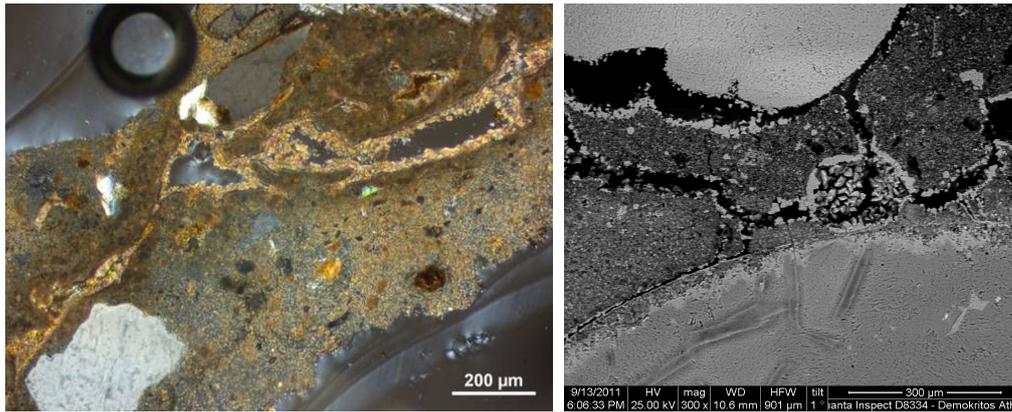
Fig. 4.29 (Left): Secondary calcite evenly precipitated along the sides of a crack - oik 20b

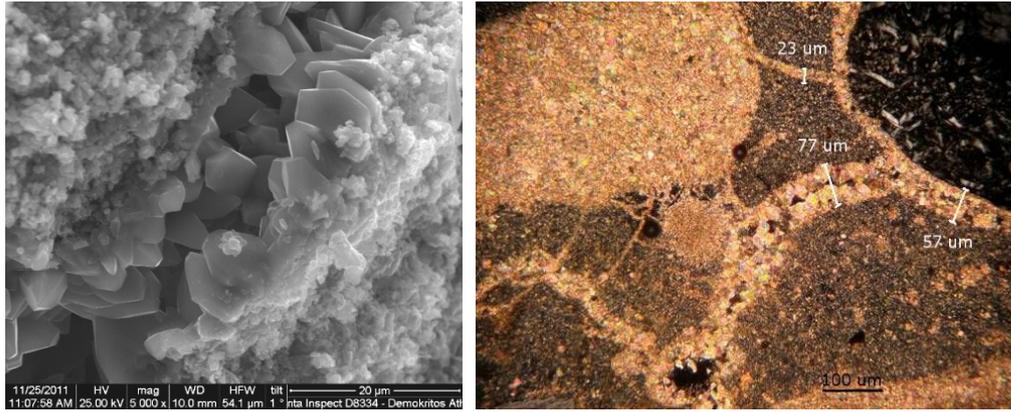
Figure 4.31(Right): Well formed sparitic calcite crystals. (Left) Calcite crystals of different morphology formed, corresponding to the crack width.

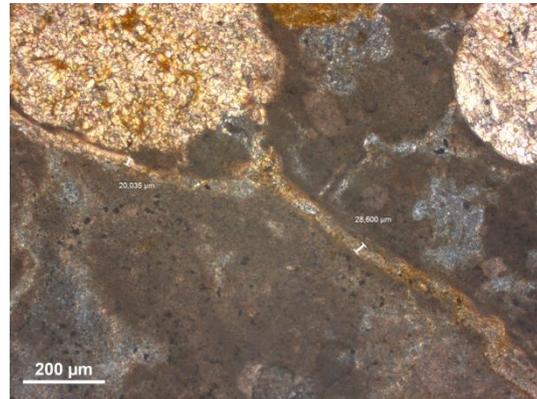
Figure 4.33 (Right): Overview of a crack (20-30μm width) filled with secondary calcite possibly due to the presence of a lime lump-XE2

Moreover, the presence of lime lumps could be a favorable condition, as poorly mixed binder hinders the carbonation process. Un-carbonated lime lumps could thus provide secondary healing products in the occurrence of damage fracture.

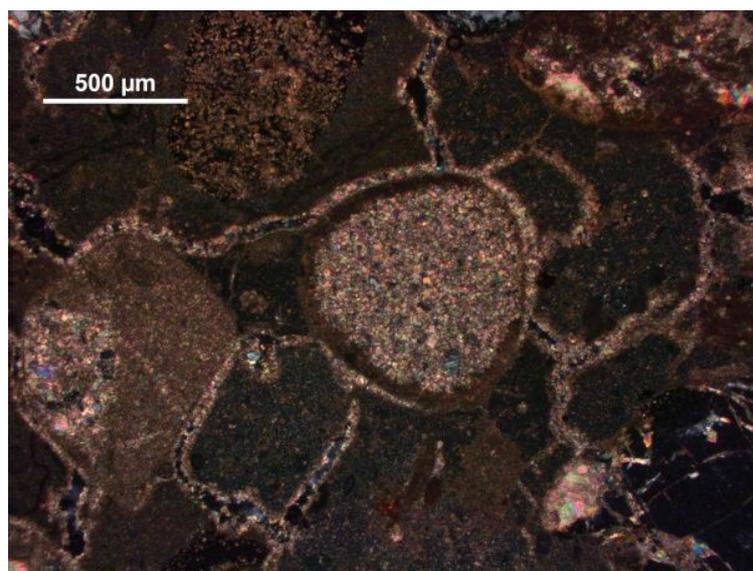
Figure 4.34: Network of cracks completely or partially filled with secondary calcite around a calcitic grain

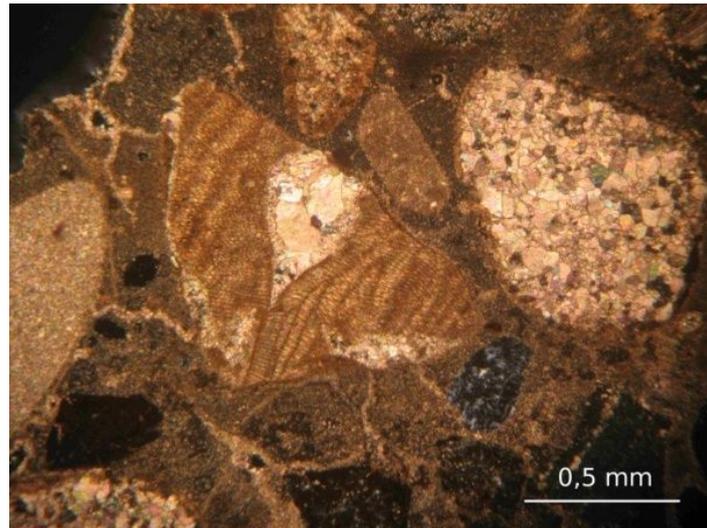
Figure 4.35: Secondary calcite formed around a fossil, possibly providing (supplying) the neighboring cracks with Ca^{2+} ions.

Self-healing phenomena were encountered in mortars with either calcareous and/or siliceous aggregates. However the presence of calcareous aggregates or fossils may provide nucleating points for calcite precipitation (Figure 4.34 - 4.37). The exact mechanism is not clear, but the compatibility of the substrate is known to enhance crystallization (Lanas et al., 2004). Additionally, the crystals' formation similarity between the calcitic grains and the secondary calcite inside the cracks points to this direction.

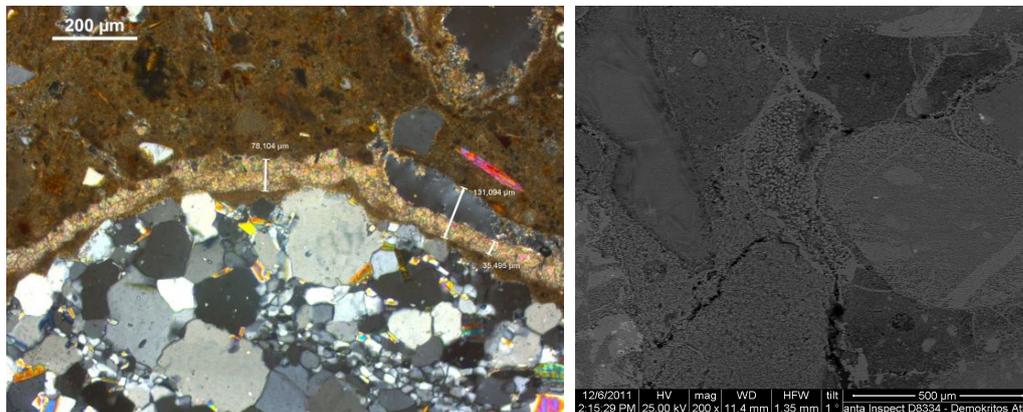
Figure 4.36: Secondary calcite crystallized in the interface between binder and siliceous aggregates Ag20-(Left), PK5-(Right).

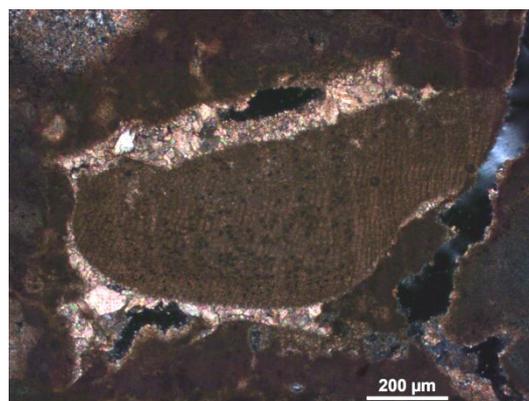
Figure 4.37: Secondary sparitic calcite precipitated around a microfossil filling a void of maximum width $150 \mu\text{m}$ - Ag20

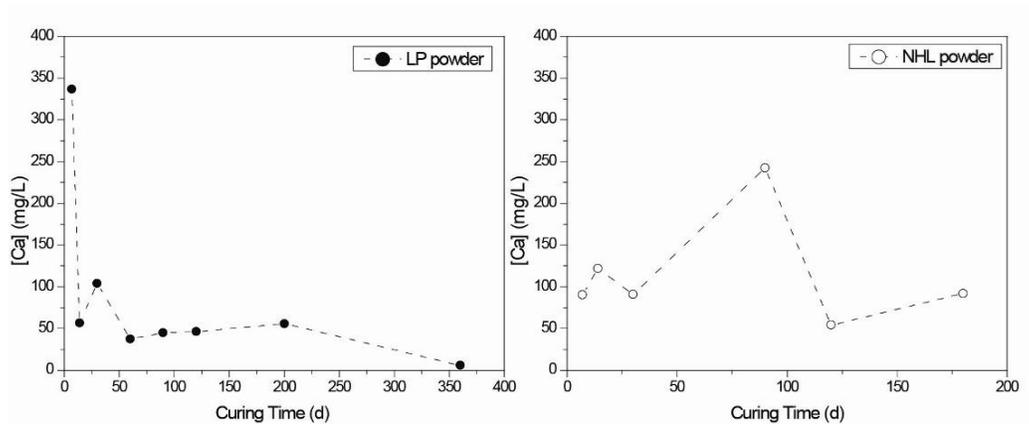
Figure 5.13: Calcium concentration in the leachate solution measured by AAS, as a function of curing period of the powdered specimens tested

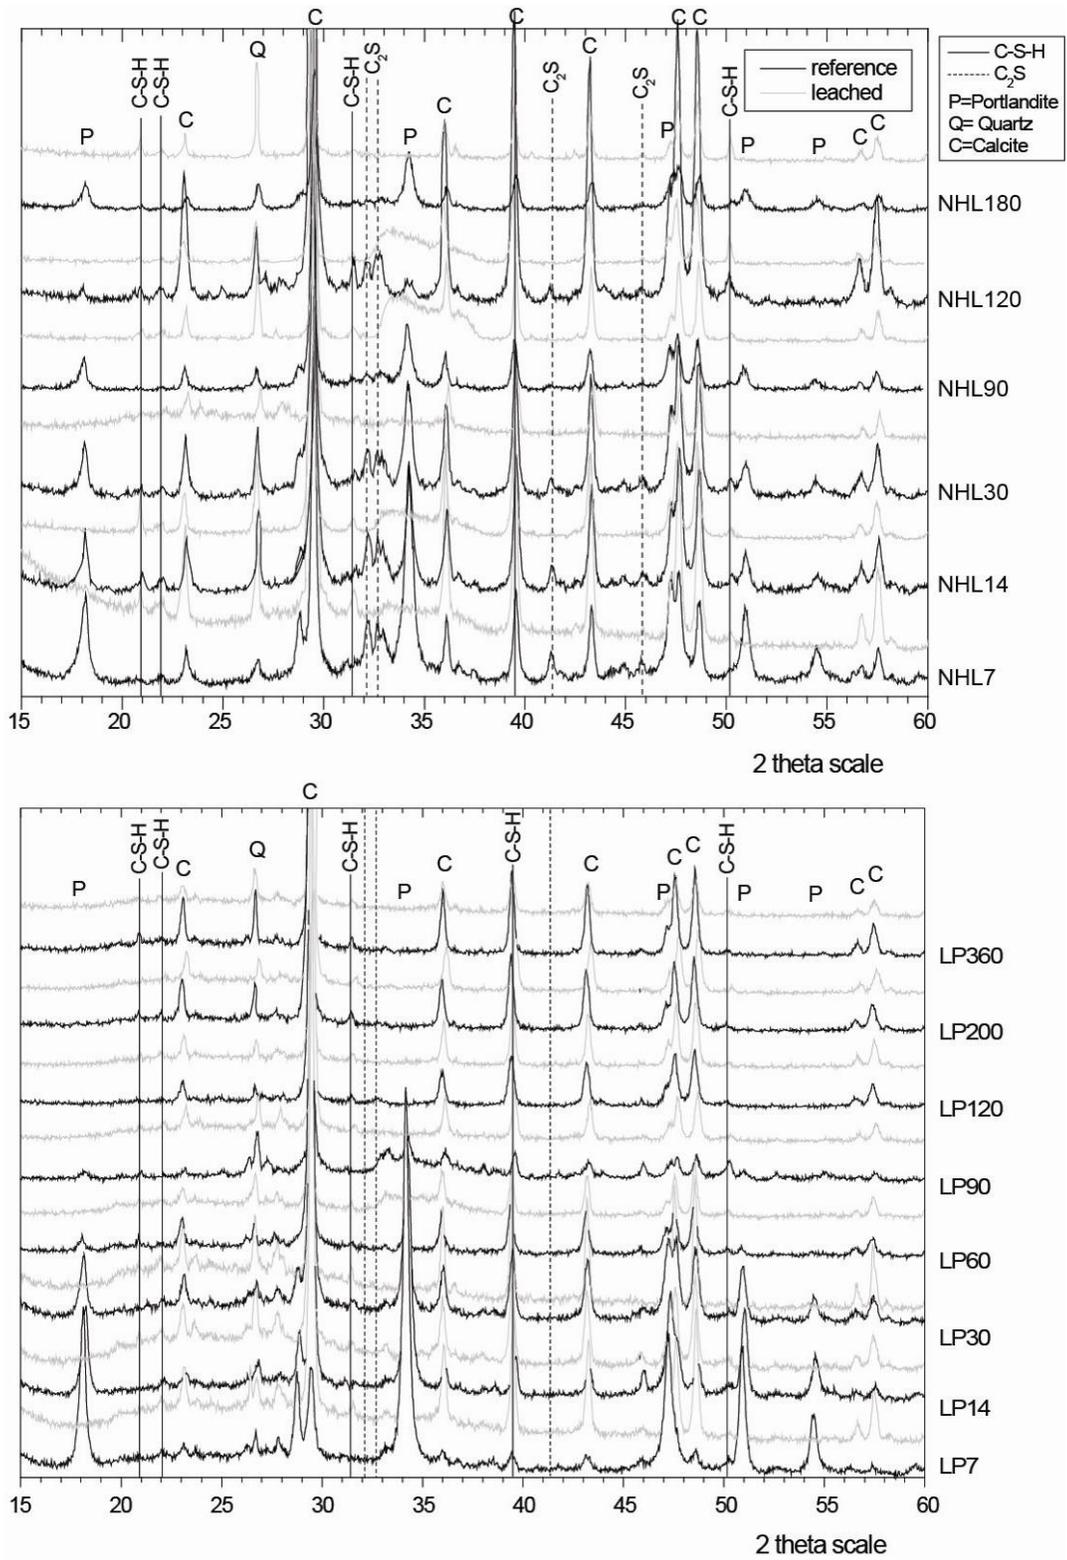
Figure 5.14: Diffractograms of reference (black line) and leached (gray line) powder NHL and LP specimens

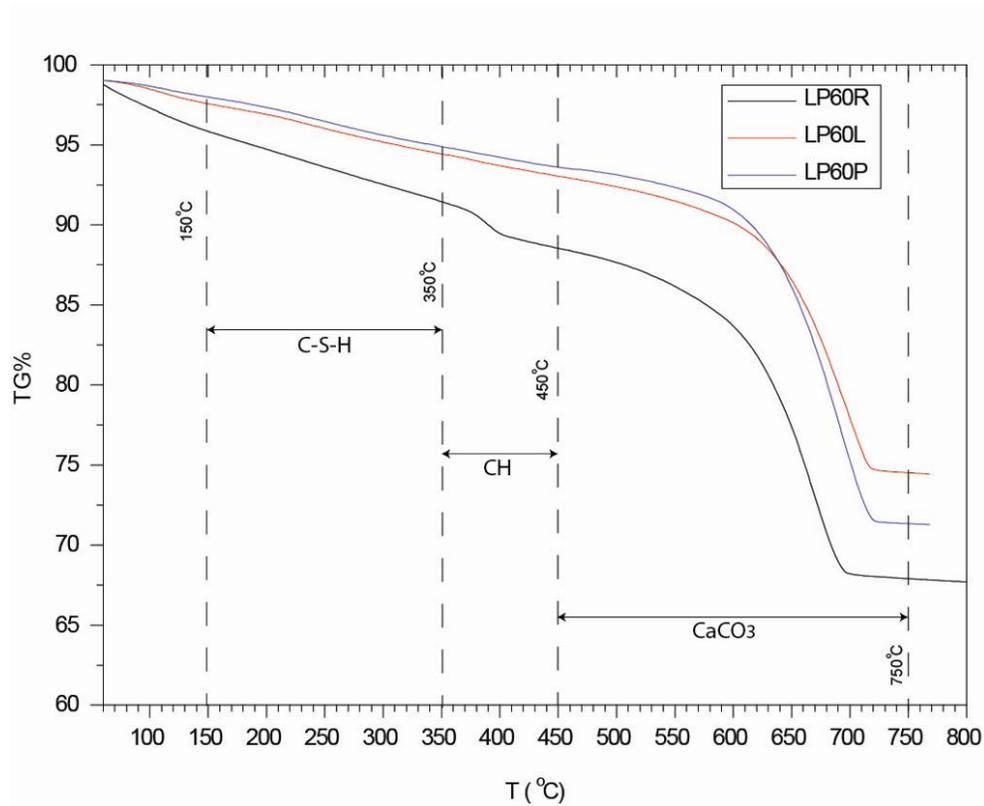
Figure 5.15: Temperature ranges used for the quantification of binder components on leached and reference cylindrical specimens.

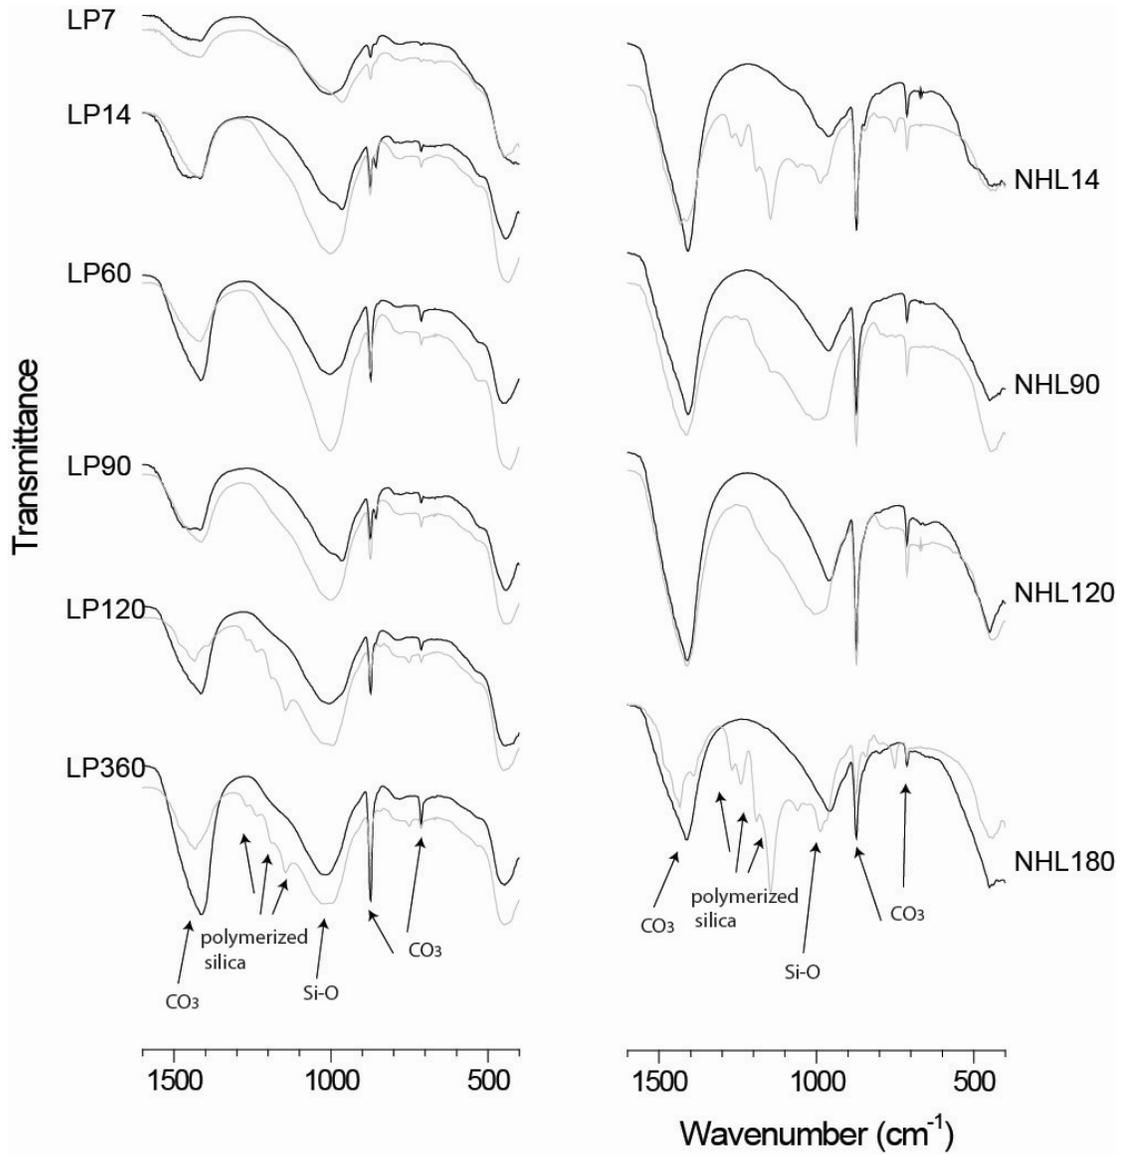
Figure 5.19: FT-IR spectra of ground NHL and LP specimens before (black line) and after (gray line) leaching.

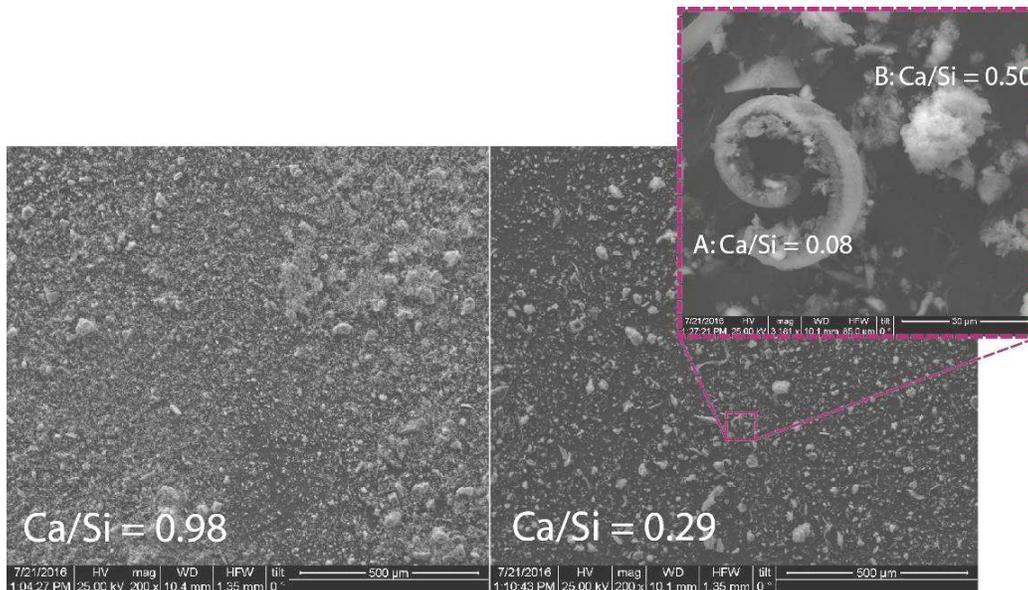
Figure 5.21: Microphotographs of reference (left) and leached (right) powder NHL specimens. Ca/Si ratio is result of bulk analysis during SEM examination. In detail microphotograph, the two main particle types are presented along with their measured Ca/Si ratio.

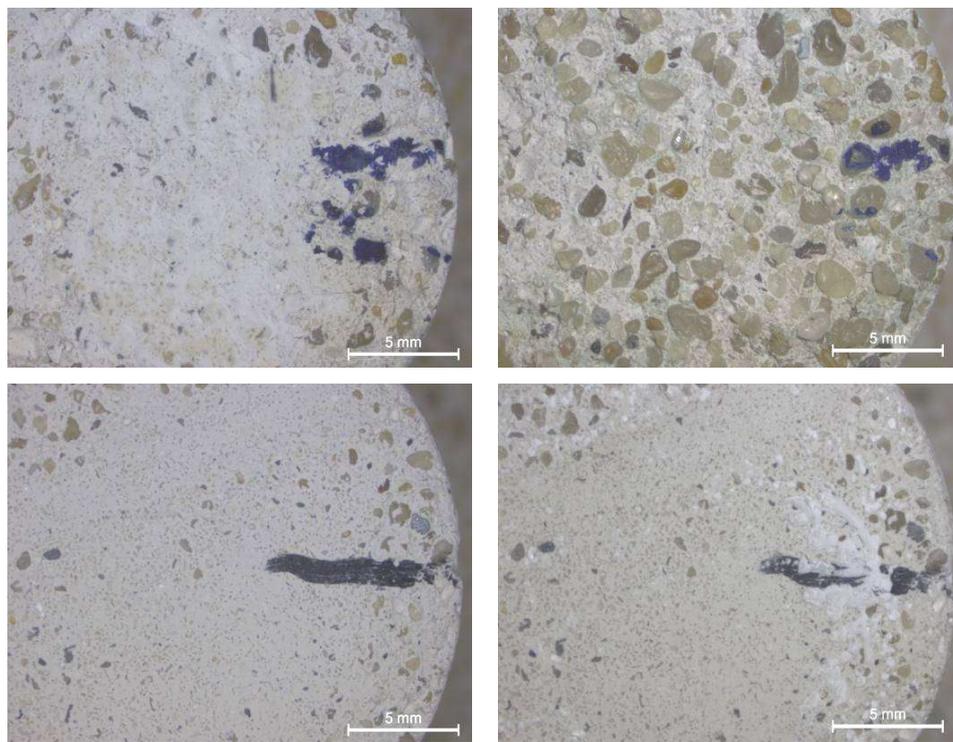
Figure 5.22: LP specimens as captured before (left) and after (right) leaching. On top the surface in contact with the anode solution (L) and at the bottom the surface in contact with the cathode solution (P)

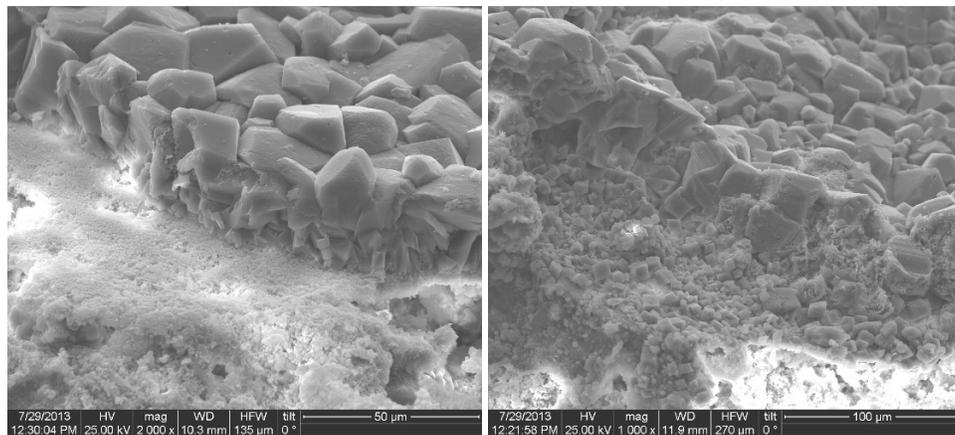
Figure 5.24: Microphotograph of the specimen's surface in contact with the anode solution (P) is characterized by a precipitated layer of pure calcite crystals

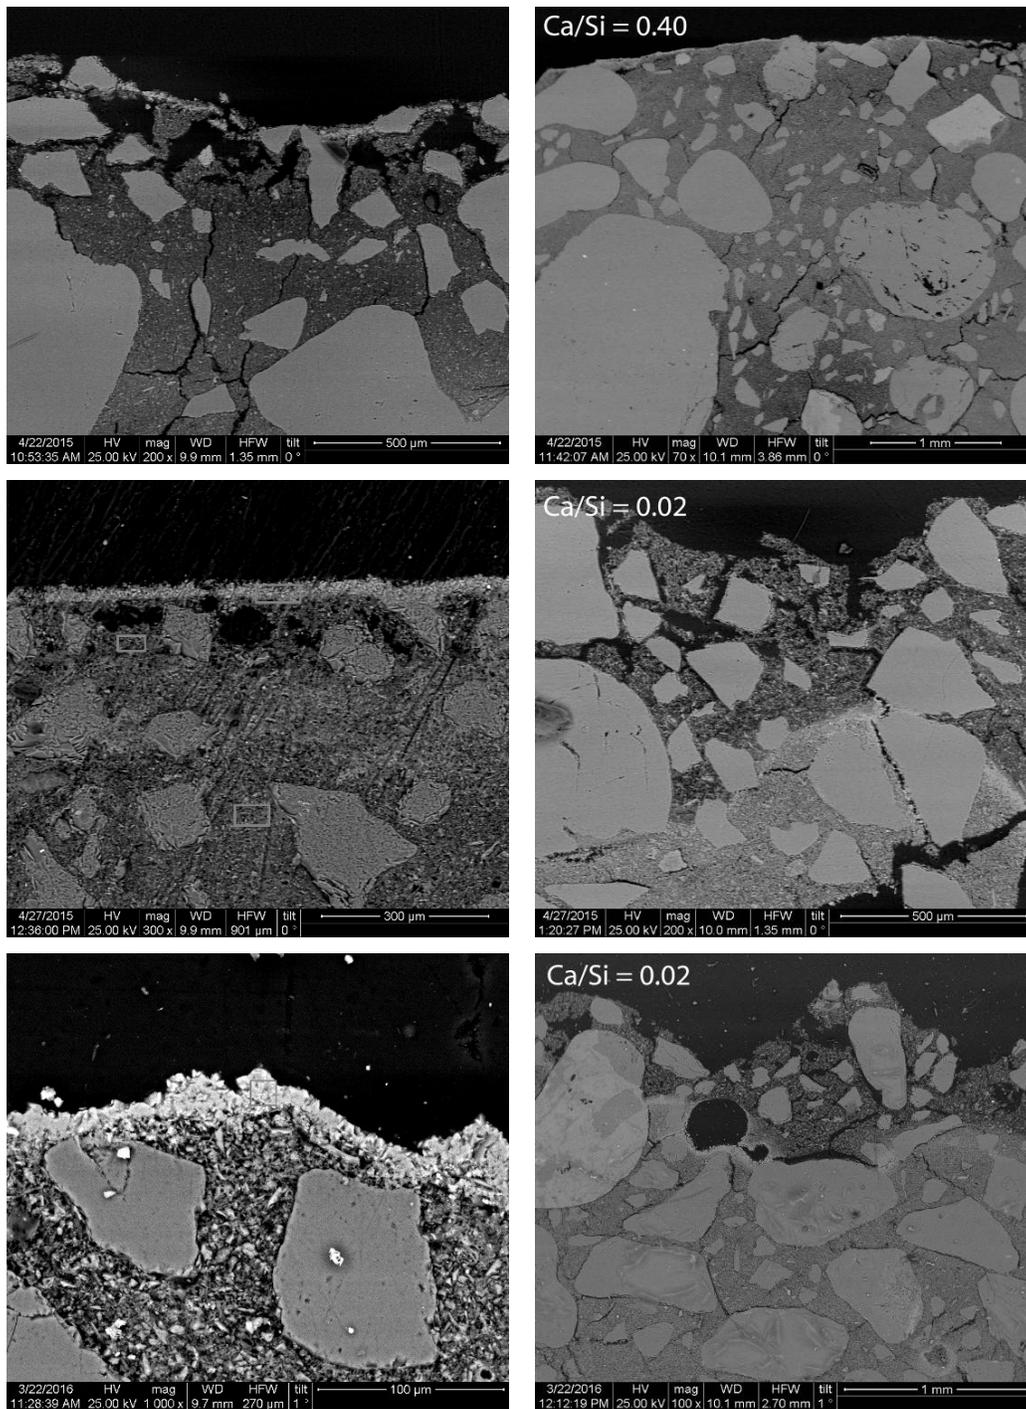
Figure 5.26: Microphotographs of both sides of LP specimens (P-left) (L-right) and Ca/Si ratio calculated by analysis of the leached zone.

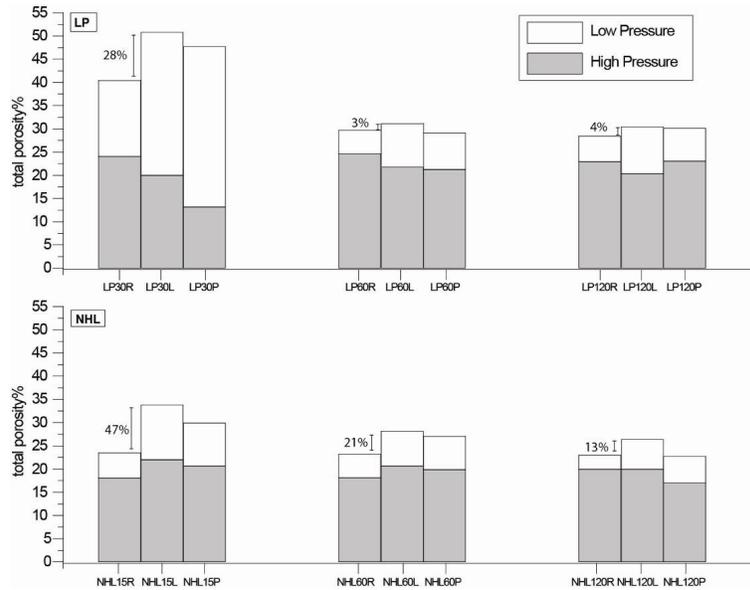
Figure 5.28: Total porosity % of reference and leached LP and NHL cylindrical specimens. The porosity increase % due to leaching on the side of the anode solution (L) is stated.

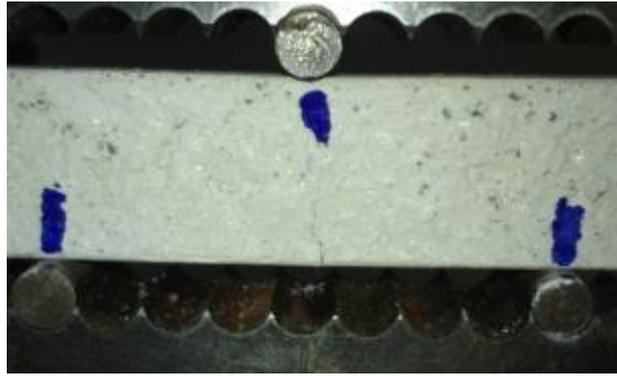
In order to study the healing mechanisms, the specimens were damaged by controlled cracking, under three point bending test using an INSTRON -100kN compression machine. A continuous load (100 μ m/min) was applied to all specimens, allowing the controlled deformation of specimens after crack initiation (Fig 6.1).

Figure 6.1: Crack initiation by three point bending.

A set of preliminary tests were conducted in order to correlate displacement values with the width of the crack generated by three-point bending tests. During crack generation special care was given to ensure that the aforementioned displacement would not result in the collapse of the specimen. This was applied in all groups of specimens, as their fracture profiles demonstrate a clear variation in mechanical properties depending on the curing period and the type of binder (Fig. 6.2). In all cases the specimens were unloaded before their load displacement curve became parallel to the displacement axis. At this point the specimens absorb the maximum energy leading to crack propagation, which does not lead to their failure.
