**ΠΟΛΥΤΕΧΝΕΙΟ
ΚΡΗΤΗΣ**

Mechanisms and parameters for life-cycle optimization of traditional lime-based mortars

PhD Thesis
by
Maria Amenta

Chania, July 2017

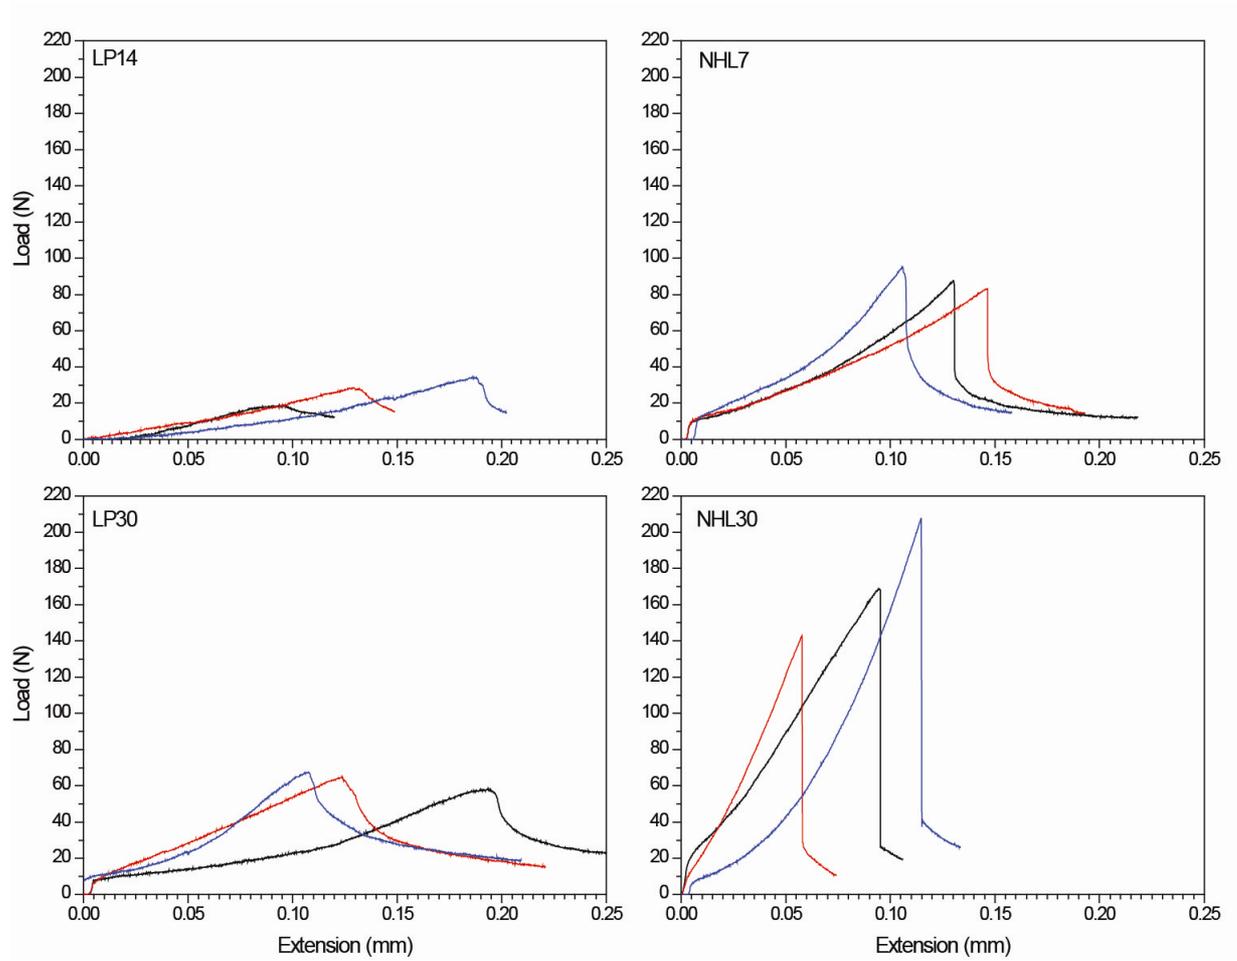
Figure 6.2: Fracture profiles generated by three -point bending

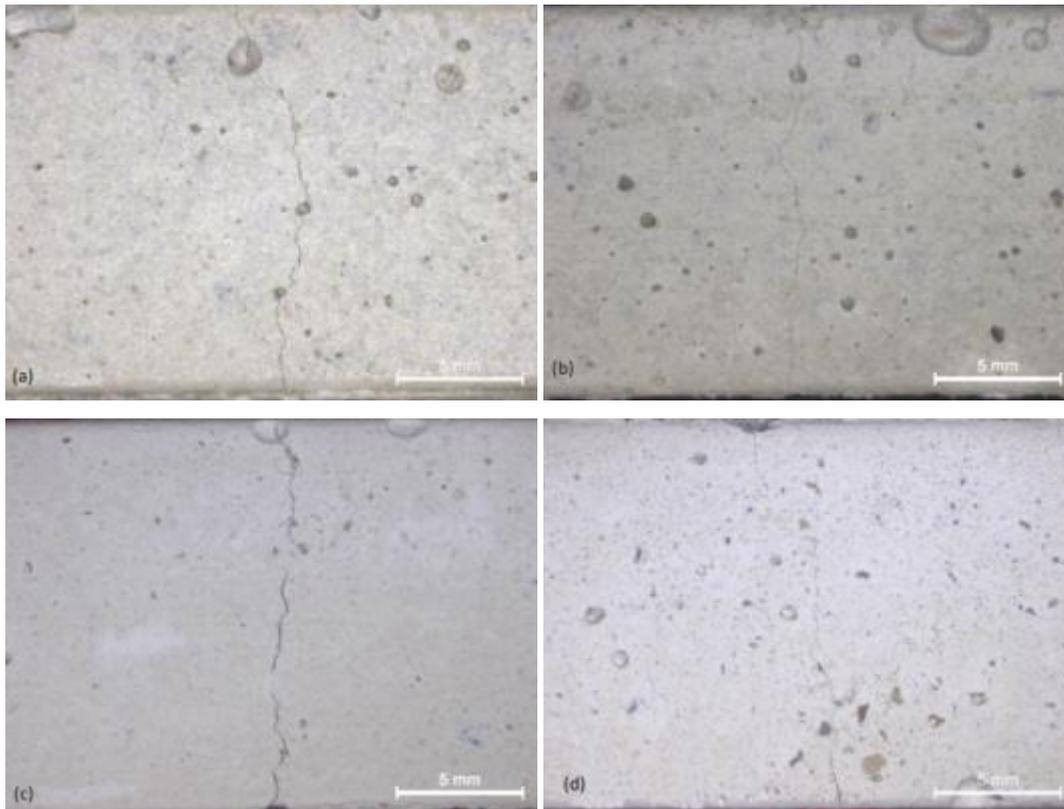
Figure 6.4: Overview of cracks on the bottom side of cracked specimens.

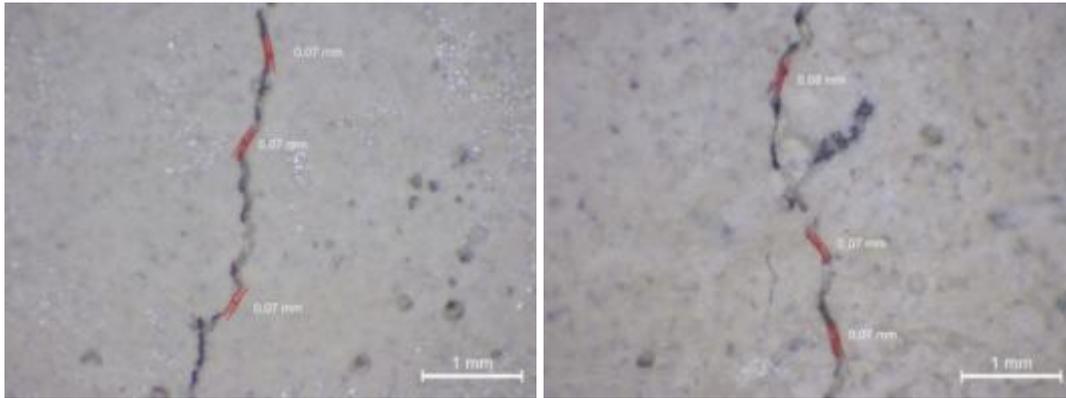
Figure 6.5: Detailed measurement of crack

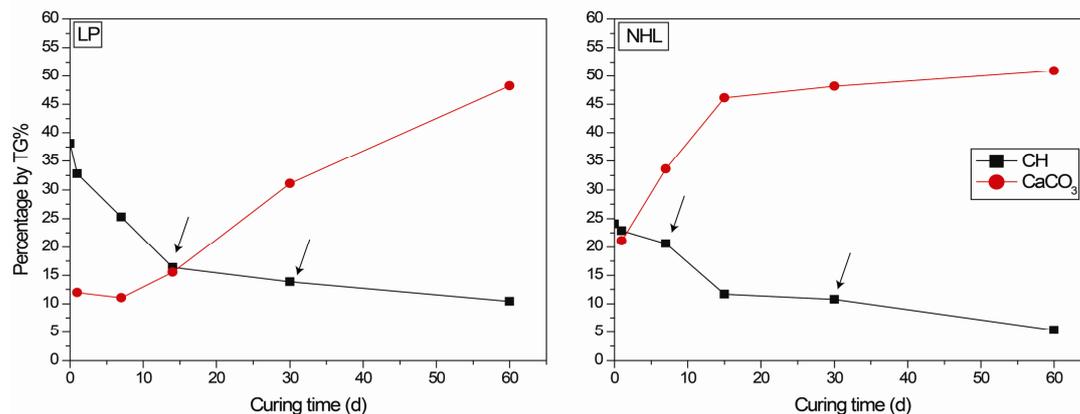
Figure 6.6: The evolution of portlandite and calcite content (wt%), as they were calculated by thermo-gravimetric analysis of LP and NHL reference mortars during the first two months of curing (60 d).

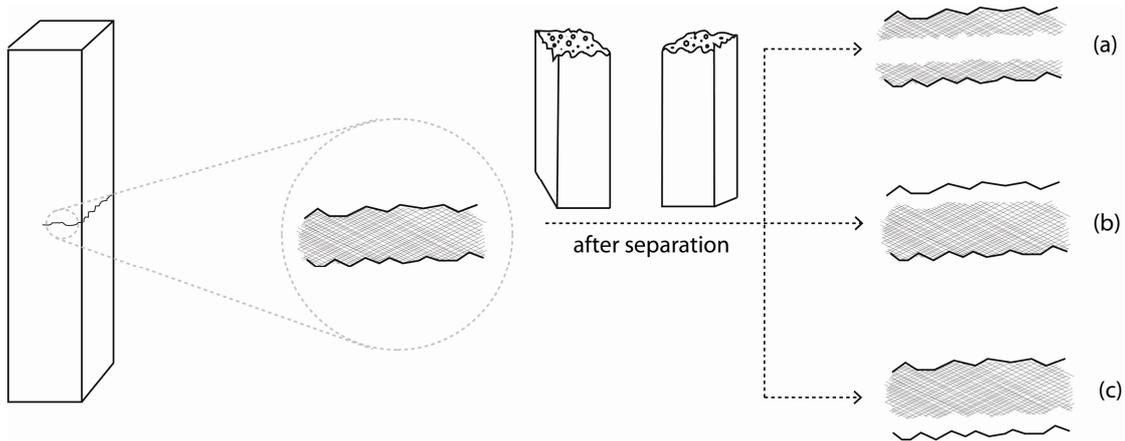
Figure 6.9: Separation of the crack walls might lead to: the observation of secondary healing products in either walls (a) or the detachment from one wall due to low cohesion with the crack surface (b and c)

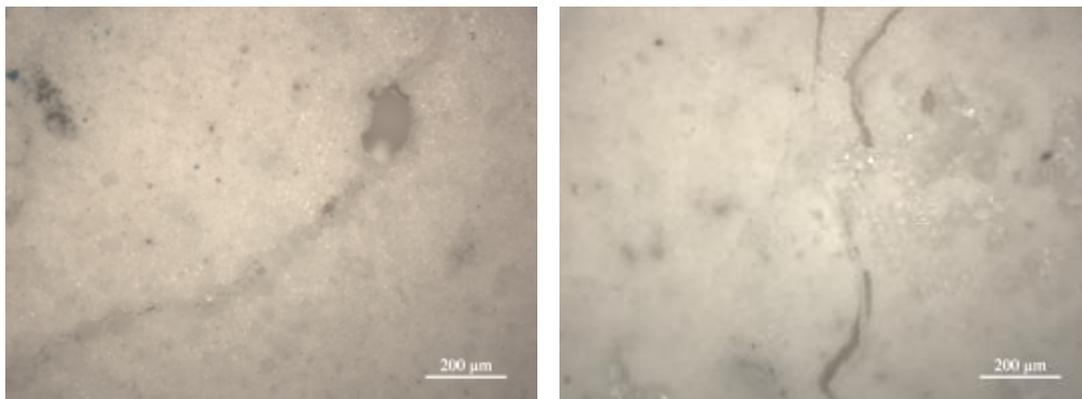
Figure 6.12: Precipitation of secondary calcite on the crack mouth as observed in under polarizing microscope (left-LP, right-NHL)

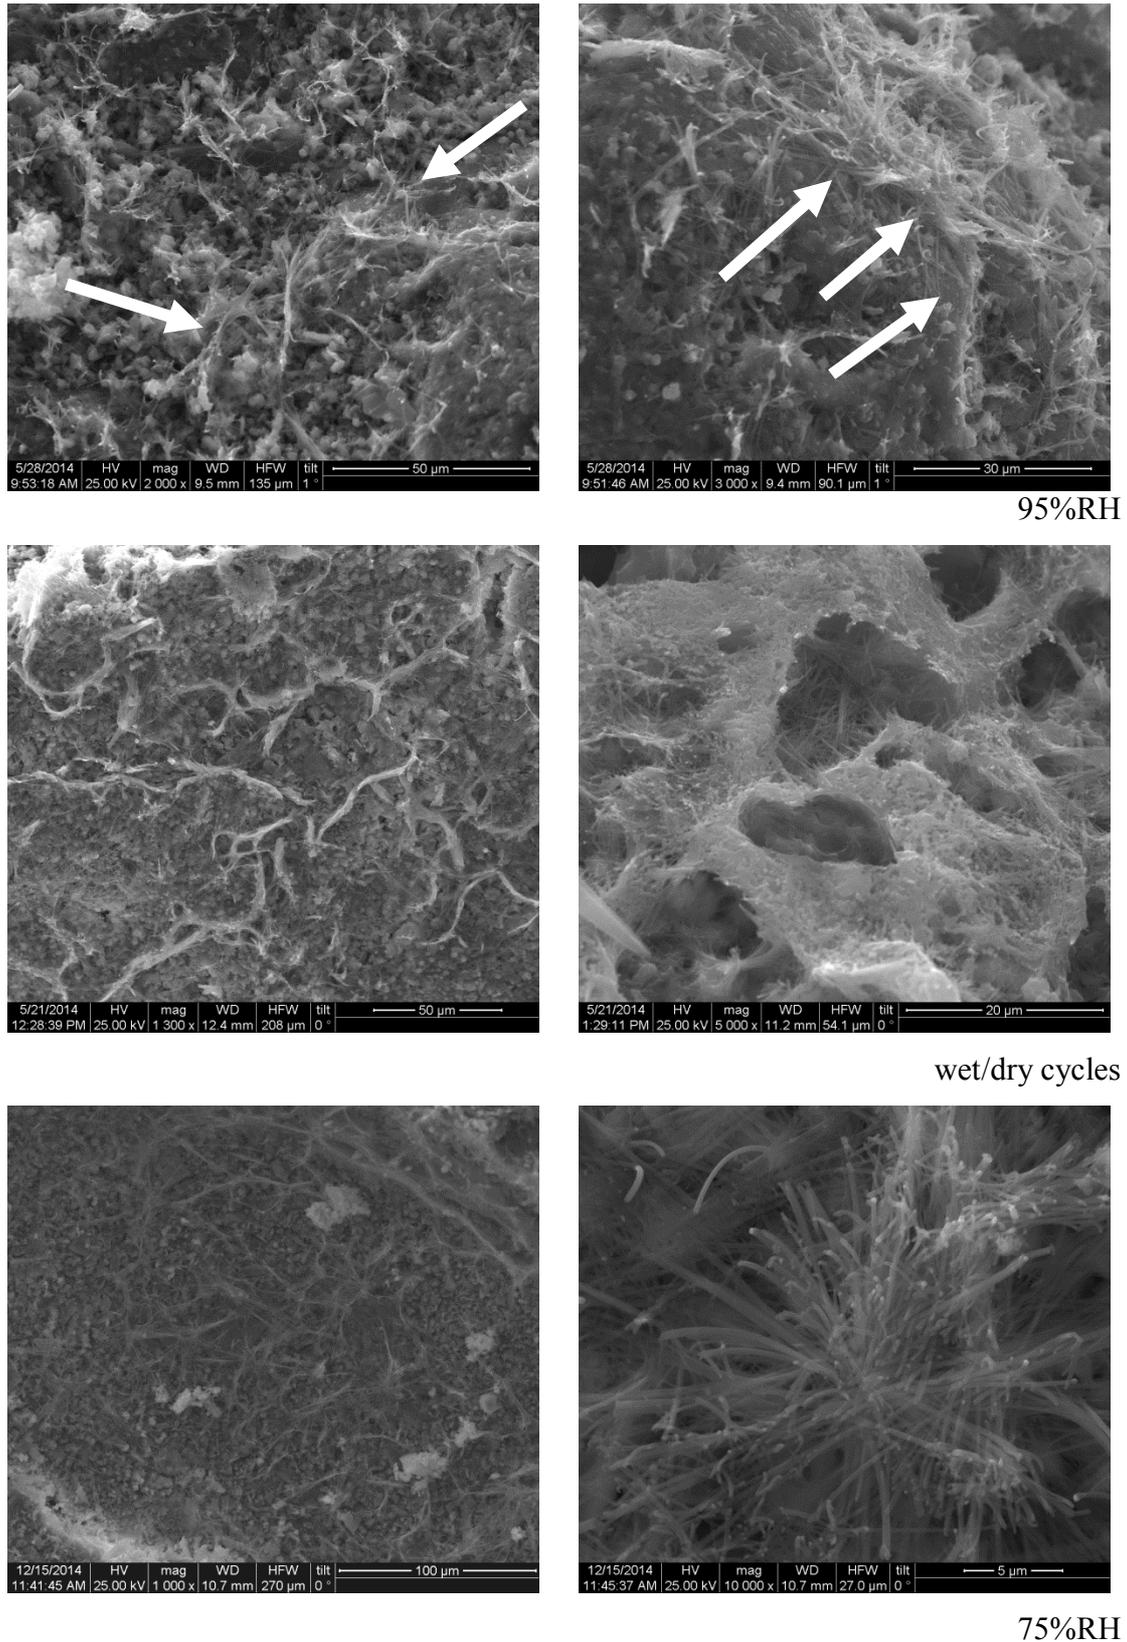
Figure 6.13: Secondary hydraulic phases at different healing conditions (95% RH, 75% RH and wet/dry cycles) develop a single uniform layer of interconnected fibers. In detail: the outward orientation of the fibers.

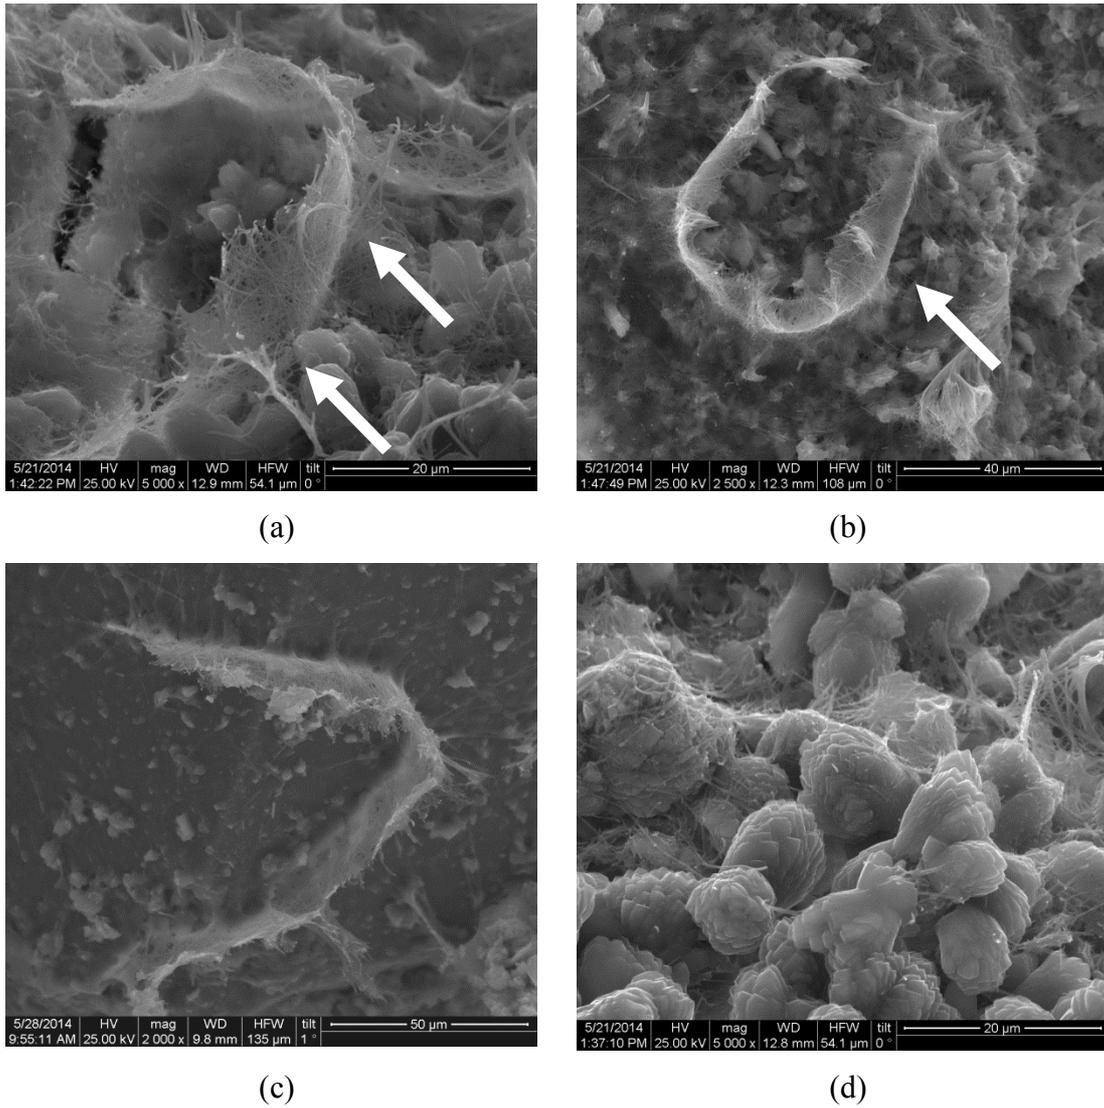
Figure 6.14: Secondary hydraulic phases are formed on various substrates such as (a) and (b) on micritic calcite in the binder matrix, (c) on the surface of aggregates and (d) together with secondary calcite.

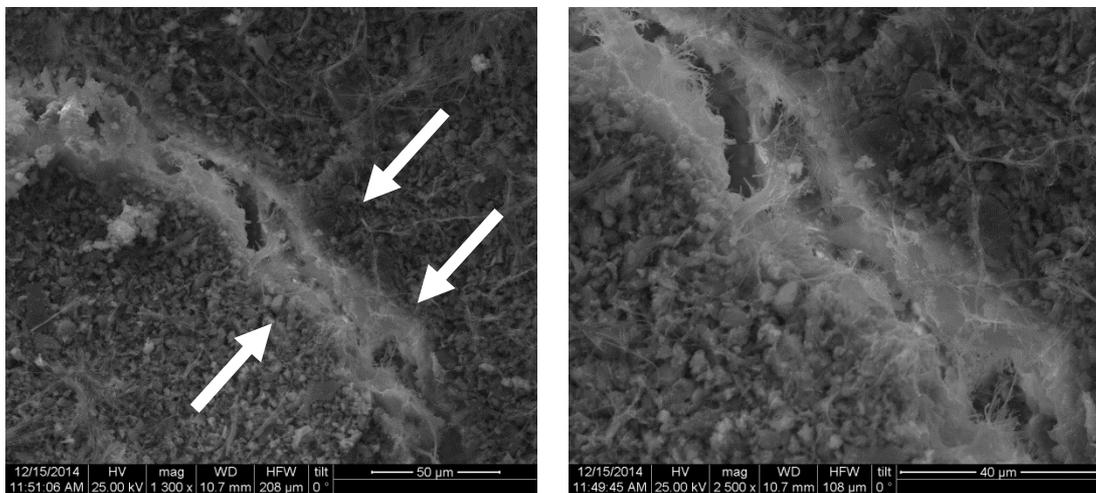
Figure 6.15: Fiber-like secondary hydraulic phases bridging a micro-crack of ~30 μm width.

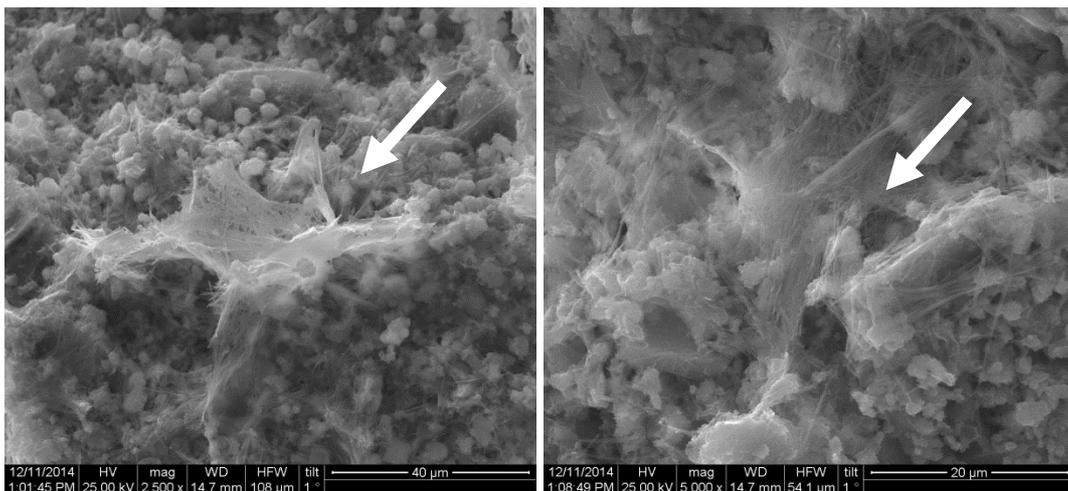
Figure 6.17: Secondary fiber-like hydraulic phases

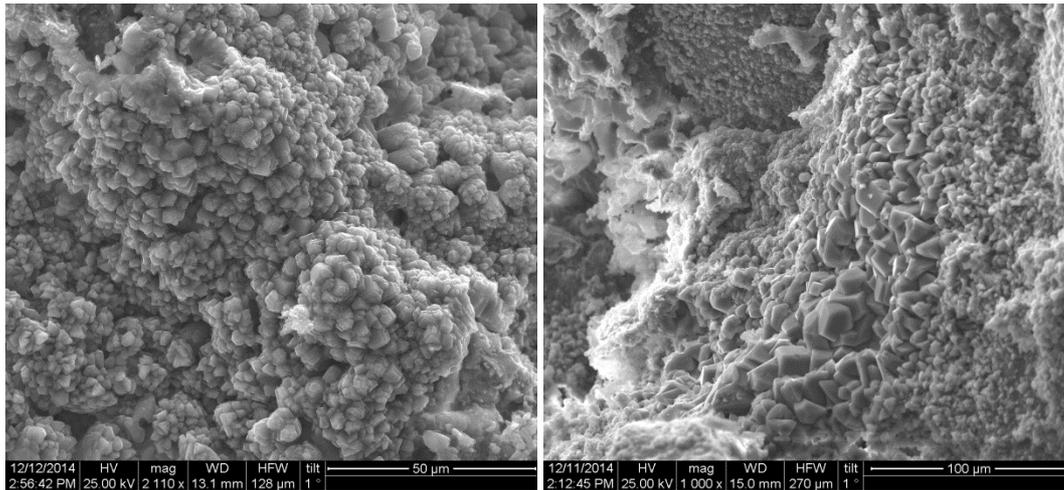
Figure 6.18: Extended zones of secondary calcite precipitation on the crack surface

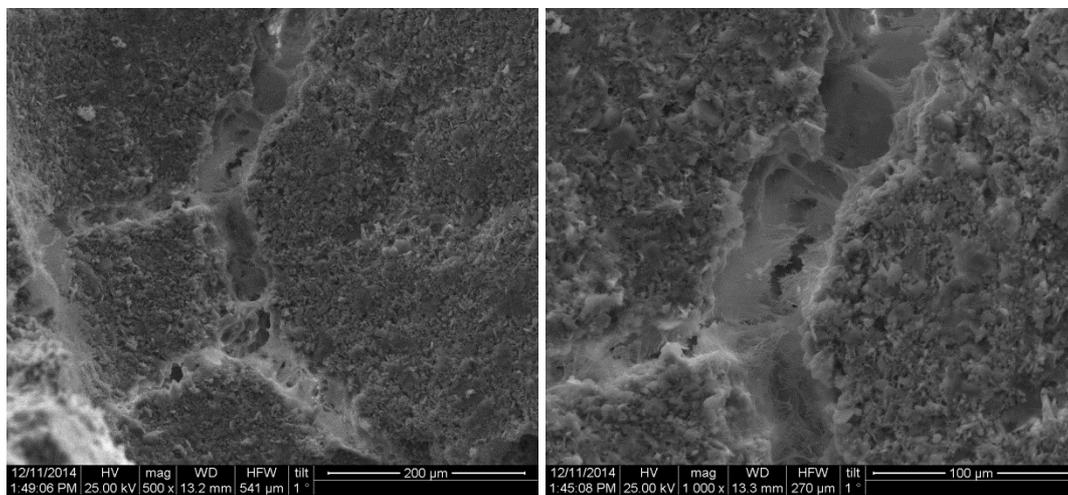
Figure 6.19: Fiber-like secondary hydraulic phases bridging a ~70 µm micro-crack.

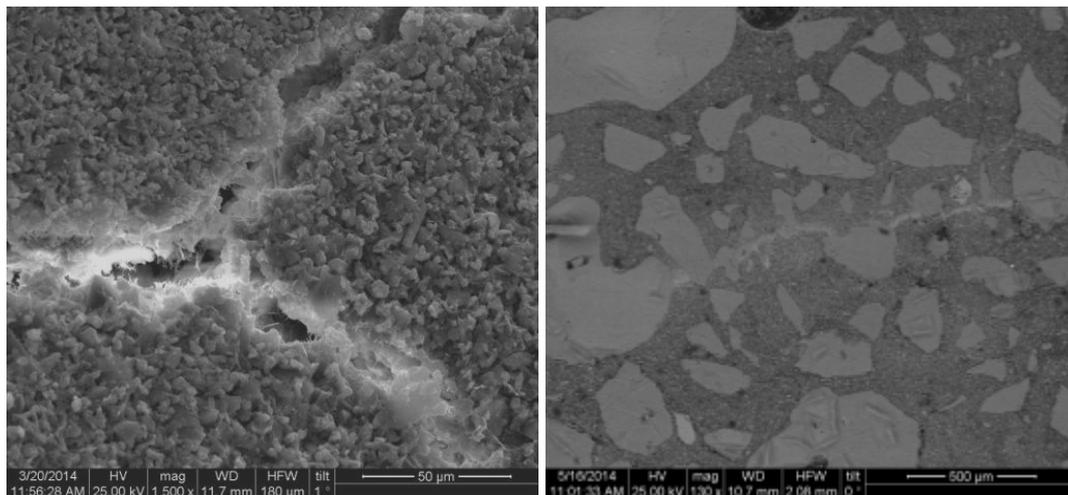
Figure 6.22: Microphotographs of LP303075. Hydration products formed along a smaller perpendicular crack (left) and a micro crack completely filled by calcite (right).

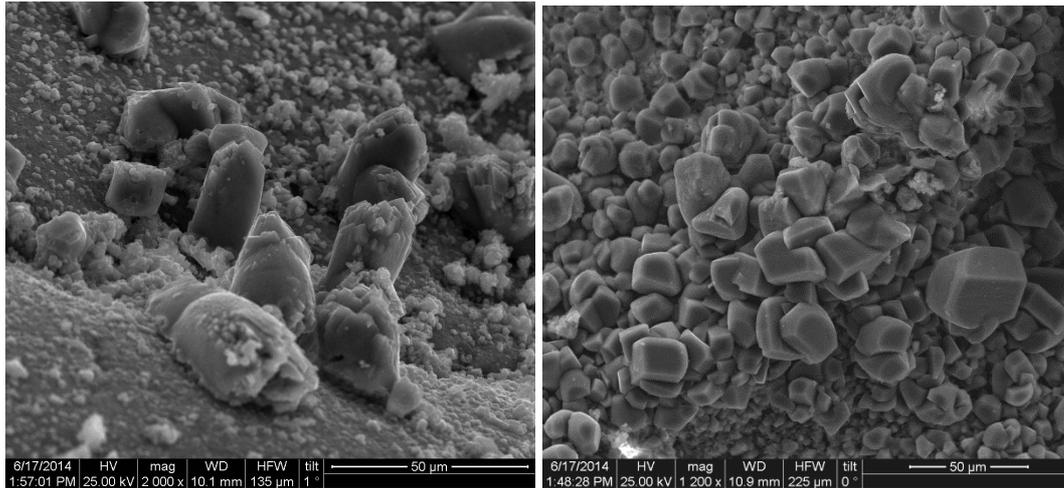
Figure 6.23: Well-formed secondary calcite crystals up to $\sim 50\ \mu\text{m}$ in diameter.

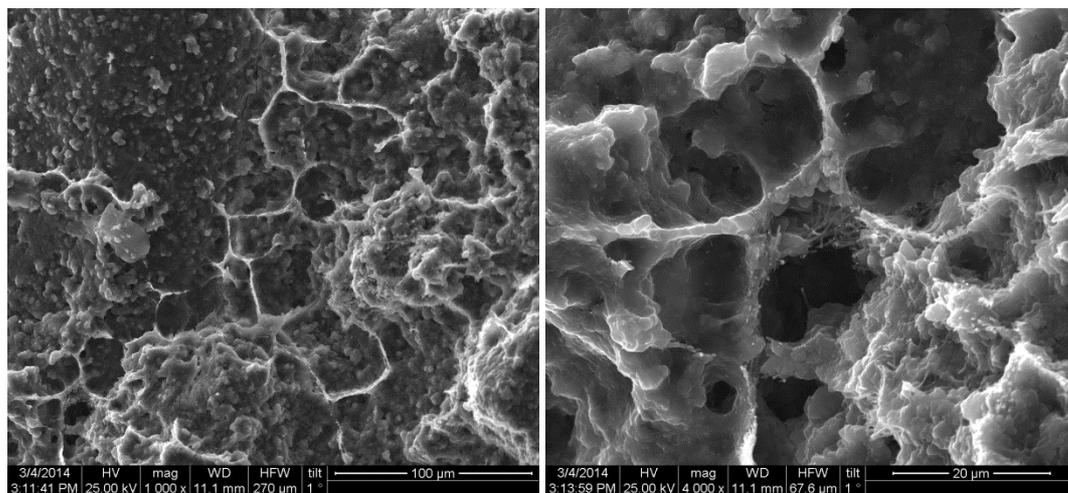
Figure 6.25: Honeycomb formation observed in specimens cured under wet/dry cycles and detail.

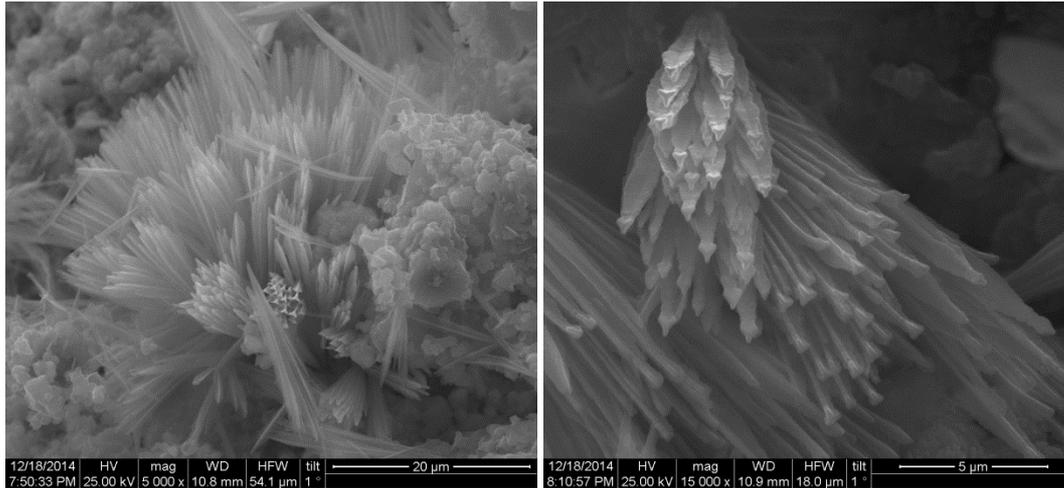
Figure 6.26: CSH needle-like formations observed in specimens cured at 95%RH.

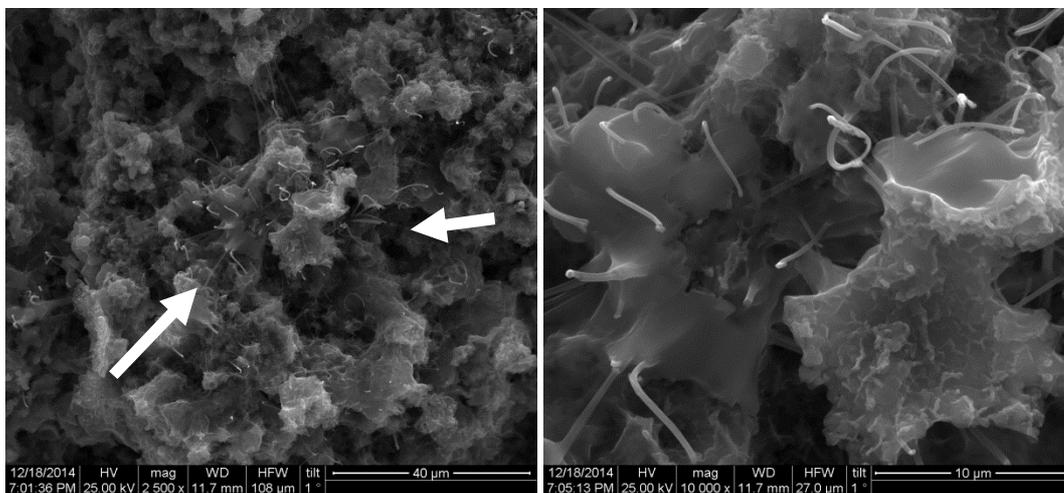
Figure 6.27: Highly gelatinous hydraulic phases in specimens cured at 95%RH

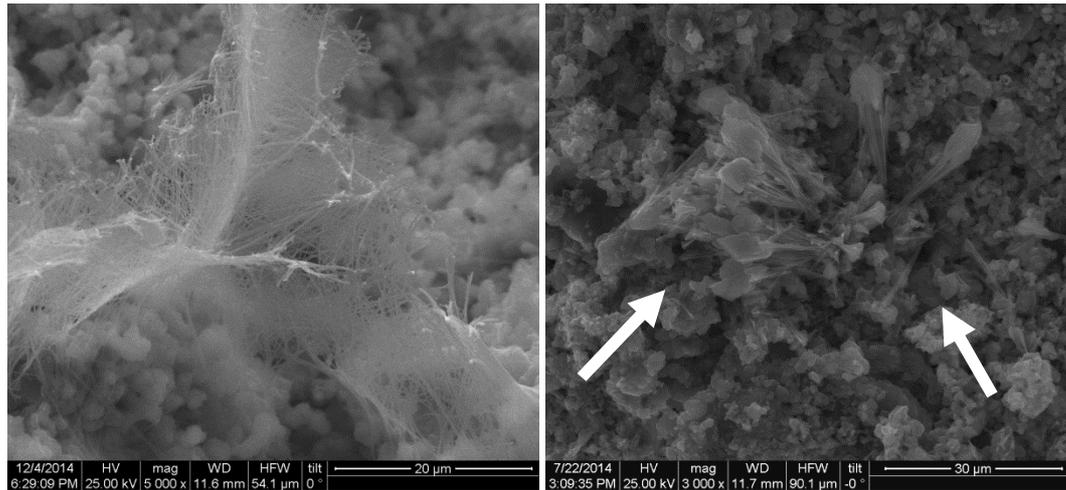
Figure 6.28: Secondary fiber and needle-like hydraulic phases in specimens healed for 90 days.

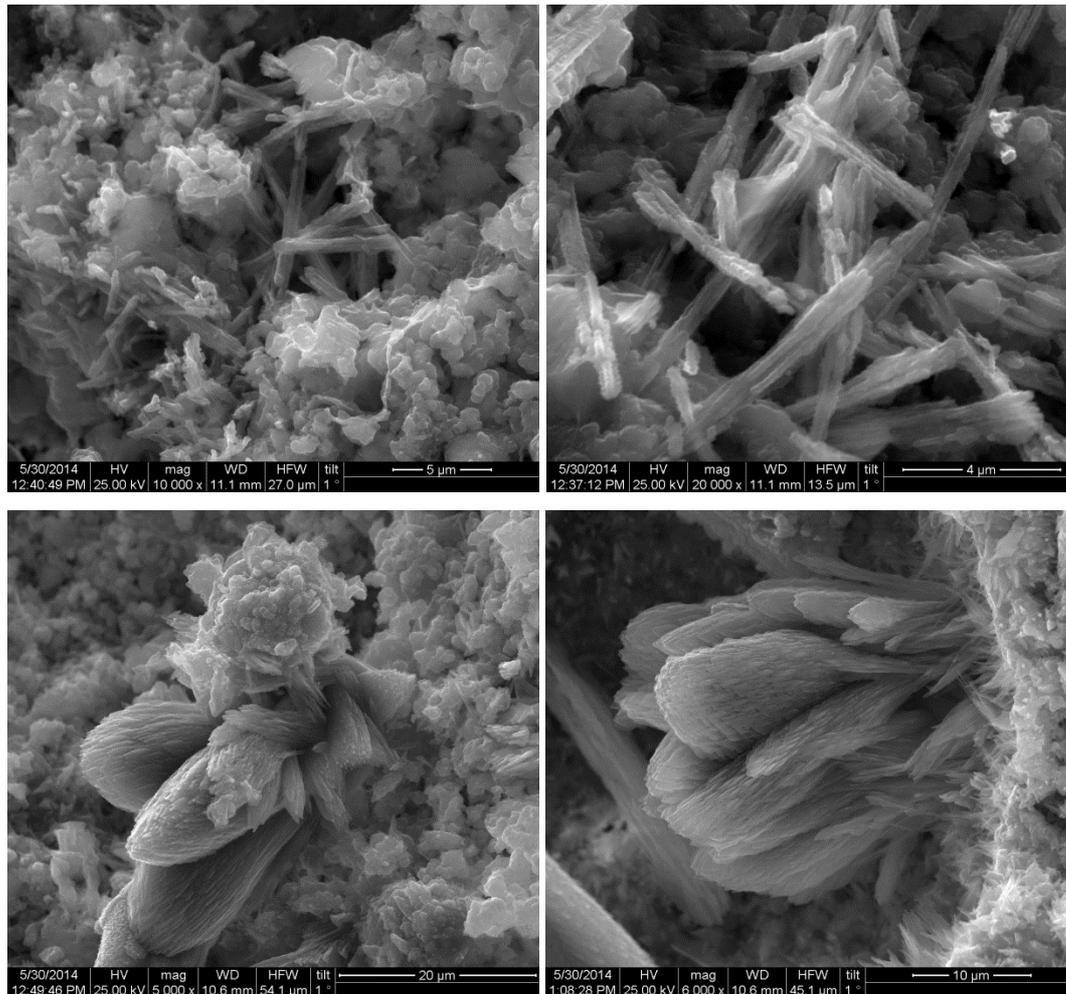
Figure 6.31: Conglomerates of needle-like formations in NHL specimens cracked after 30 days of curing.

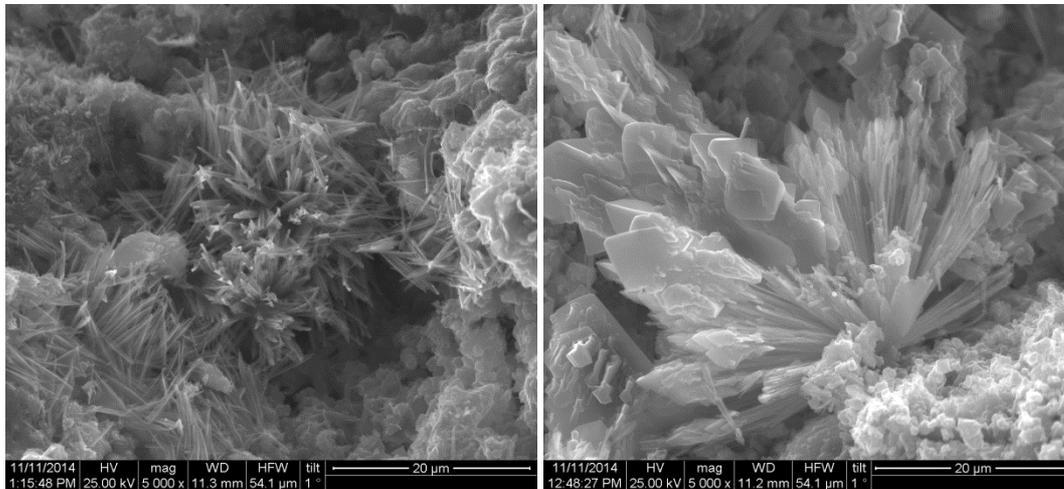
Fig 6.32: Needle-like formations in NHL specimens cracked after 30 days of curing and healed for 90 days.

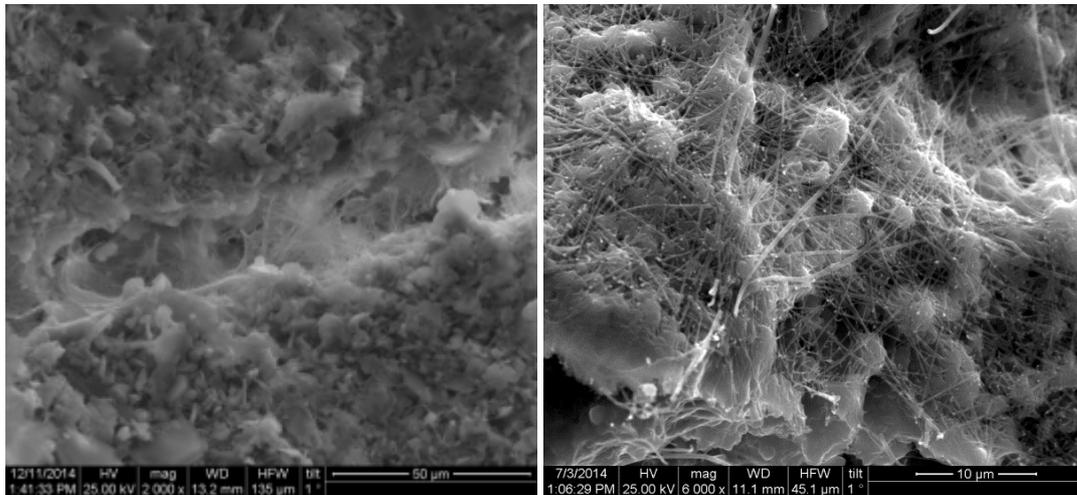
Figure 6.34: First-step, fiber-like or “low-density” CSH forms a continuous layer.

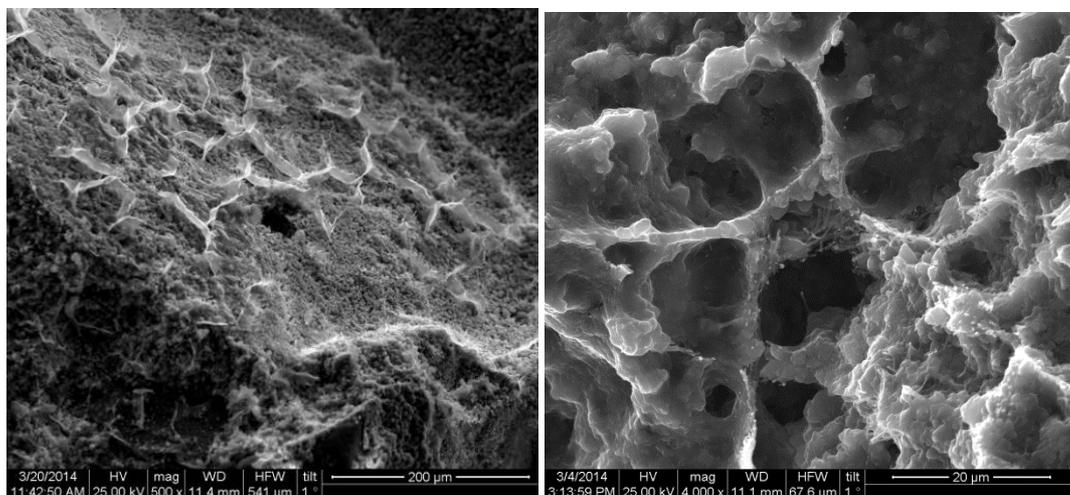
Figure 6.36: Second-step honeycomb CSH formations

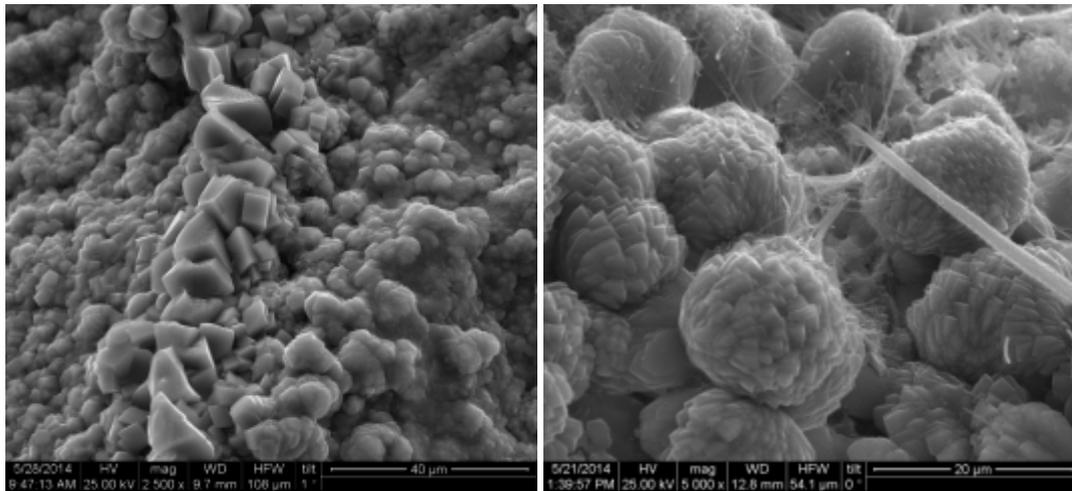
Figure 6.37: Typical patterns of calcium carbonate formations of varying size and morphology.

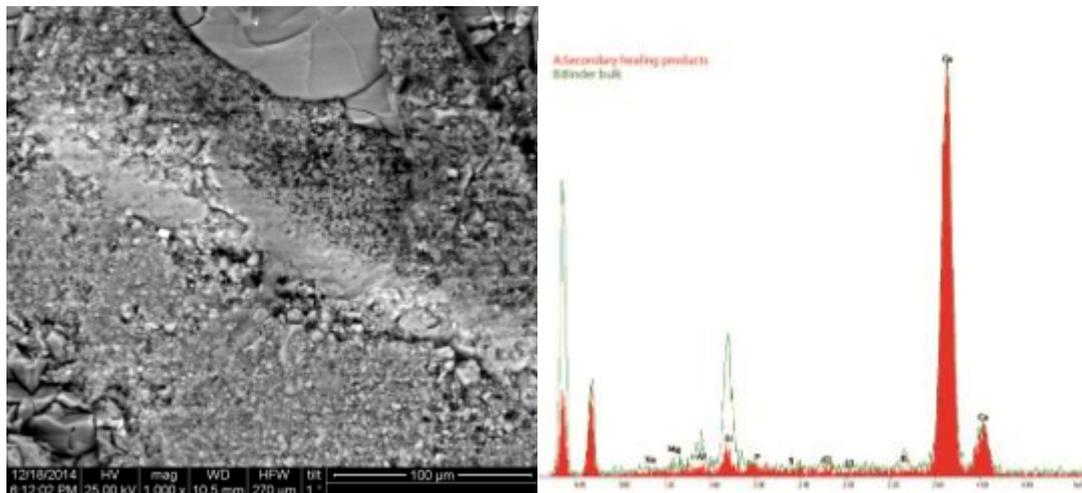
Figure 6.38: Secondary formed calcite in LP mortars completely filling a micro crack (left). Chemical characterization of secondary calcite was also determined by EDAX analysis (right).

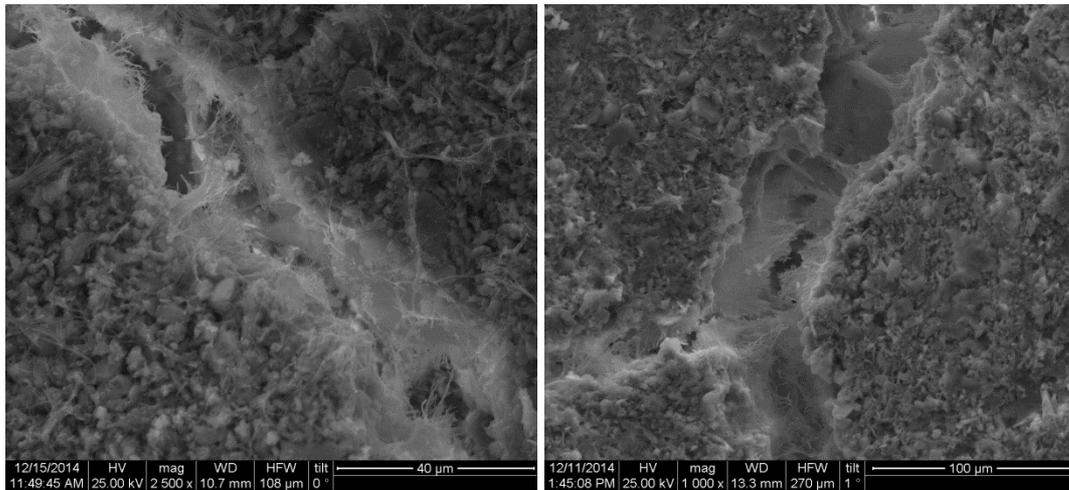
Figure 6.39: Fiber-like secondary hydraulic phases bridging micro-cracks of ~30 and ~70 μm after prolonged healing period.

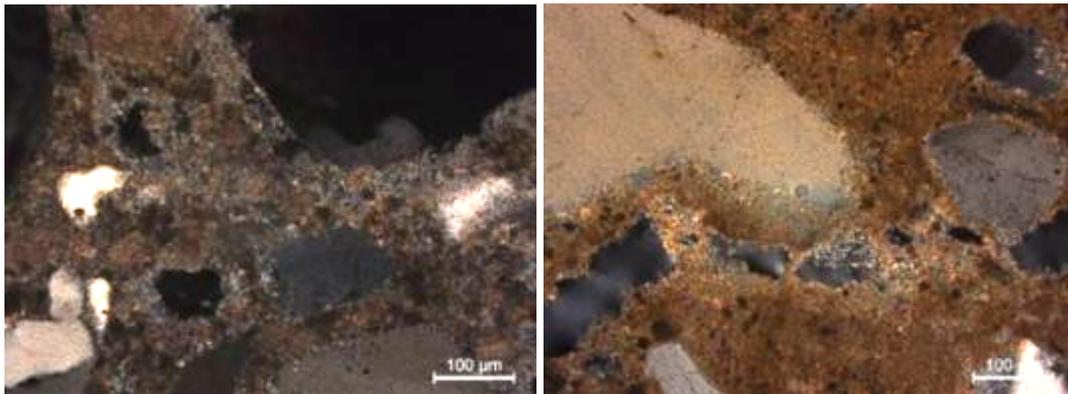
Figure 6.40: Secondary formed calcite in NHL mortars after ten (left-NHL730cy) and thirty wet-dry cycles (right-NHL790cy).

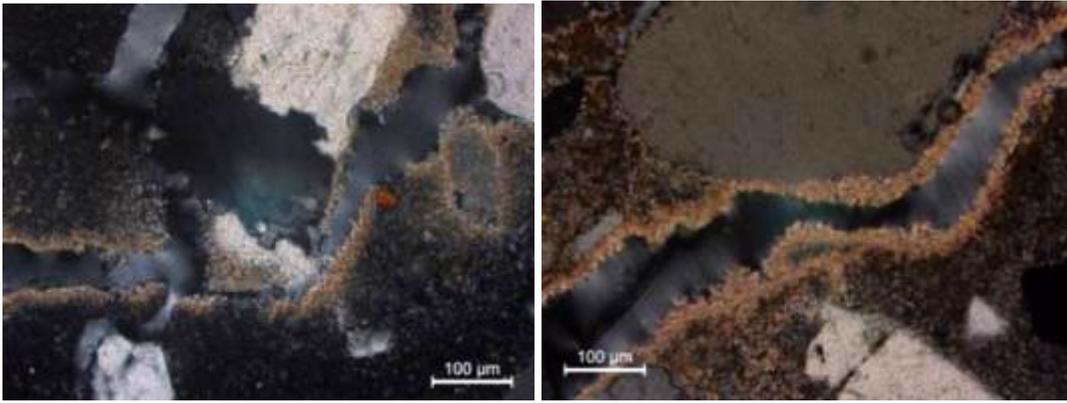
Figure 6.41: Secondary formed calcite in LP mortars after ten (left-LP1430) and thirty wet-dry cycles (right-LP1490). It was observed that the precipitation of calcite advances with additional cycles.

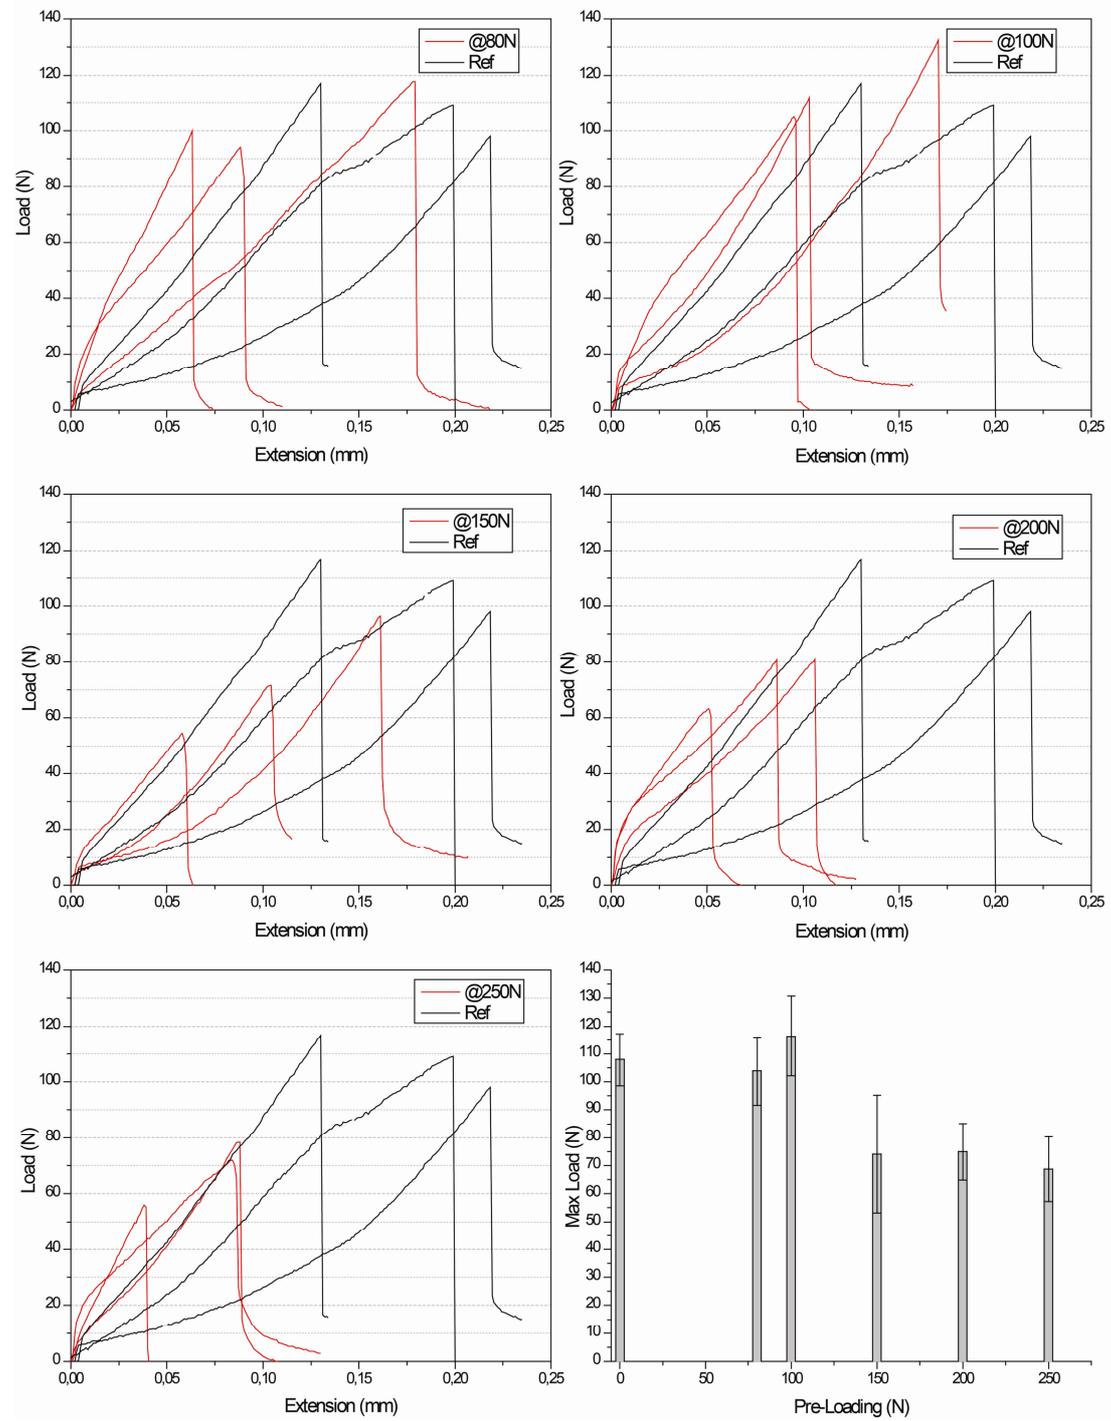
Figure 7.6: Loading curves obtained during three-point bending tests and damage degree calculated by three-point bending tests after incremental loads applied by hertzian stress.

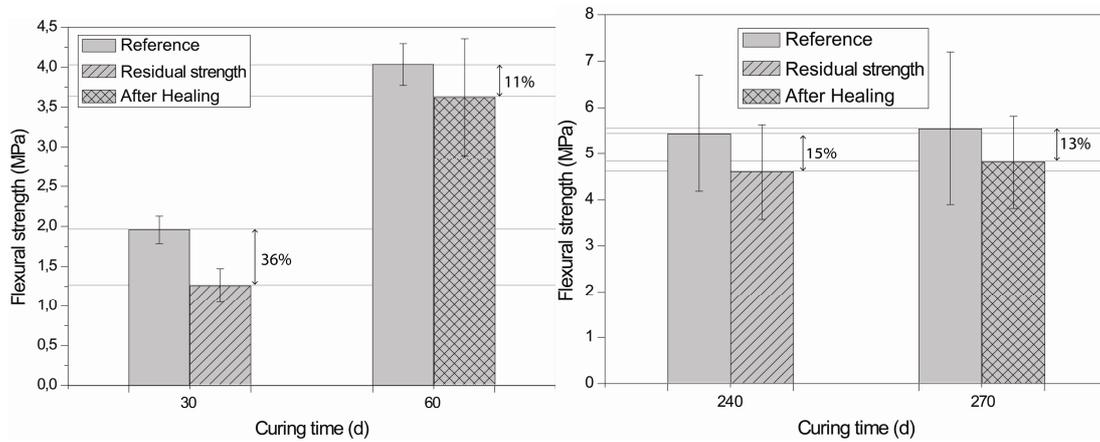
Figure 7.8: Flexural strength values of NHL specimens damaged at 30 and 240 days and healed for a 30 day healing period in elevated humidity conditions.

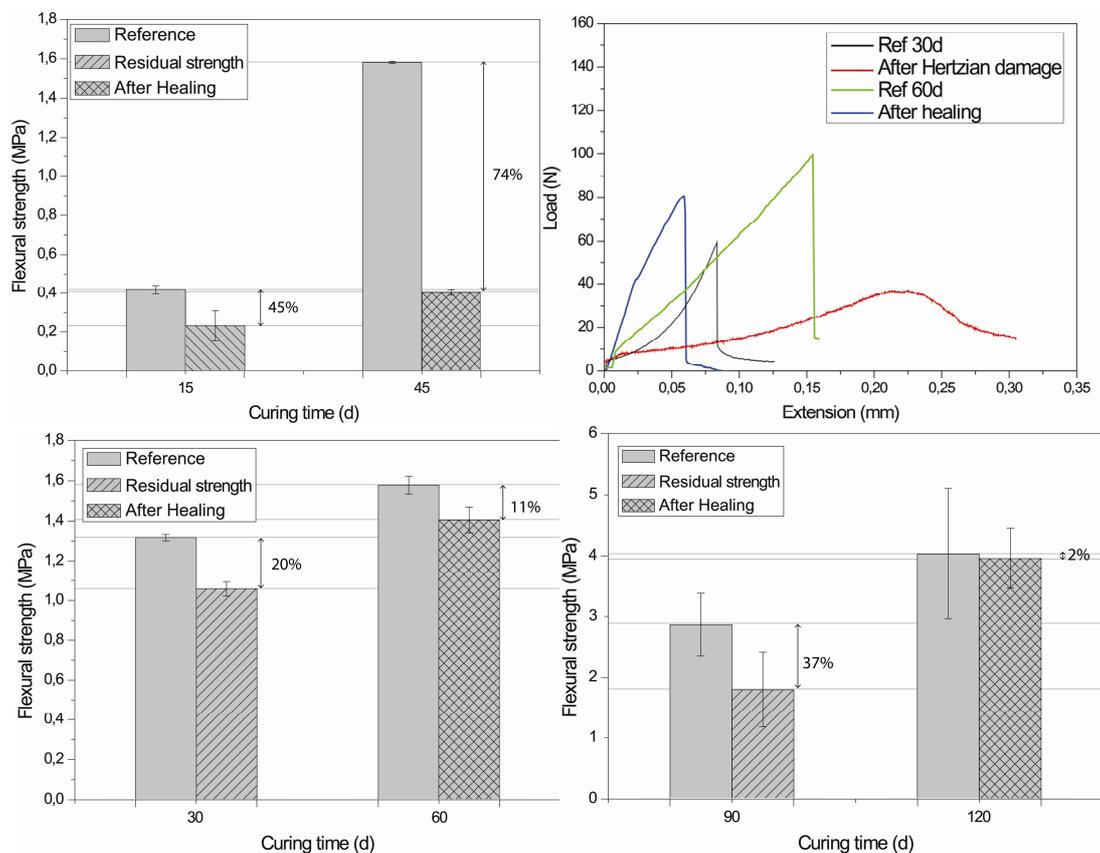
Figure 7.9: Flexural strength values of healed LP specimens damaged at 15 days 30 and 90 days respectively and healed for a 30 day healing period in elevated humidity conditions.

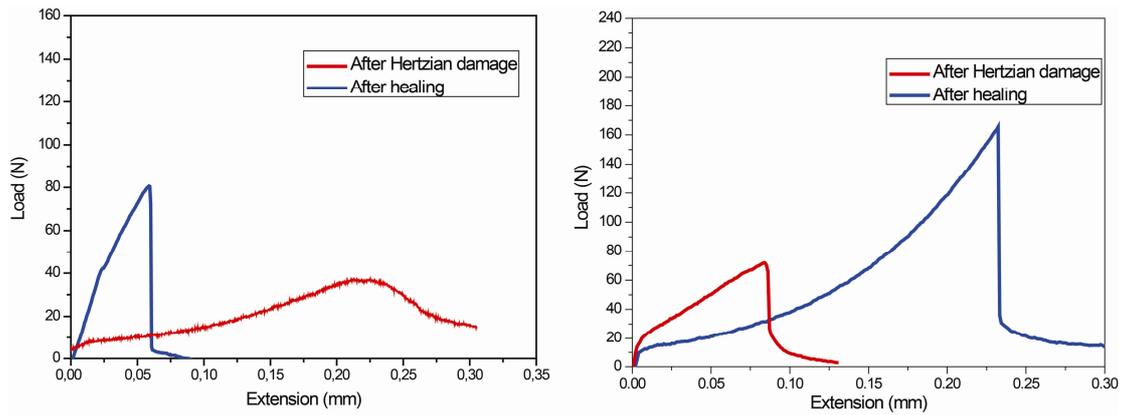
Figure 7.10: Representative loading curves obtained during three-point bending tests of LP (left) and NHL (right) specimens damaged after 30 day curing and healed for another 30 days.

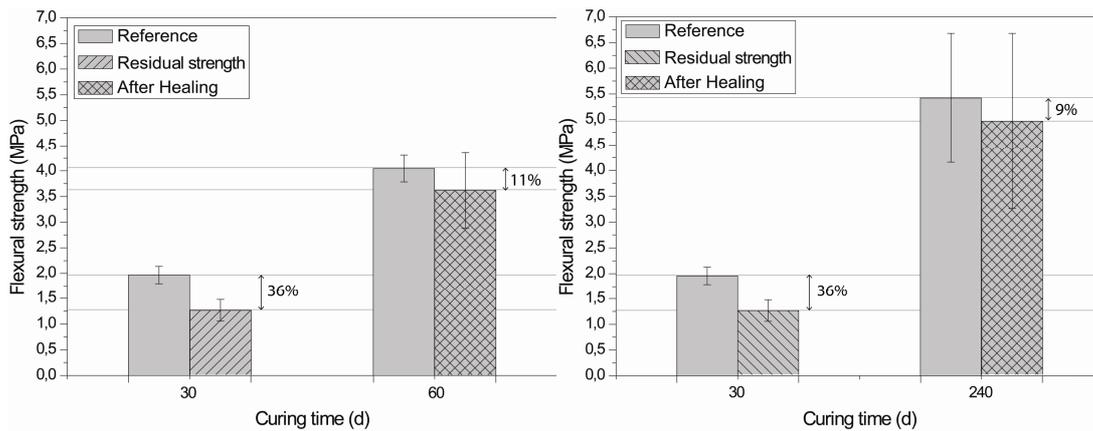
Figure 7.11: Flexural strength values of NHL specimens, damaged at 30 days (left) and subsequently cured for 30 (left) or 210 (right) day healing period respectively under high humidity conditions (95%RH).

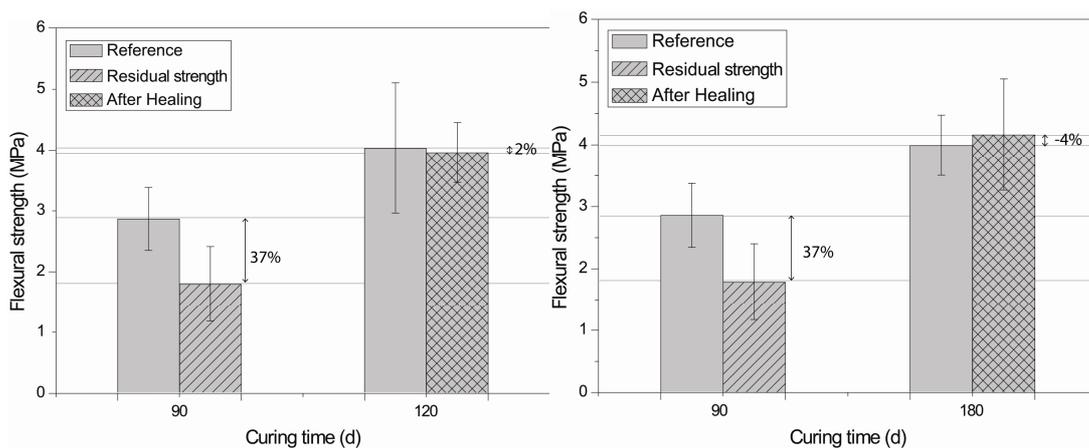
Figure 7.12: Flexural strength values of LP specimens, damaged at 90 days and subsequently cured for 30 (left) or 90 (right) days under high humidity conditions (95%RH).
