**ΠΟΛΥΤΕΧΝΕΙΟ
ΚΡΗΤΗΣ**

Mechanisms and parameters for life-cycle optimization of traditional lime-based mortars

PhD Thesis
by
Maria Amenta

Chania, July 2017

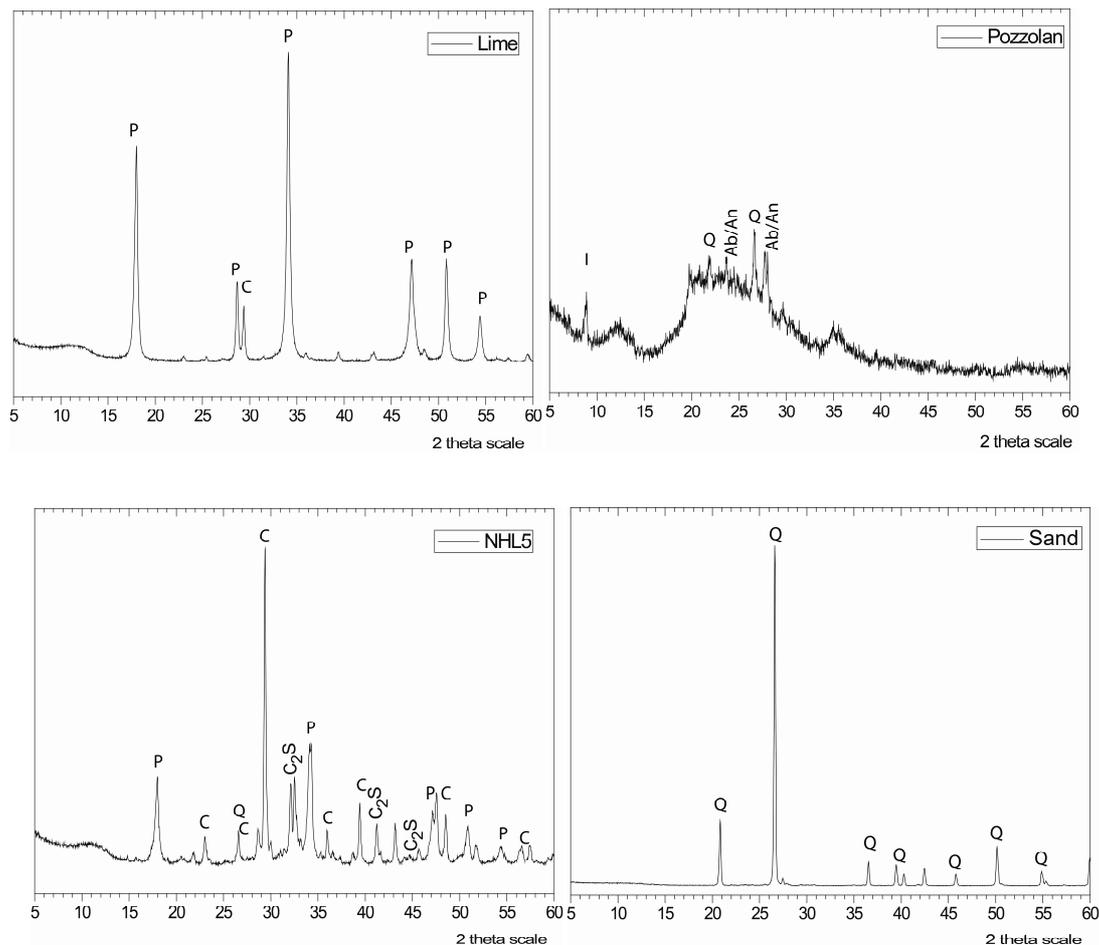
Figure 1: Diffractograms of the raw materials used in this study. P: portlandite, C: calcite, Q: quartz, I: illite, Ab: albite, An: anorthite, C₂S: dicalcium silicate

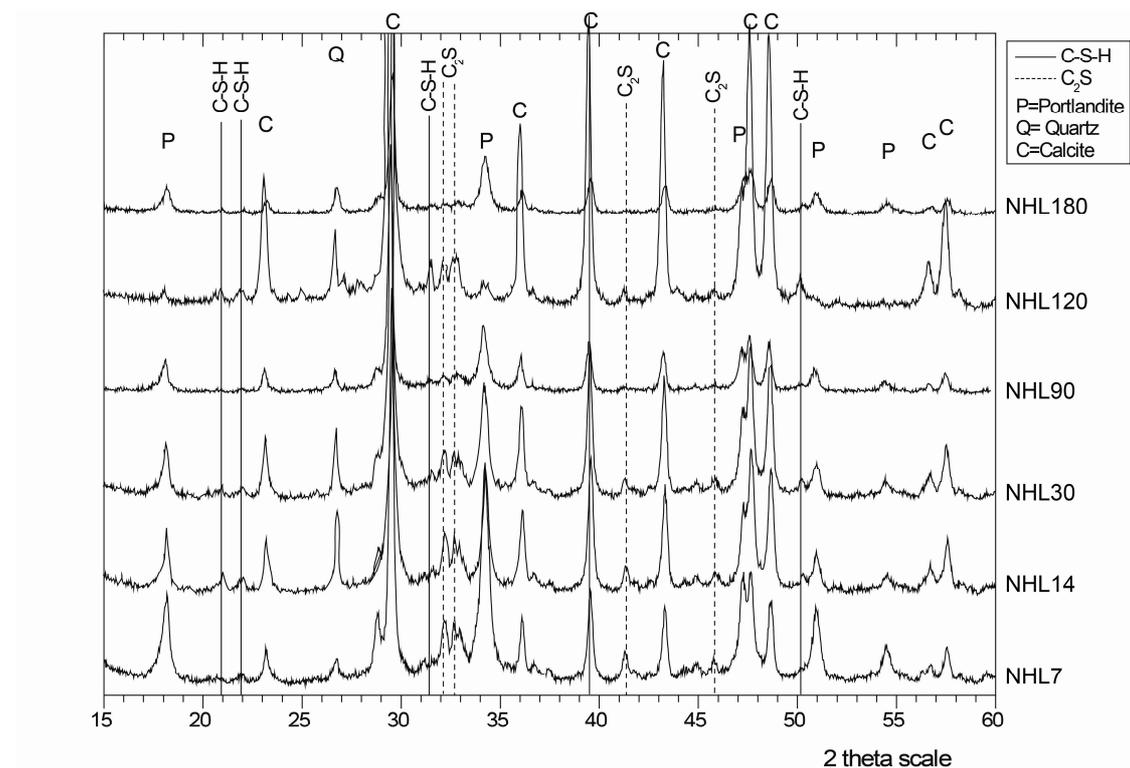
Figure 3: Diffractograms of NHL mortars.

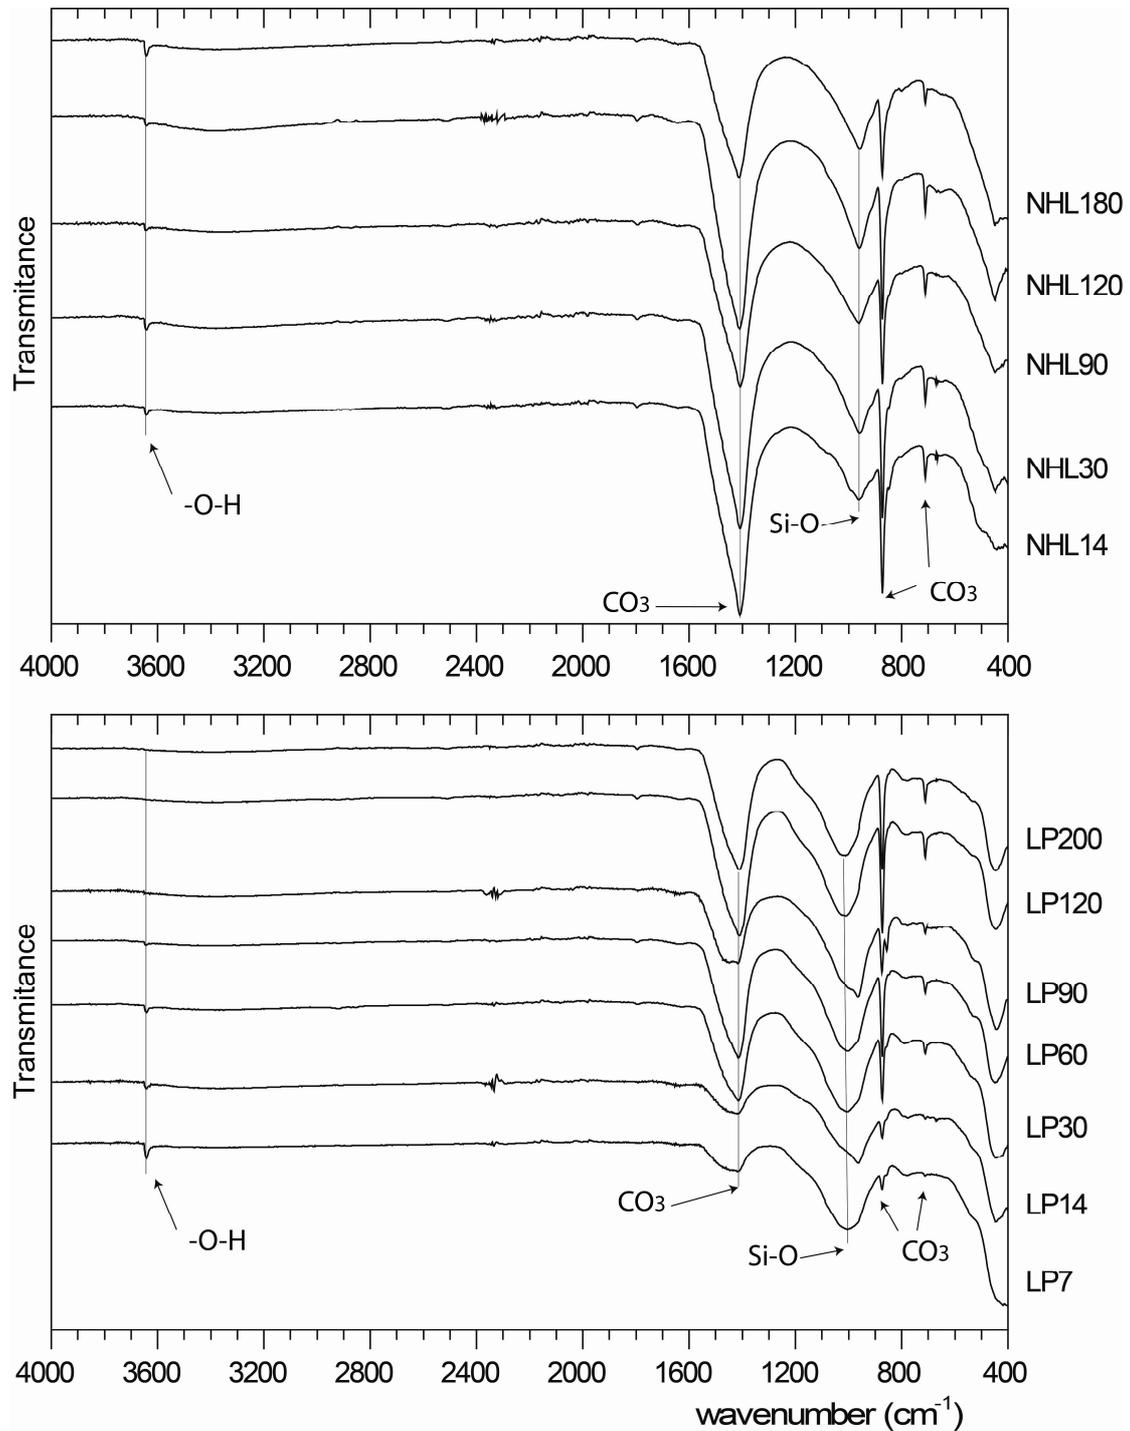
Figure 5: FTIR spectra of NHL and LP mortars after varying curing periods.

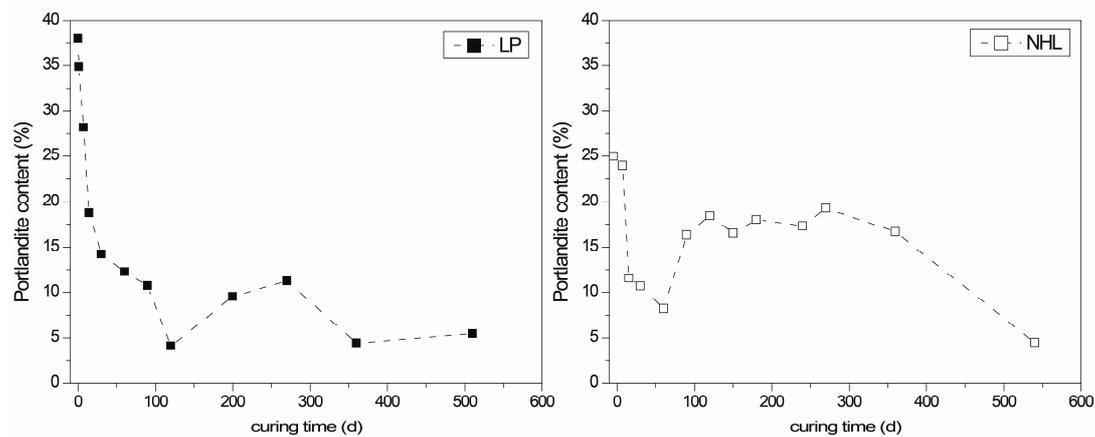
Figure 6: Portlandite content in NHL and LP mortars after varying curing periods.

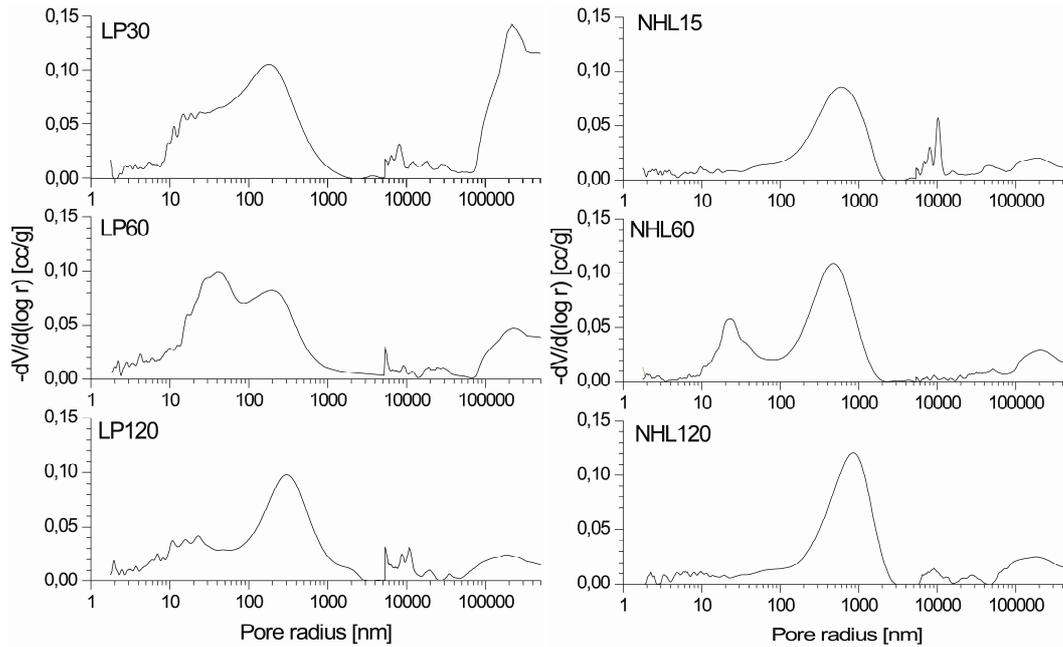
Figure 8: Total porosity of NHL and LP mortars after varying curing periods.
